Analysis of paint traces to determine the ship responsible for a collision

H. Lee[✉], D. Lee & J. M. Seo

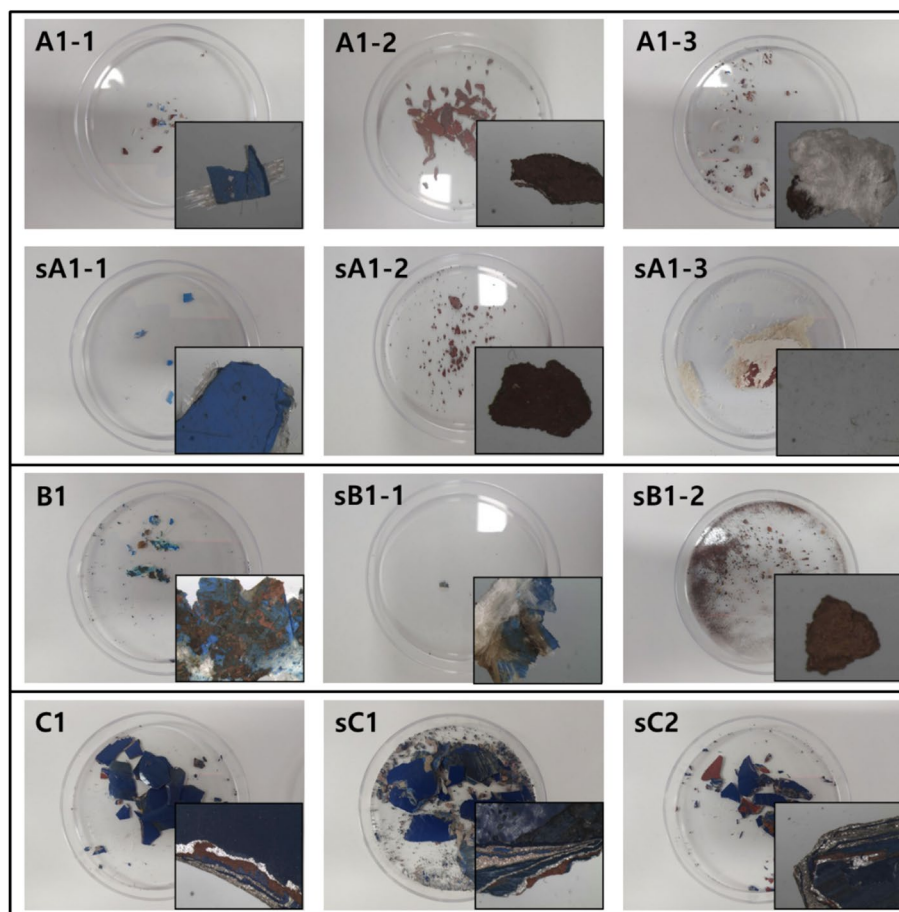
Case I: Ship collision in June 2020. Twelve samples were collected from the collision site. Of these, six were selected for a comparative analysis. The ship painted brown was the damaged ship, and the ship painted in white and blue was the suspected ship. The SEM surface images of the blue paint samples collected from the

Figure 1. Paint collected from the actual collision site.

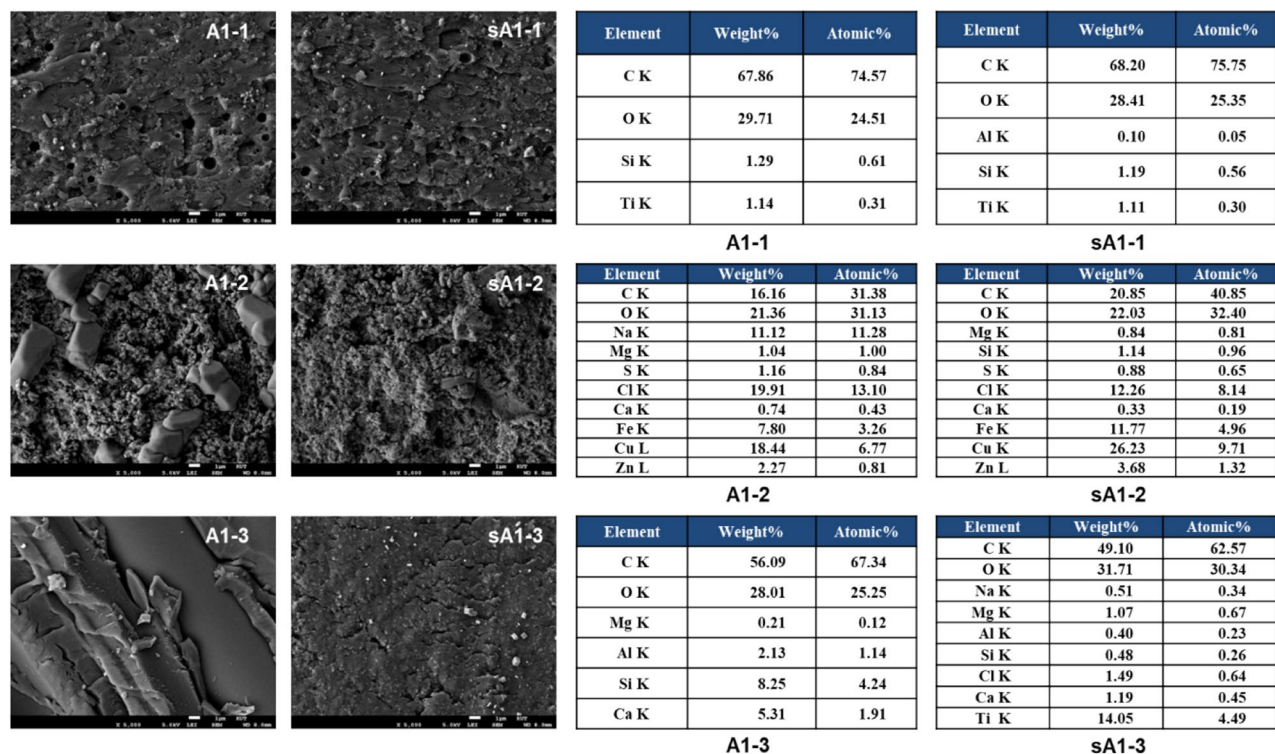
Figure 2. SEM-EDS image of Case I evidence.

port of the damaged ship (A1-1) and the starboard deck of the suspected ship (sA1-1) are similar to each other (Fig. 2). In addition, the surface images of the brown traces of A1-2 and sA1-2 collected from the backside of the port and the part of the fore deck were similar. However, the surface images of the white paint collected from the port (A1-3) and starboard center (sA1-3) were different. C, O, Si, and Ti were observed in the blue fragments, while C, O, Cl, Fe, and Cu were detected as the main elements in the brown paint samples (EDS images, Fig. 2). However, more atomic elements were distributed in the white paint collected from the suspected ship than that collected from the damaged ship. In the damaged ship sample, C, O, Si, and Ca were detected as the principal elements, while Ti and Cl were also detected in the suspected ship sample. It is not possible to accurately determine why the analysis results of the white paint samples of the damaged ship and the offending ship are different. The analysis results may differ because of the contaminants or other traces. Optical microscopy and SEM analysis results are shown in Figs. 1 and 2, respectively. A fibrous material was observed in the white paint layer and a smooth long shape was observed in the surface morphology, suggesting that the paint may contain the fibrous material. Parks et al. and Soroldoni et al. reported the presence of C, O, Mg, Al, Si, S, K, Ca, Fe, Ti, Ba, and Mn, depending on the paint type^{19,20}.

The SEM-EDS analysis of the white paint traces taken from the damaged and suspected ships did not match. However, the surface elements of the other samples were similar, and the pyrogram patterns and compounds of Py-GC/MS were also consistent. It is not easy to match all the evidence collected from the site of maritime accidents, because the surface of the ship contains various contaminants and sampling is not easy. The surface morphology of the white paint did not match, but the blue and brown paint samples taken together perfectly matched. Therefore, it can be concluded that the suspect ship was the dominant offender.

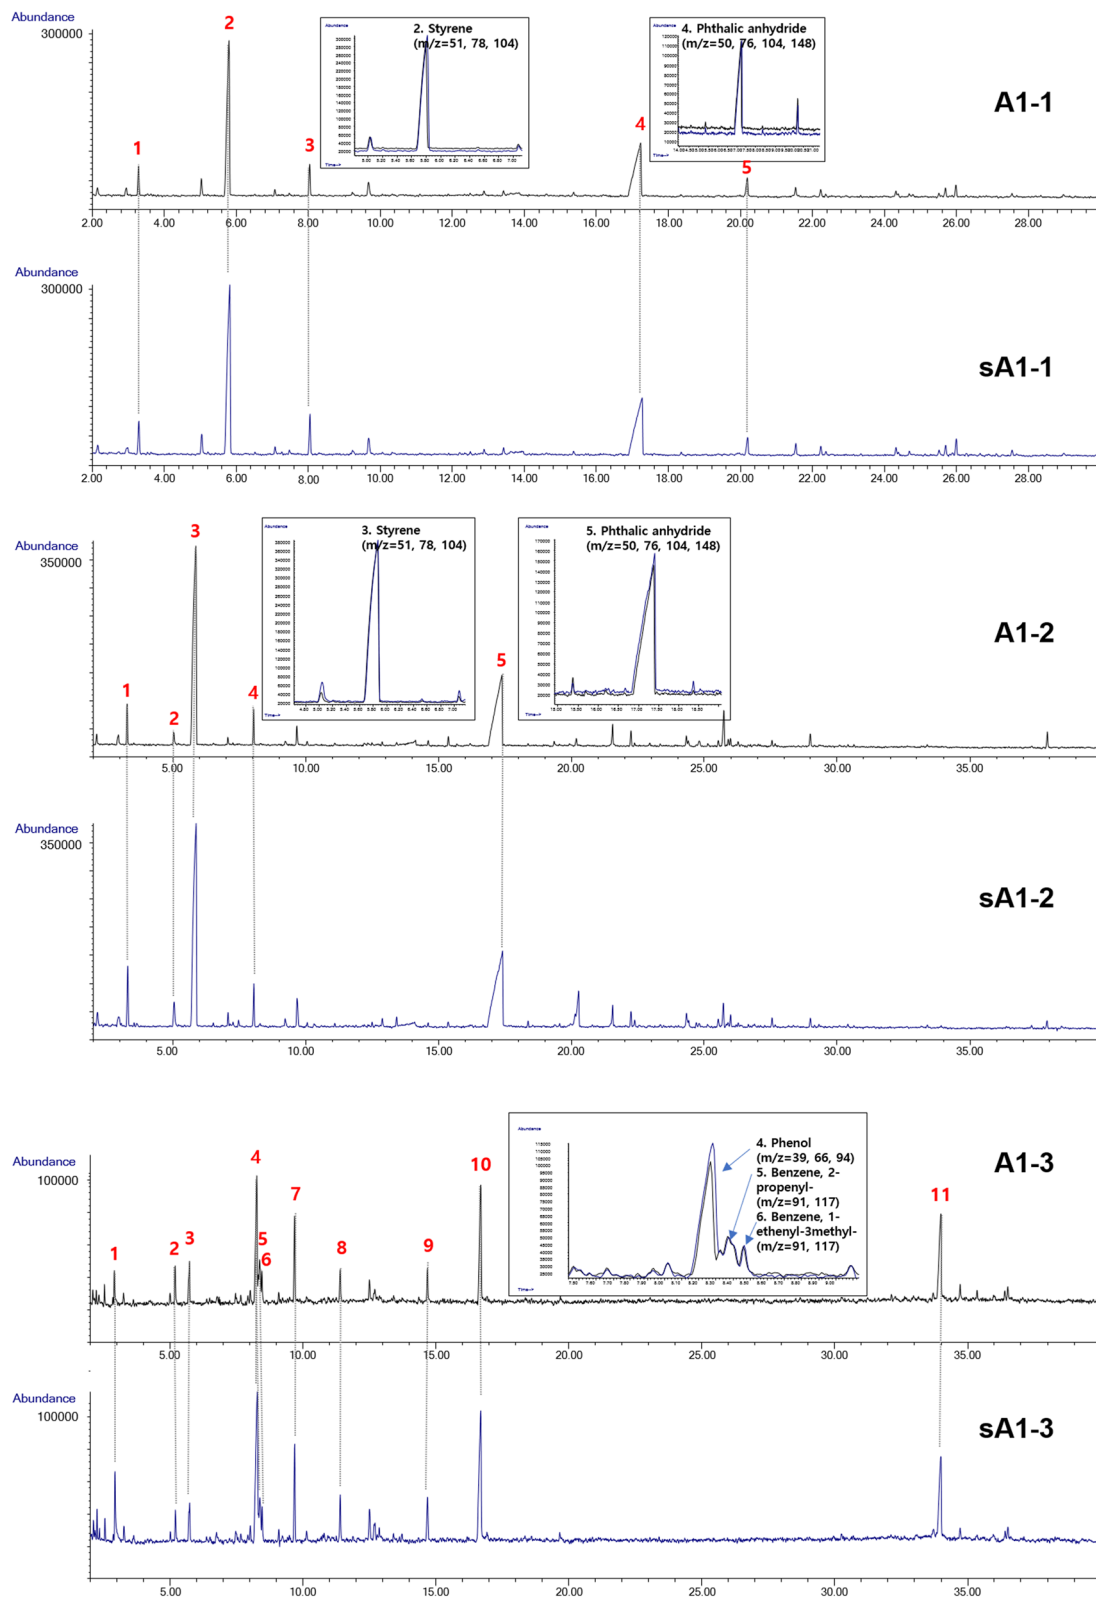
Figure 3. Py-GC/MS spectra of Case I evidence.

Figure 3 shows the chromatogram obtained from Py-GC/MS. The pyrolysis patterns of the blue, white, and brown samples of the damaged and suspected ships were similar. The major compounds of the blue samples were (1) toluene, (2) styrene, (3) α -methylstyrene, (4) phthalic anhydride, and (5) dimethyl phthalate. In the white paint sample, (1) toluene, (2) ethylbenzene, (3) styrene, (4) α -methylstyrene, and (5) phthalic anhydride were detected. In the brown samples, (1) toluene, (2) ethylbenzene, (3) styrene, (4) α -methylstyrene, (5) phthalic anhydride (1) pyridine, (2) p-xylene, (3) p-xylene, (4) phenol, (5) benzene, 2-propenyl, (6) benzene, 1-ethenyl-3-methyl-, (7) indene, (8) triisopropylsilanol, (9) phenol, 4-(1-methylethyl)-, (10) p-isopropenylphenol, and (11) phenol, 4,4'-(1-methylethylidene)bis- were identified. Styrene and phthalic anhydride were the most prominent components. Phthalic anhydride is known to be dominant in alkyd formulations^{21,22}. Poly(acrylate/styrene) is an unsaturated polyester widely used in emulsion-based paints^{23–25}. Song et al. indicated that alkyds and poly(acrylate/styrene) derived from marine paint resins in microplastics dominate the sea surrounding Korea²³. Pyridine and triisopropylsilanol were the characteristic compounds in the brown paint traces. These chemicals are used in antifouling paints for ships because they inhibit the growth of marine bacteria²⁶. In addition, common ship surface-coating materials such as toluene, ethylbenzene, and xylene were identified.

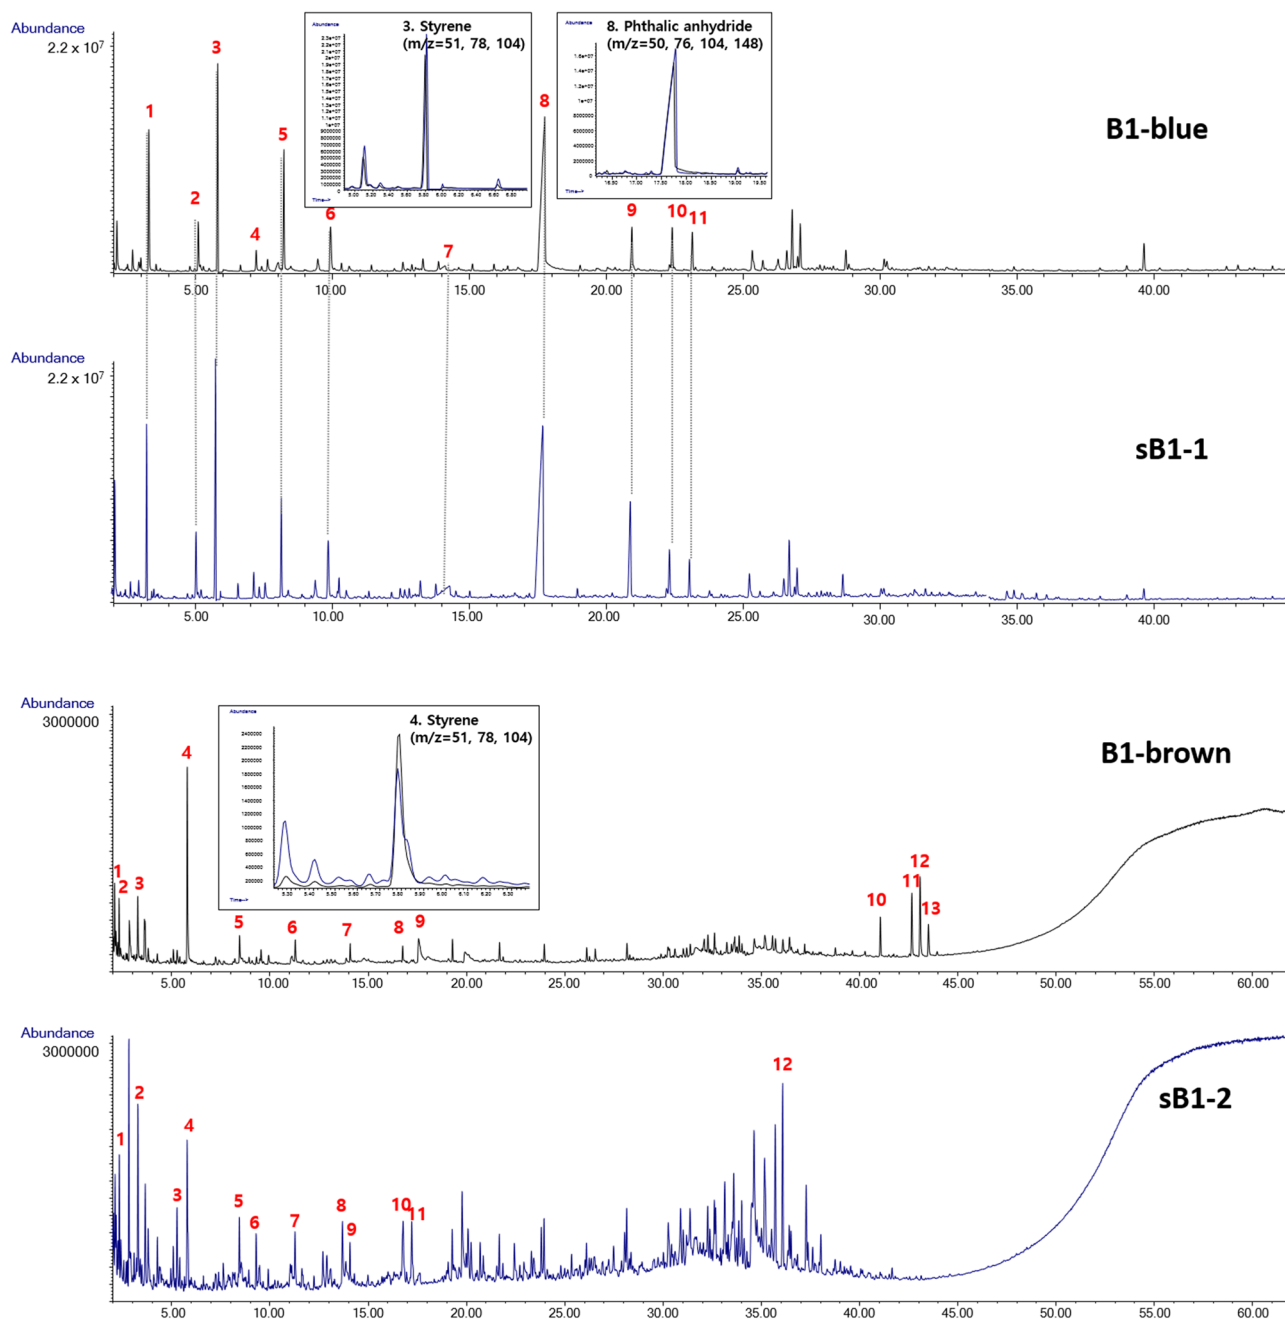
Figure 5. Py-GC/MS spectra of Case II evidence.

Figure 5 presents the Py-GC/MS results. The chromatograms of the blue samples, B1 and sB1-1, were similar. However, the brown samples of the damaged and suspected ships showed different patterns. The main components of the blue sample were (1) toluene, (2) ethylbenzene, (3) styrene, (4) 2-propenoic acid, 2-methyl-, 2-methylpropyl ester, (5) α -methylstyrene, (6) benzene, (1-methylenepropyl)-, (7) benzenecarboxylic acid, (8) phthalic anhydride, (9) dimethyl phthalate, (10) benzene, 1,1'-(1,2-ethanediy)bis-, and (11) benzene, 1,1'-(1,2-ethanediy) bis-. (1) benzene, (2) 1-heptene, (3) toluene, (4) styrene, (5) 1-decene, (6) 1-dodecene, (7) 1-dodecene, (8) 1-tridecene, (9) phthalic anhydride, (10) bis(2-ethylhexyl) phthalate, (11) phosphoric acid, tris(3-methylphenyl) ester, (12) phosphoric acid, tris(3-methylphenyl) ester, and (13) phosphoric acid, tris(3-methylphenyl) ester were identified in the B1 sample, and (1) benzene, (2) toluene, (3) o-xylene, (4) styrene (5) 1-decene, (6) benzene, 1-methyl-3-(1-methylethyl)-, (7) 1-dodecene, (8) naphthalene, (9) 1-dodecene, (10) naphthalene, 1-methyl-, (11) naphthalene, 1-methyl-, and (12) phenanthrene, 1-methyl-7-(1-methylethyl)- were detected in the sB1-2 sample. In the blue sample (B1 and sB1-1) as in Case I, phthalic anhydride, the main component of the alkyd paint, and styrene were observed. As shown in Fig. 5, the two samples showed similar peaks. Phosphoric acid, tris(3-methylphenyl) ester—a characteristic component of brown paint—was detected in B1, while naphthalene compounds such as (1) naphthalene, (2) naphthalene, 1-methyl-, and (3) phenanthrene, 1-methyl-7-(1-methylethyl)- were identified in sB1-2. The brown part was collected in a powder form from the ship guardrail, making it difficult to distinguish between the paint and the contaminants. In fact, it was difficult to identify the composition of a part of the sample because of the overall low intensity of the chromatogram.

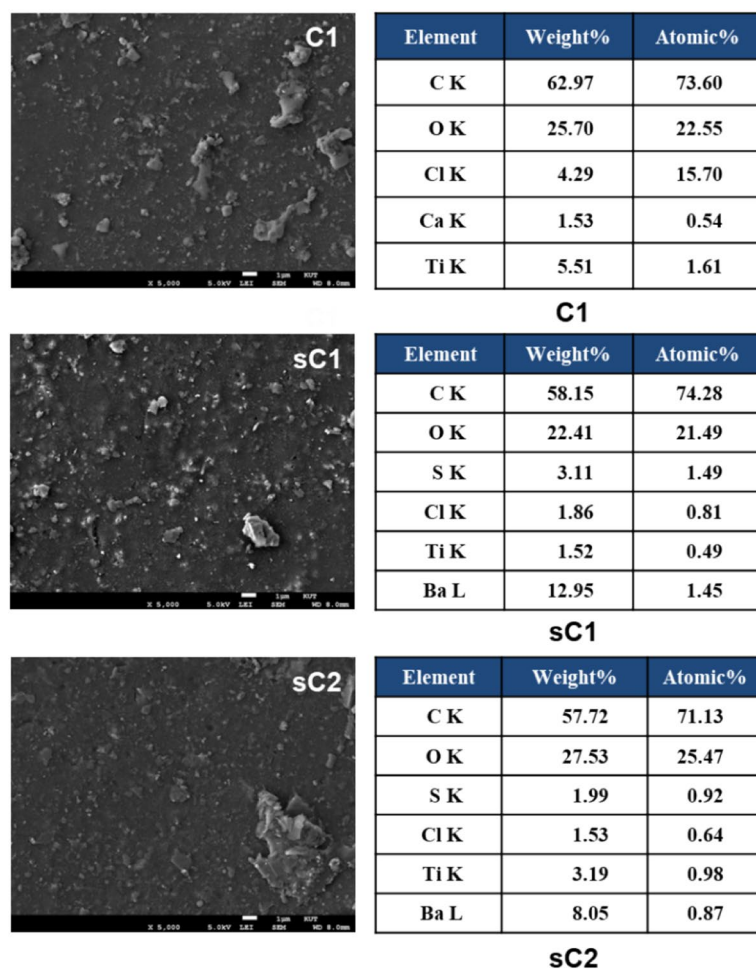
Figure 6. SEM-EDS image of Case III evidence.

Case III: Ship collision in March 2020. Three samples were collected from the collision site. Two suspected ships were identified after investigating the damage. The damaged ship sample C1 and the suspected ship samples sC1 and sC2 had similar surface textures. However, the elemental analysis of the suspected ship samples conducted using EDS was not consistent with that of the damaged ship (Fig. 6). C, O, Ti, Cl, and Ca elements were detected in the damaged ship sample; S and Ba were also identified in the paint traces obtained from the two suspected ships.

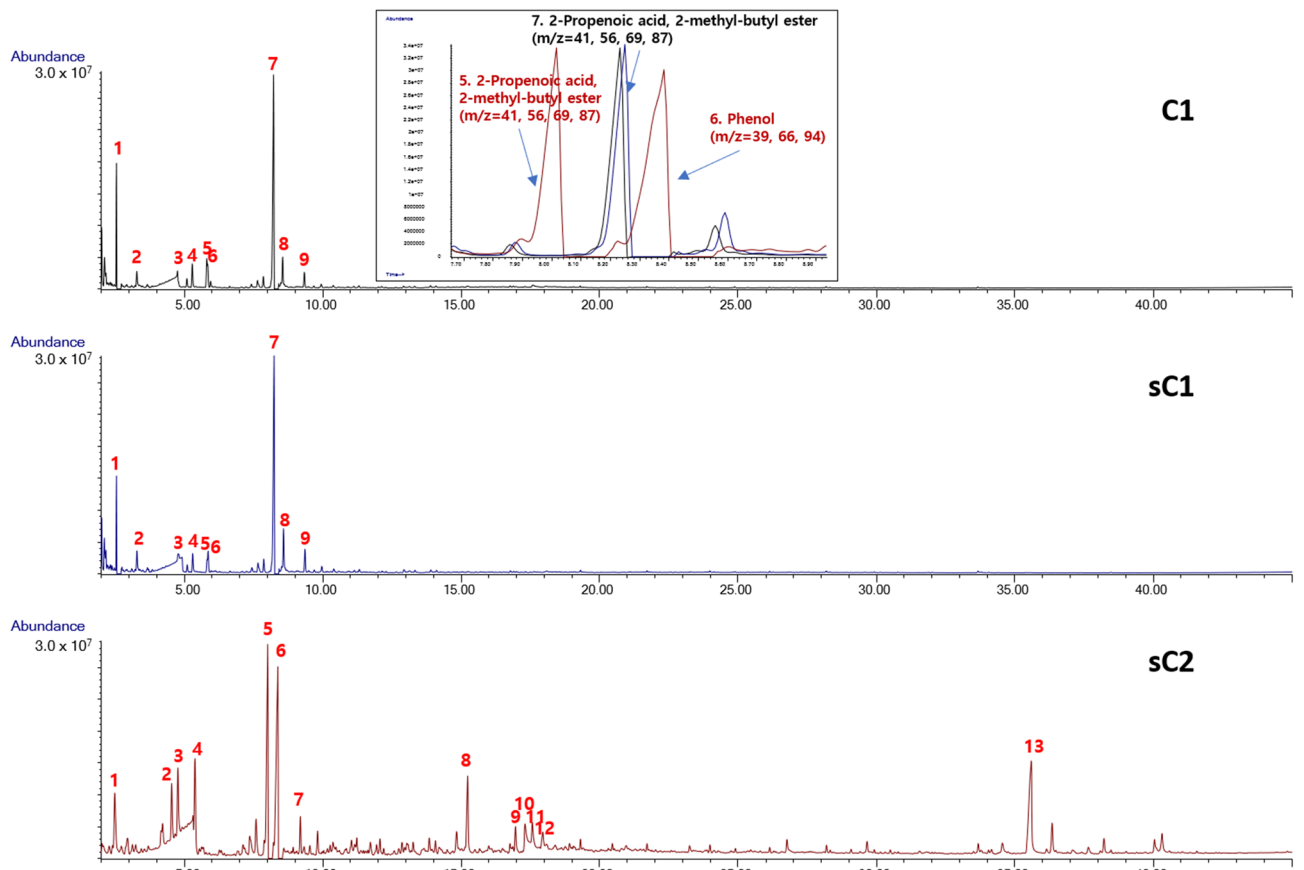
Figure 7. Py-GC/MS spectra of Case III evidence.

The chromatogram results of C1, sC1, and sC2 samples are shown in Fig. 7. C1 and sC1 showed similar chromatogram patterns, while sC2 showed a different profile. The following were the major compounds of C1 and sC1 samples: (1) 2-propenoic acid, 2-methyl-, methyl ester, (2) toluene, (3) 2-propenoic acid, 2-methyl-, (4) p-xylene, (5) styrene, (6) o-xylene, (7) 2-propenoic acid, 2-methyl-, butyl ester, (8) benzene, 1,2,3-trimethyl-, and (9) benzene, 1,2,3-trimethyl-. For the sC2 fragments, the major elements were (1) toluene, (2) ethylbenzene, (3) p-xylene, (4) p-xylene, (5) 2-propenoic acid, 2-methyl-, butyl ester, (6) phenol, (7) benzene, 1,2,3-trimethyl-, (8) phenol, 4-(1-methylethyl)-, (9) phenol, p-tert-butyl-, (10) p-isopropenylphenol, (11) phthalic anhydride, (12) 1,3-benzenedicarbonitrile, and (13) phenol, 4,4'-(1-methylethylidene)bis-. Hydrocarbons such as toluene and xylene were mainly detected in the C1 and sC1 samples. In the sC2 sample, in addition to hydrocarbons, O-compounds such as 2-propenoic acid, 2-methyl-, butyl ester, phenol, 4-(1-methylethyl)-, benzaldehyde, 3-methyl-, and N-compounds of 1,3-benzenedicarbonitrile were detected.

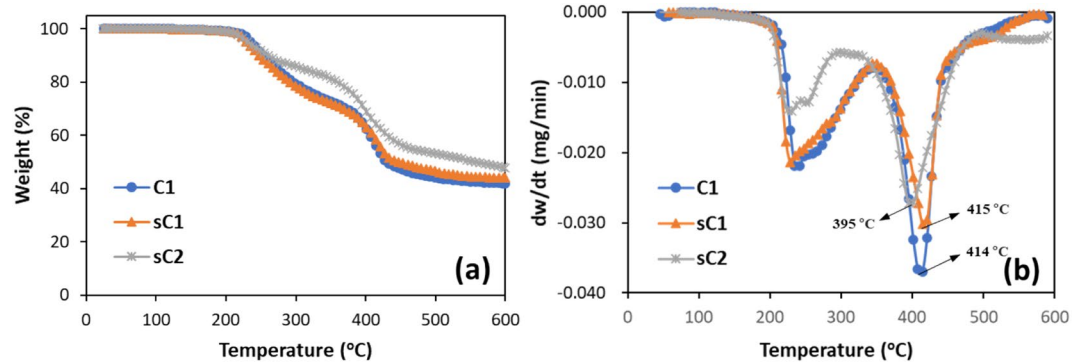
Figure 8. TG-DTG curves of Case III evidence.

Figure 8 shows the TG and DTG curves of the Case III evidence. All three samples present two decomposition stages in the TG and DTG curves. The first stage was from 200 to 350 °C, and the second stage was from 350 to 500 °C. The C1 and sC1 samples presented similar behavior; in contrast, sC2 showed less weight loss compared to the other samples. The weight losses of C1, sC1, and sC2 were 27%, 28%, and 19% at 350 °C, respectively, and 56%, 53%, and 47% at 500 °C, respectively. Because of the presence of phenolic compounds such as phenol, 4-(1-methylethyl)-, phenol, p-tert-butyl-, p-isopropenylphenol, phenol, 4,4'-(1-methylethylidene)bis in the sC2 sample, the weight loss was estimated to be less in the TG-DTG curve measured from room temperature to 600 °C. Zhou et al. and Souza et al. reported the thermal decomposition of a phenolic resin converted to an amorphous carbon at 700 °C, and showed that the thermogravimetric loss rate of pure phenolic resin reached a maximum at 550 °C^{27,28}.

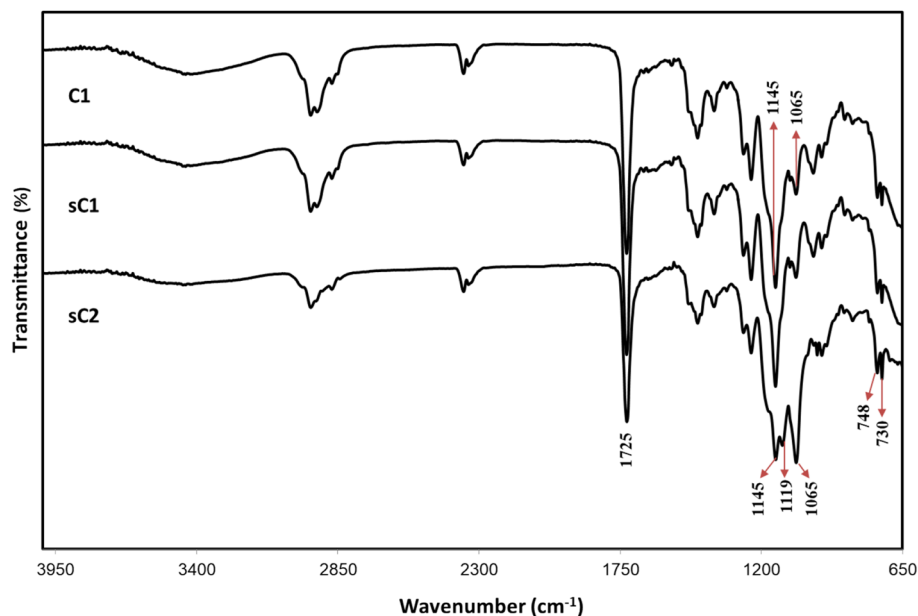
Figure 9. ATR-FTIR spectra of Case III evidence.

The infrared spectra of the Case III evidence are shown in Fig. 9. The ATR-FTIR spectra of C1, sC1, and sC2 showed similar absorption bands. In particular, the peak position and intensity of C1 were similar to those of sC1. An investigation of the paint evidence based on the spectra obtained from the FTIR polymer library at OMNIC (Thermo Nicolet Corporation, Sprouse Polymer by ATR Library) showed that the spectra matched well with that of poly(butyl methacrylate). A comparison of the paint evidence spectra with the Py-GC/MS results showed the presence of 2-propenoic acid, 2-methyl-, butyl ester (=butyl methacrylate), which showed the highest intensity in the chromatogram. These spectra are similar to those obtained for the alkyd resin, as reported by Hayes et al. and Burns et al. using ATR-FTIR. The spectral regions of the alkyd resin were identified as 1680–1770, 1000–1360,

and $630\text{--}800\text{ cm}^{-1}$ for ester C=O, ester C–O–C, aromatic C–H and aromatic ring bending, respectively^{21,22}. Although the spectra of the sC2 sample were similar to those of the damaged ship sample, different peaks were observed in the 1119 and 1065 cm^{-1} regions. He et al. analyzed the ship deck paint and reported peaks at 1120 , 1070 , 830 , and 740 cm^{-1} , indicating the presence of nitrocellulose and alkyd resins⁵.
