CASE REPORT

# Two stage fracture of a polyethylene post in a 9-year-old posterior-stabilized knee prosthesis: a case report

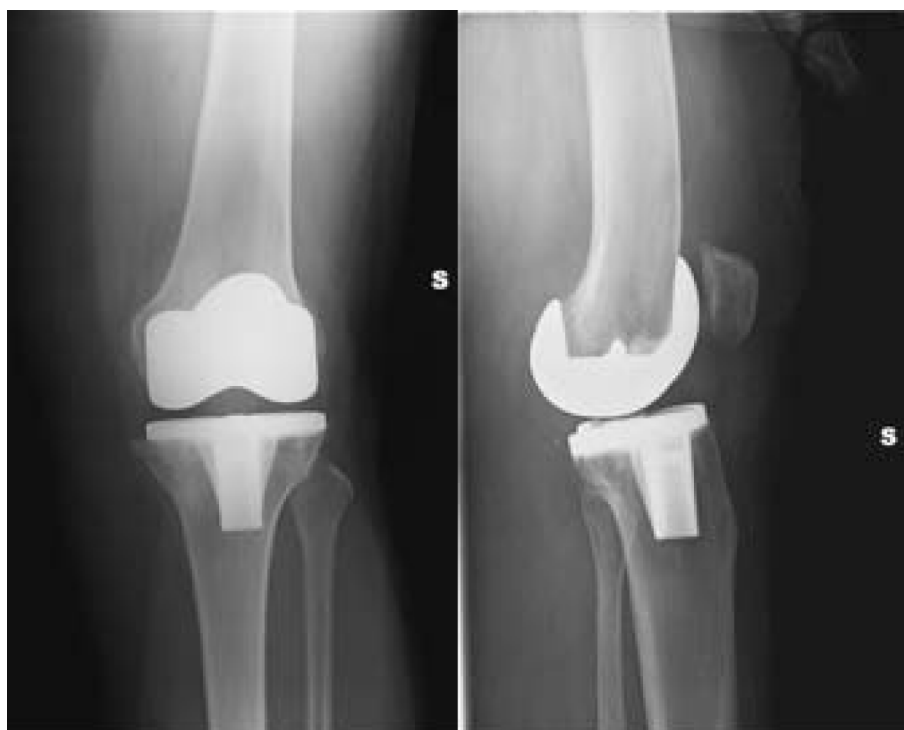
acute event she was unable to bear weight on her left knee, and was thus forced to use crutches. On physical examination she presented a mild effusion of the knee, a flexion of 90°, and knee hyperextension. The joint presented signs of both anteroposterior and varus to valgus instability. X-ray examinations showing the anteroposterior view of the knee did not indicate any remarkable alteration in polyethylene wear, while the lateral view showed a hyperextension of the tibia with a posterior subluxation of the femur (Figure 1). The hypothesis of post breakage was thus made.

**Figure 1 Preoperative X-rays.** The hyperextension of the tibia in relation to the posterior subluxation of the femur can be seen.

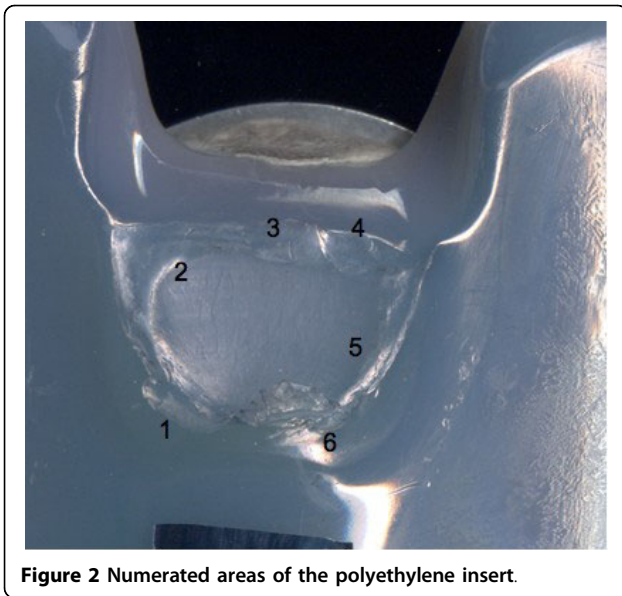
**Figure 2** Numerated areas of the polyethylene insert.

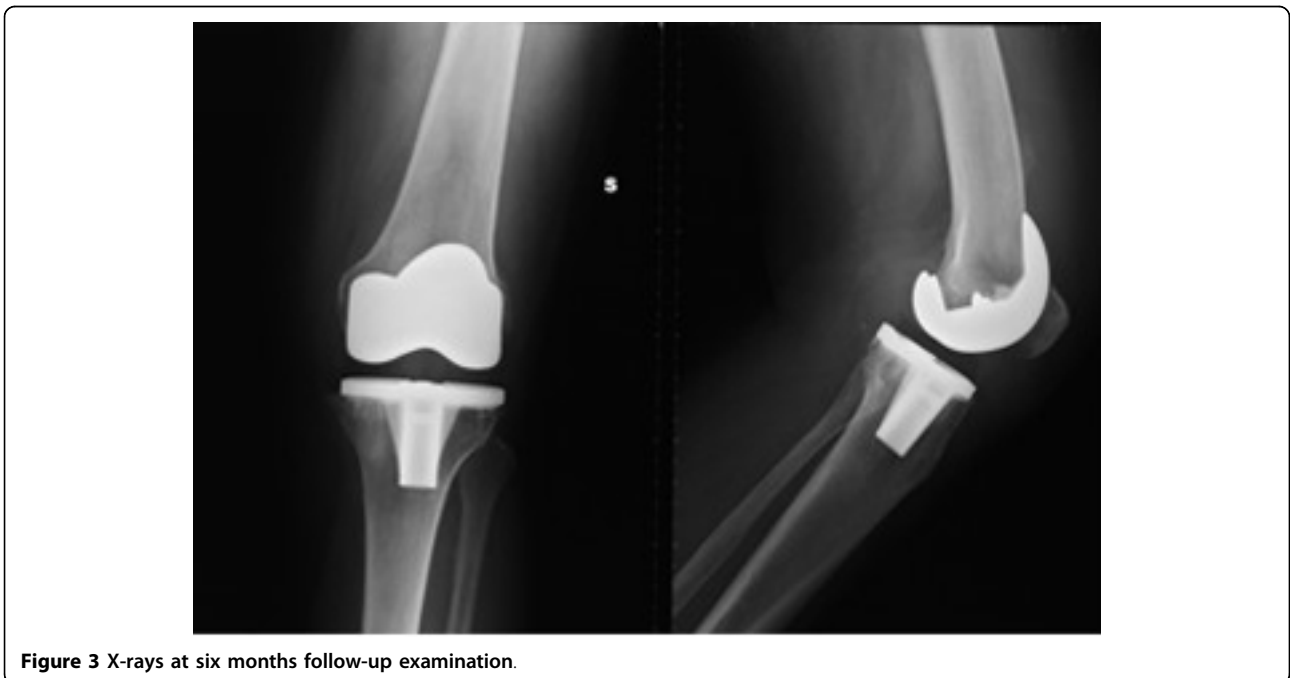
At six months follow-up the patient had recovered complete function of her left knee. She was free from pain and could walk normally without any support (Figure 3).

**Figure 3** X-rays at six months follow-up examination.

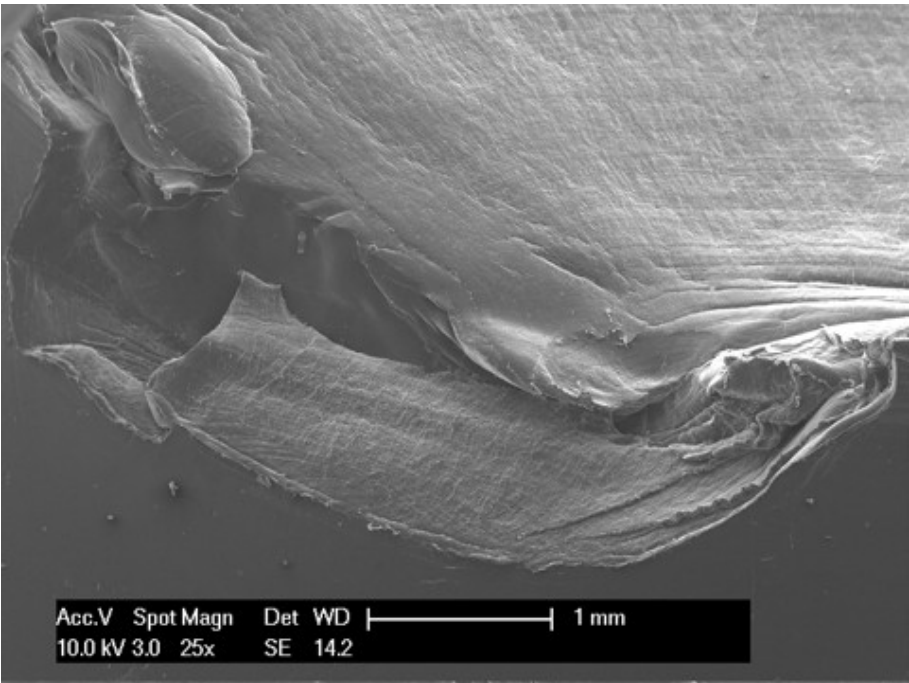
Figure 4 Area 1 of Figure 2.

Scanning electron microscopy, as reported in the literature [14,18], is an effective modality for analyzing the surface of fatigue fractures. An evaluation of the retrieved tibial polyethylene insert via SEM revealed two different damage patterns, considering the medial part and the lateral aspect (Figure 4). The medial part (Figure 2 areas 1, 2 and 3, Figure 4, Figure 5, Figure 6) presented a fracture line laminated in front and smooth behind and with the tear lines with a mediolateral and anterior posterior orientation.

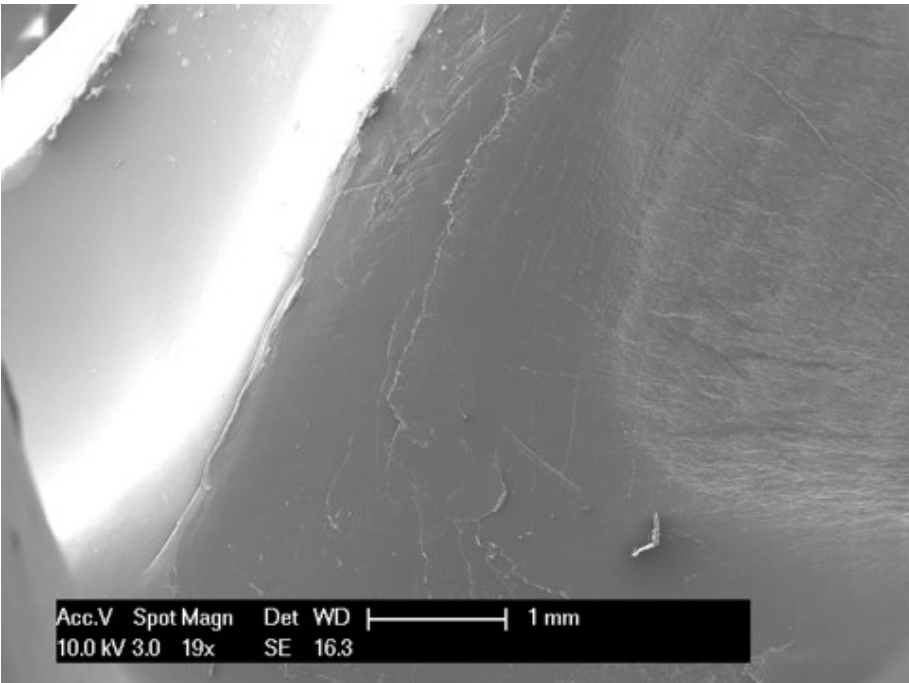
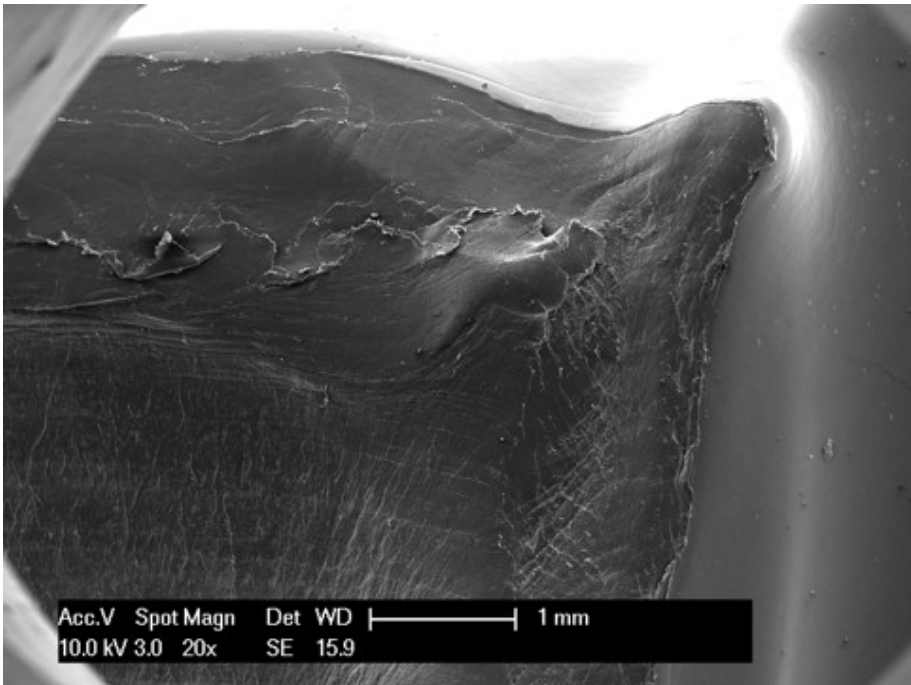
The medial part of the fracture edge appears to be smooth (Figure 2 areas 2 and 3) and with a different orientation of the fracture lines. These characteristics suggest a chronic instability of the varus valgus knee prosthesis that slowly weakened the polyethylene post.

Figure 5 Area 2 of Figure 2.

Figure 6 Area 3 of Figure 2.

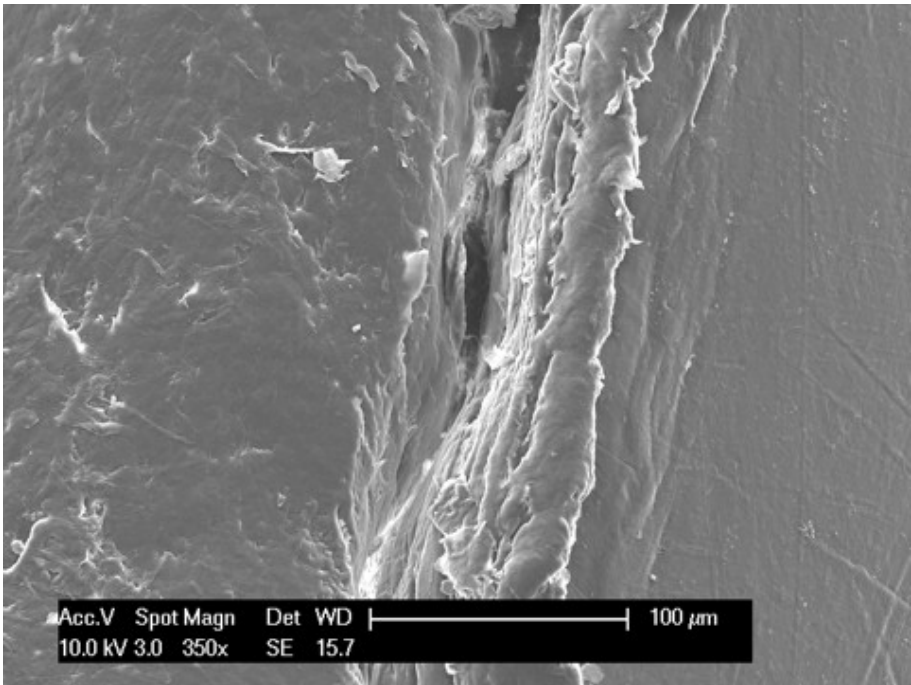
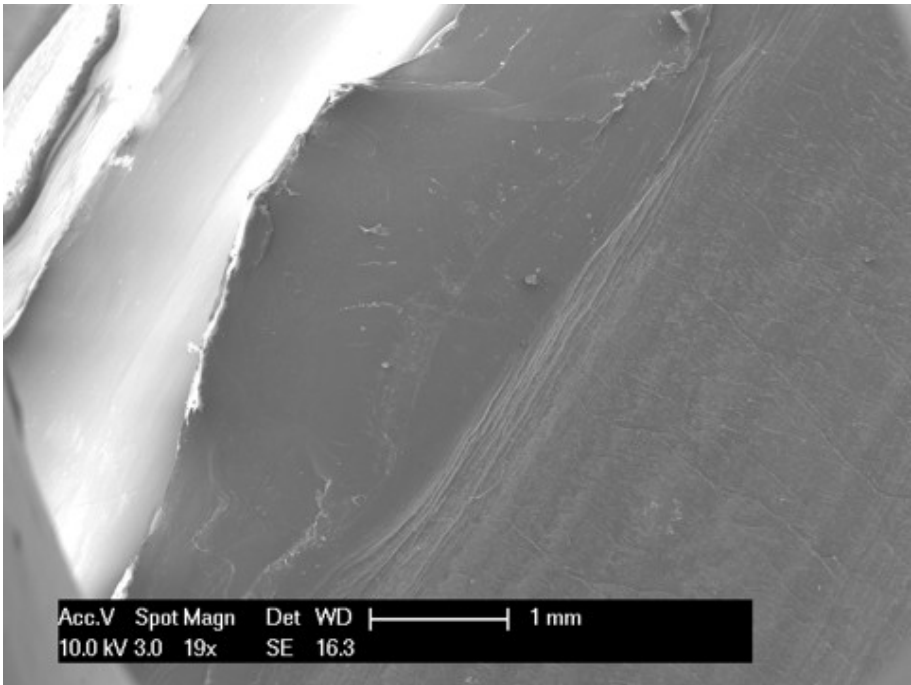
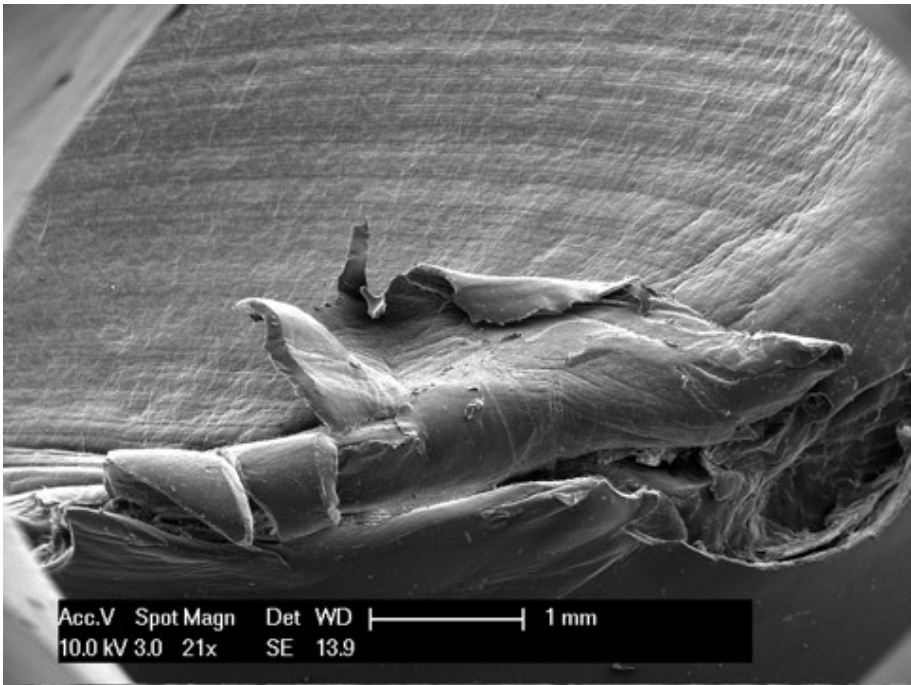
Meanwhile, the lateral part (Figure 2 areas 4, 5 and 6, Figure 7, Figure 8, Figure 9) of the fracture presented a sharp line that ends anteriorly with a laminated tear (Figure 2 area 6, Figure 9) parallel to the anterior edge of the polyethylene insert. This implies that this area could be the terminal acute failure area of the fractured post. The final rupture occurred after the chronic weakening of the polyethylene due to the mediolateral stress on the tibial post. These features could be explained with a two-stage rupture of the polyethylene post. First, a varus and anteroposterior force caused partial rupture and instability of the post, which caused progressive smoothing of the medial and posterior fracture edges. Consequently, an anteroposterior lift-off force led to the complete rupture of the post. This could have been

Figure 7 Area 4 of Figure 2.

Figure 8 Area 5 of Figure 2.

Figure 9 Area 6 of Figure 2.

caused by a non-optimal ligamentous balancing during the first implant surgery. Our patient's knee probably developed progressive varus instability that slowly weakened the post, and then an anteroposterior stress finally broke the polyethylene.

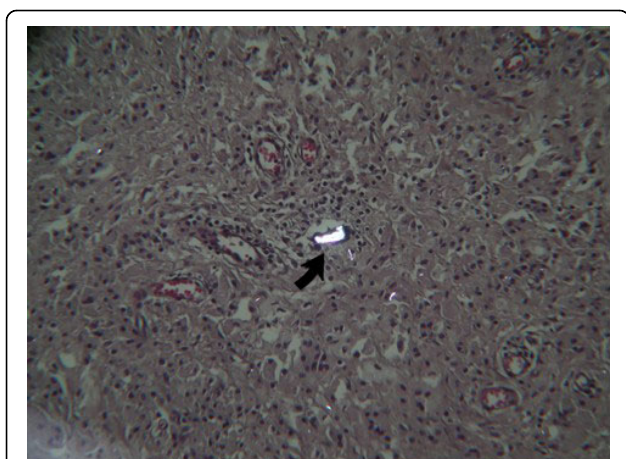
**Figure 10** Dense connective tissues with typical inflammatory cells and rare polyethylene flakes (arrow) are identifiable.

Light microscopy evaluation showed a typical chronic inflammatory reaction. Rare polyethylene flakes were identifiable under polarized light. These particles appeared to be well-controlled by giant cells. No metallosis was observed (Figure 10). Von Kossa staining returned negative results. Such findings can be considered normal synovia in TKA. The absence of polyethylene particles confirmed the macroscopic evidence of the absence of wear, which could have caused the breakage.
