Temporary device malfunction of an MR conditional cardiac resynchronization defibrillator when undergoing MRI without appropriate re-programming: a case report

Barts Heart Centre, West Smithfield, London EC1A 7BE, UK

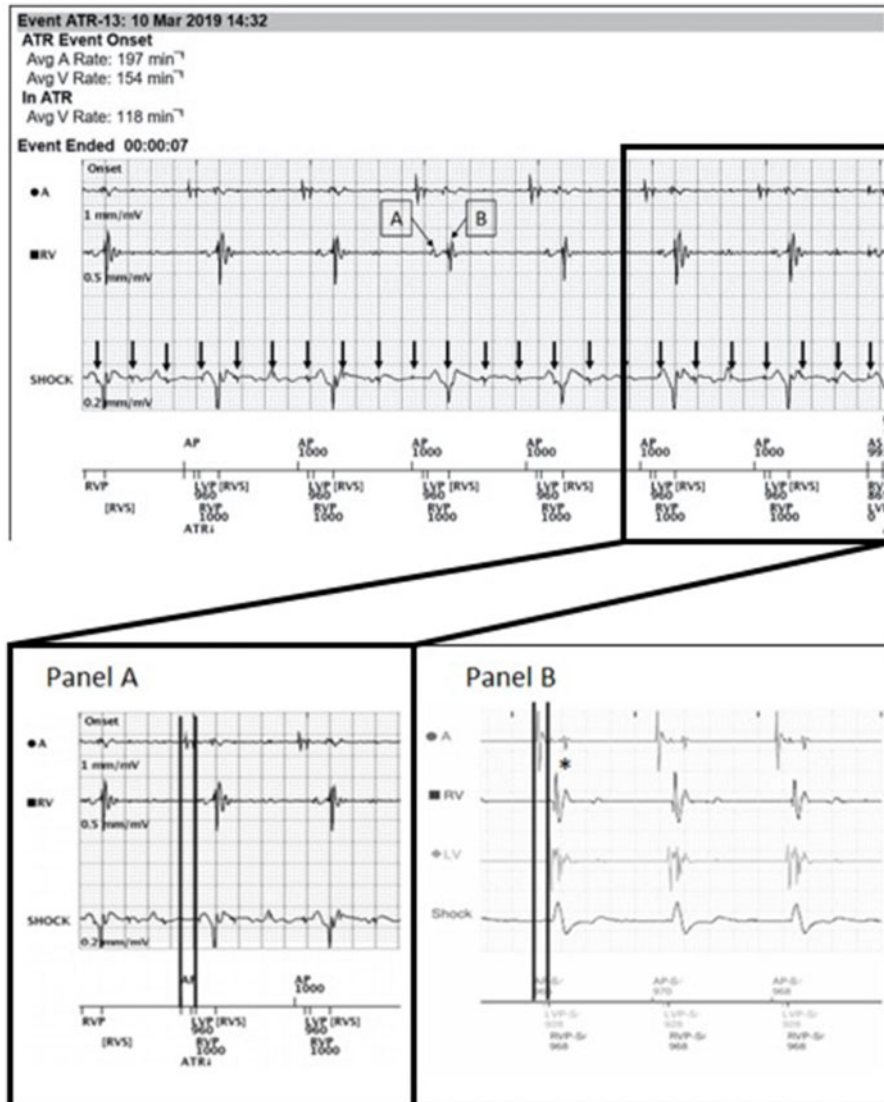
- 3) Loss of RV capture (Figures 2 and 3)
- 4) Figure EGM demonstrates temporary loss of capture on the endocardial RV lead, however, there is capture on the epicardial (coronary sinus LV lead. This is proved in Figure 3, where the loss of evoked response on the RV channel is shown compared to the capture seen in clinic (*). The implications for our patient were minimal due to his continuing pacing from his LV lead and underlying AV conduction.

Figure 2 Stored atrial tachycardia response episode during the magnetic resonance imaging scan. Electrograms: Top—right atrial (A); second—right ventricular; third—shock/farfield; bottom—marker channel. Point A on the trace shows loss of capture on the right ventricular lead. Point B indicating right ventricular activation from left ventricular pacing. The arrows on the shock channel indicate electromagnetic interference artefact (which also correspond visibly on the A and right ventricular channels). The signals are regular, high frequency and low amplitude at the rate of magnetic resonance imaging rotation.
