Leaflet fracture and embolization from an On-X mechanical mitral valve

CENTRAL MESSAGE

We report the case of a 26-year-old male who presented with cardiogenic shock due to leaflet fracture and embolization from an On-X mitral valve prosthesis that had been implanted just 1 year earlier.

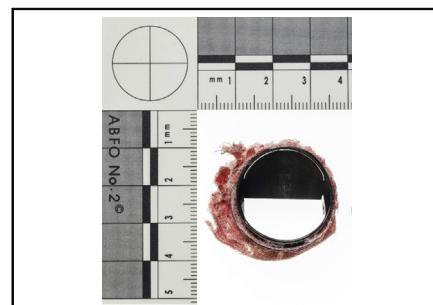
Explanted On-X mitral prosthesis with 1 leaflet missing.

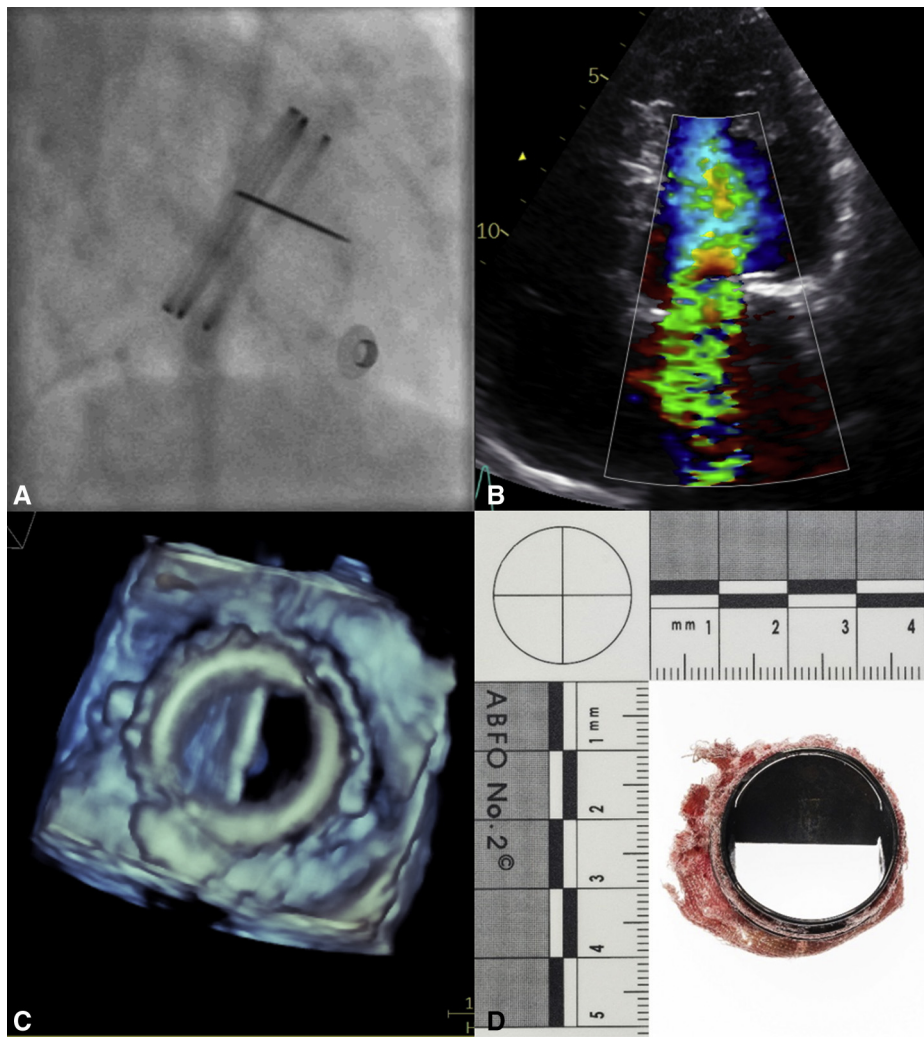
He was taken directly from the emergency room to the cardiac catheterization laboratory, where fluoroscopy revealed a single leaflet opening (Figure 1, A, and Video 1) and TTE confirmed the single moving leaflet and significant mitral regurgitation in the mitral valve prosthesis (Figure 1, B). Intravenous thrombolysis was administered on the suspicion of acute valve thrombosis, with no beneficial or adverse effects.

The next morning, the patient was still in cardiogenic shock and was stabilized with an intra-aortic balloon pump. Repeat TTE raised a suspicion that the nonvisualized leaflet was not in situ, which was later supported by transesophageal echocardiography (Figure 1, C, and Video 1). Plain X-ray of the abdomen could not visualize any escaped leaflet. Thus, he was taken directly to the operating room for emergency mitral valve surgery, which confirmed the

FIGURE 1. Fluoroscopy (A), transthoracic echocardiography (B), and transesophageal echocardiography with 3D reconstruction (C) of a patient in cardiogenic shock showing the mitral prosthesis with 1 missing leaflet and significant regurgitation. D, After emergency mitral valve replacement, the explanted prosthesis with 1 leaflet clearly missing. (Photo credit: Øystein Horgmo, University of Oslo.)

diagnosis of leaflet escape. The old prosthesis was explanted (Figure 1, D) and replaced with a new prosthesis of the same size and brand.

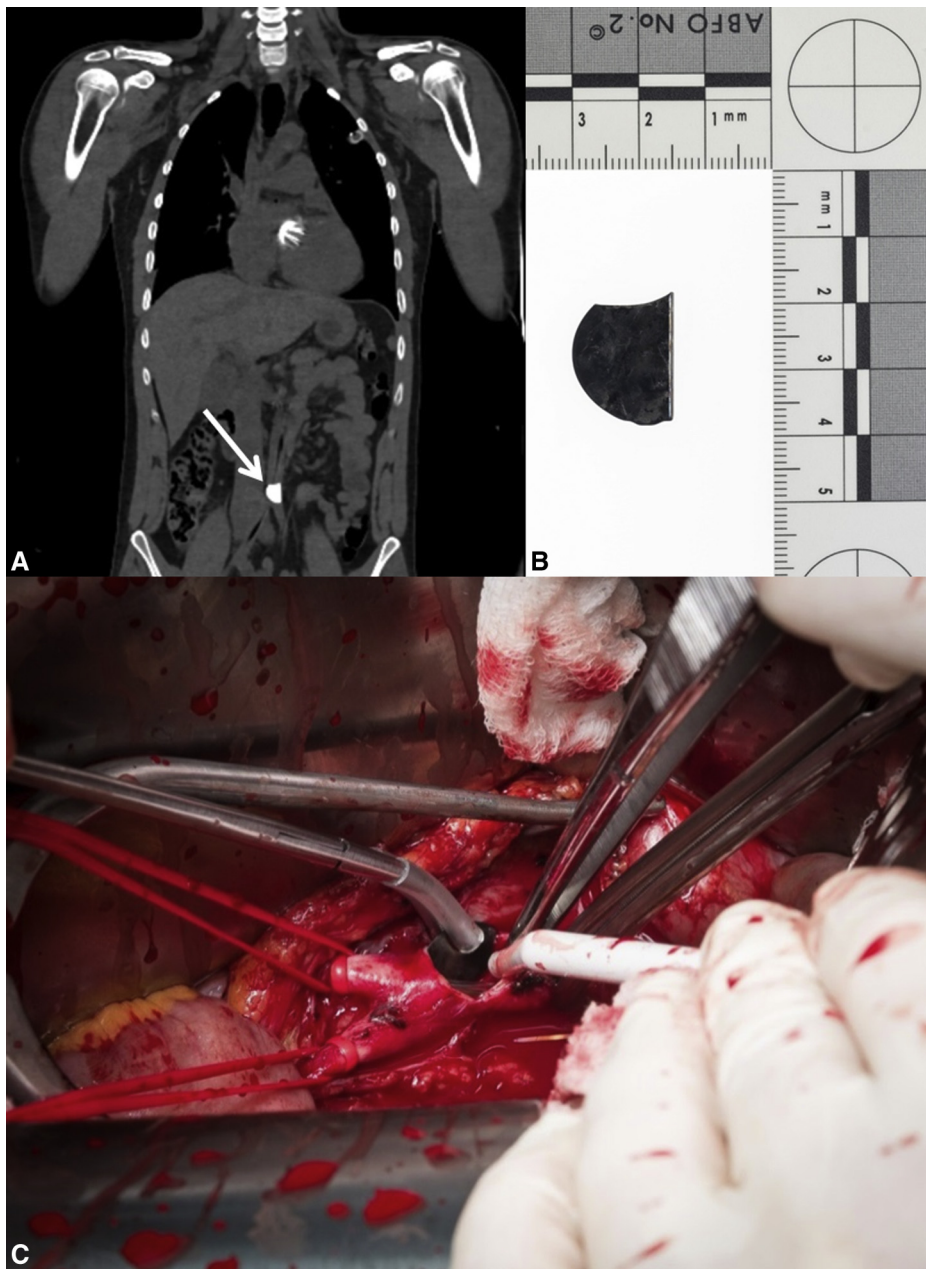
Postoperative computed tomography scan without contrast located the missing leaflet in the abdominal aorta just above the bifurcation (Figure 2, A). Laparotomy was performed the next day, and the valve lid was explanted through a transverse aortotomy (Figure 2, B and C). Only after vessel closure was the intra-aortic balloon pump removed under direct visual control to avoid any tears or damage to either the device or the vessel wall. The remaining one-quarter of the leaflet was not accounted for but was suspected to lay distal to the knees, the only area not yet imaged. The patient was discharged to his local hospital 4 days after admission and was doing well without any lasting disability at his 3-month postoperative follow-up.

FIGURE 2. A, Postoperative computed tomography scan without contrast showing the location of the embolized leaflet in the abdominal aorta (*white arrow*). Three quarters of the missing valve lid (B) was removed from the abdominal aorta via laparotomy (C). The remaining one-quarter was not accounted for but was suspected to lay distal to the knee, the only area not imaged. (Photo credit: Øystein Horgmo, University of Oslo.)
