Fractography of clinically fractured, implant-supported dental computer-aided design and computer-aided manufacturing crowns

SAGE Open Medical Case Reports
Volume 5: 1–9
© The Author(s) 2017
Reprints and permissions:
sagepub.co.uk/journalsPermissions.nav
DOI: 10.1177/2050313X17741015
journals.sagepub.com/home/sco

The aim of this study was to analyze the clinical fracture process of three Lava Ultimate crowns, bonded to zirconia implant abutments. All fractures occurred during the first year of function and within a randomized controlled clinical trial (RCT). Fractographical analysis was performed on the crown material as well as on the zirconia implant abutments in order to speculate on possible reasons for failure. Chemical surface analysis of the implant abutment surface as well as water absorption measurements of the polymeric material were performed for a deeper analytical insight into responsible mechanisms leading to failure.

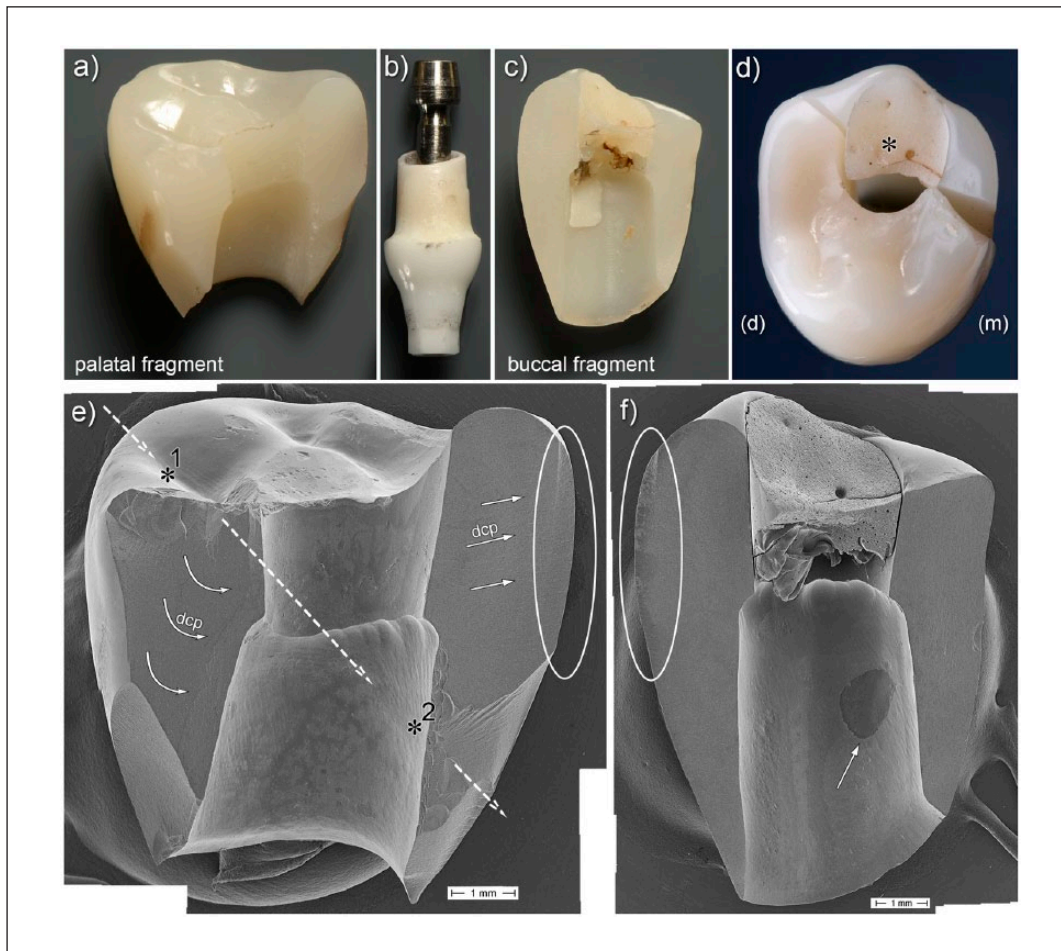
Figure 1. (a–d) Photographs of the crown and the abutment of case 1. The crown fractured mesio (m)- distally (d) in two fragments, while some minor fragments on the mesial side went missing, most likely during intraoral fracture. (b) Luting remnants can be found on the implant abutment surface. (d) The screw hole clinically filled with glass ionomer cement (*). (e and f) Higher resolution SEM images (mapped from individual SEM images) from the fracture surfaces of the fragments shown in (a) and (c). Both fragments exhibit the corresponding compression curl (circle), indicating the termination of the fracture event. (e) The palatal fragment shows clear fracture patterns on the cusp of the mesial proximal ridge (*1) and on the intaglio side of the disto-buccal margin (*2). The buccal fragment shows only minor luting remnants on the intaglio side (arrow). Most of the yellowish luting remnants are found on the zirconia abutment (b), indicating the crown–adhesive interface as the weakest link. In consequence, it seems very likely that the crown fracture was preceded by a debonding event, most likely leading to wedging of the crown and subsequent inclined shear loading in the direction assigned in (e) (dotted arrows). The fracture origin on the distal intaglio surface (*2) is thus termed a secondary event leading to abfraction of the missing marginal fragment. (e) The general direction of crack propagation (dcp) is indicated with arrows. The fracture started on the mesial side and ended on the disto-buccal side.

This crown was retrieved from tooth #14 of a 60-year-old male patient and fractured after 2 months in situ without any complications or reported malfunction. The fractographic examination is presented in Figures 1 and 2.

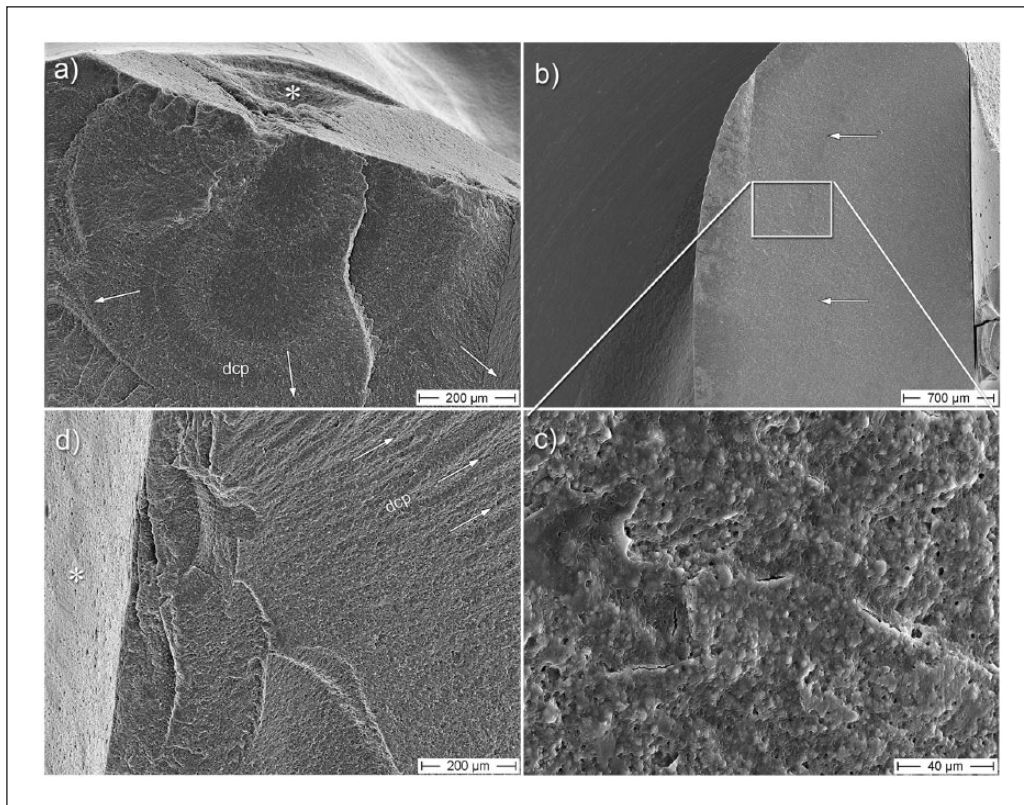
Figure 2. (a) The fracture origin on the palatal fragment of Figure 1 (e) (see *1). A large wear facet and damage accumulation zone can be seen on the surface (*) as well as multiple and overlaying mist and hackle regions and radial crack extension (arrows). (b) A magnification of the compression curl of Figure 1 (e) and (f), the endpoint of the fracture event on the disto-buccal side of the crown. (c) A high magnification of a fracture region close to the compression curl in (b). Small cracks are observable hypothesizing a degradation artifact in the microstructure of the resin composite crown material. (d) The secondary fracture event. Hackle indicates the dcp (arrows) radial from the fracture origin. (d) A clean intaglio surface (*) without any remnants of the luting agents, indicating an adhesive failure at the crown–adhesive interface.

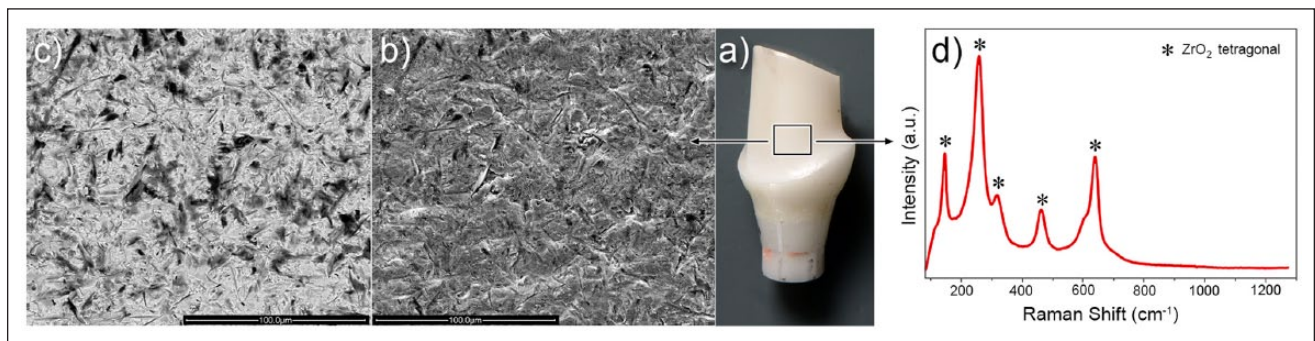
should conclude that adhesion is compromised. Sandblasting of tetragonal stabilized zirconia (TZP) is known to transform and degrade the microstructural cohesion of the zirconia (sub-) surface.^{22,23} Such degradation could have an effect on adhesion as well. However, the Raman spectrum in Figure 7 confirms the sole existence of the tetragonal zirconia on the buccal side of the implant abutment and no signs of the monoclinic polymorph. Apparently, no substantial tetragonal-to-monoclinic phase transformation was induced during sandblasting, which suggests that the applied sandblasting procedure (< 50 μm , 2 bar, 2–10 mm distance) was too soft. This would explain the absence of silica on the zirconia surface, as silica on

the silicatized alumina particles need impact energy to tribochemically adhere onto the zirconia surface.

Figure 7. (a) Analytical investigations on the buccal side of one debonded zirconia implant abutment. (b) SEM surface reveals rough patterns due to sandblasting. (c) EDS analysis did not show signs of silicon in the region of interest. (d) The Raman spectrum did only indicate tetragonal zirconia and no signs of silica.
