Riata lead failure manifests as electrical storm with lead parameters showing unique postural variations: a case report

Riata implantable cardioverter-defibrillator (ICD) leads are prone to a unique type of mechanical lead failure causing conductor externalization (CE) which may be complicated by a delayed-onset electrical lead failure (ELF).

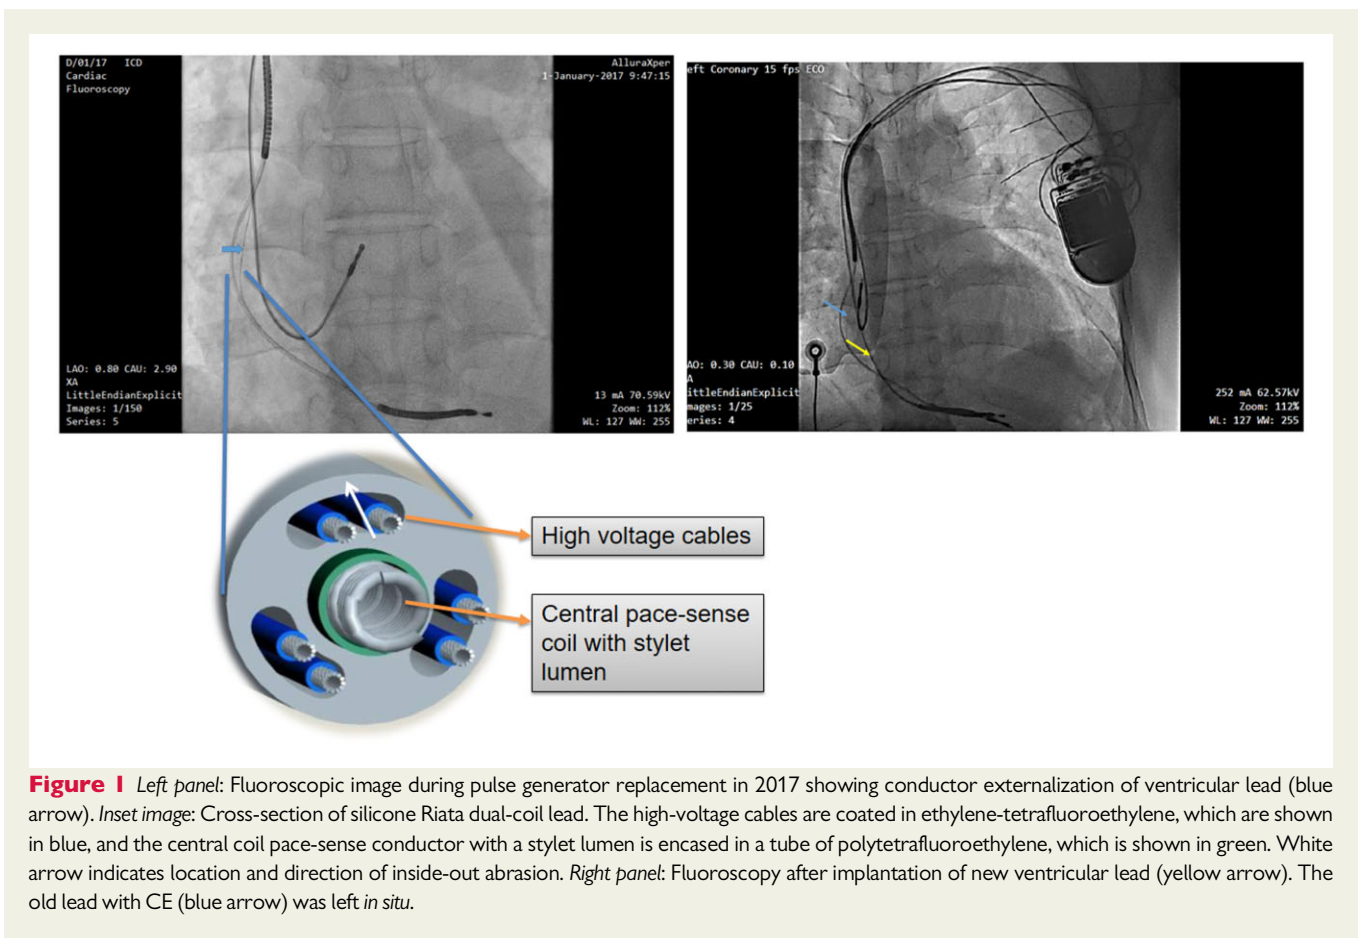
In 2017, the patient received a pulse generator replacement (PGR) for elective replacement indicator status. During the procedure, externalization of conductor elements of the ventricular lead was detected distal to the superior vena cava (SVC) coil (Figure 1, left panel). At this stage, electrical parameters of R-wave amplitude, capture threshold, and lead impedance were all within normal range and there were no noise artefacts on ventricular electrogram (EGM) (Table 1).

Figure 1 Left panel: Fluoroscopic image during pulse generator replacement in 2017 showing conductor externalization of ventricular lead (blue arrow). Inset image: Cross-section of silicone Riata dual-coil lead. The high-voltage cables are coated in ethylene-tetrafluoroethylene, which are shown in blue, and the central coil pace-sense conductor with a stilet lumen is encased in a tube of polytetrafluoroethylene, which is shown in green. White arrow indicates location and direction of inside-out abrasion. Right panel: Fluoroscopy after implantation of new ventricular lead (yellow arrow). The old lead with CE (blue arrow) was left *in situ*.

Riata/Riata ST leads have a unique hollow multilumen design that predisposes them to an 'inside-out' form of lead abrasion through breach of silicon insulation⁴ (Figure 1, inset). This resulted in a Class I US FDA recall in 2011.⁶ Conductor externalization may or may not be complicated by an ELF (defined as one of the following five: presence of non-physiological signals on ventricular EGM, pacing impedance outside the 200–2000 Ω range or a >100% increase or >50% decrease from baseline value, change in high-voltage impedance to >200 or <25 Ω , pacing threshold >5 V or >100% rise, and R-wave sensing <3 mV or >50% reduction).^{4,7}

Our patient had an electrically silent CE noted at the time of PGR and it was decided to keep him under close monitoring. Such an approach of watchful monitoring has been advocated by studies showing poor correlation between CE and ELF.^{4,7,8} The location of integrity breach distal to SVC coil, as seen in our case, has been described in about 14% cases of CE.⁴ One of the reasons hypothesized for normal Riata lead functioning despite CE is the preservation of intact internal Ethylene tetrafluoroethylene coating of conductor cables even when the outer silicon coating has undergone erosion leading to CE.⁹

assessment including documentation of left subclavian vein patency by contrast venography was done and subsequently, the patient received a new ventricular lead (Durata™ ICD St. Jude) implantation on Day 3. Due to the anticipated risks and technical challenges involved in extracting an ageing dual-coil ventricular lead, the old Riata lead was capped and abandoned (Figure 1).

Previous studies have suggested that removing Riata leads is more challenging than removing other ICD leads because of CE and the absence of coil backfill.^{11,12} Therefore, we decided to abandon the old dual-coil ventricular lead and proceeded with a new lead implant.

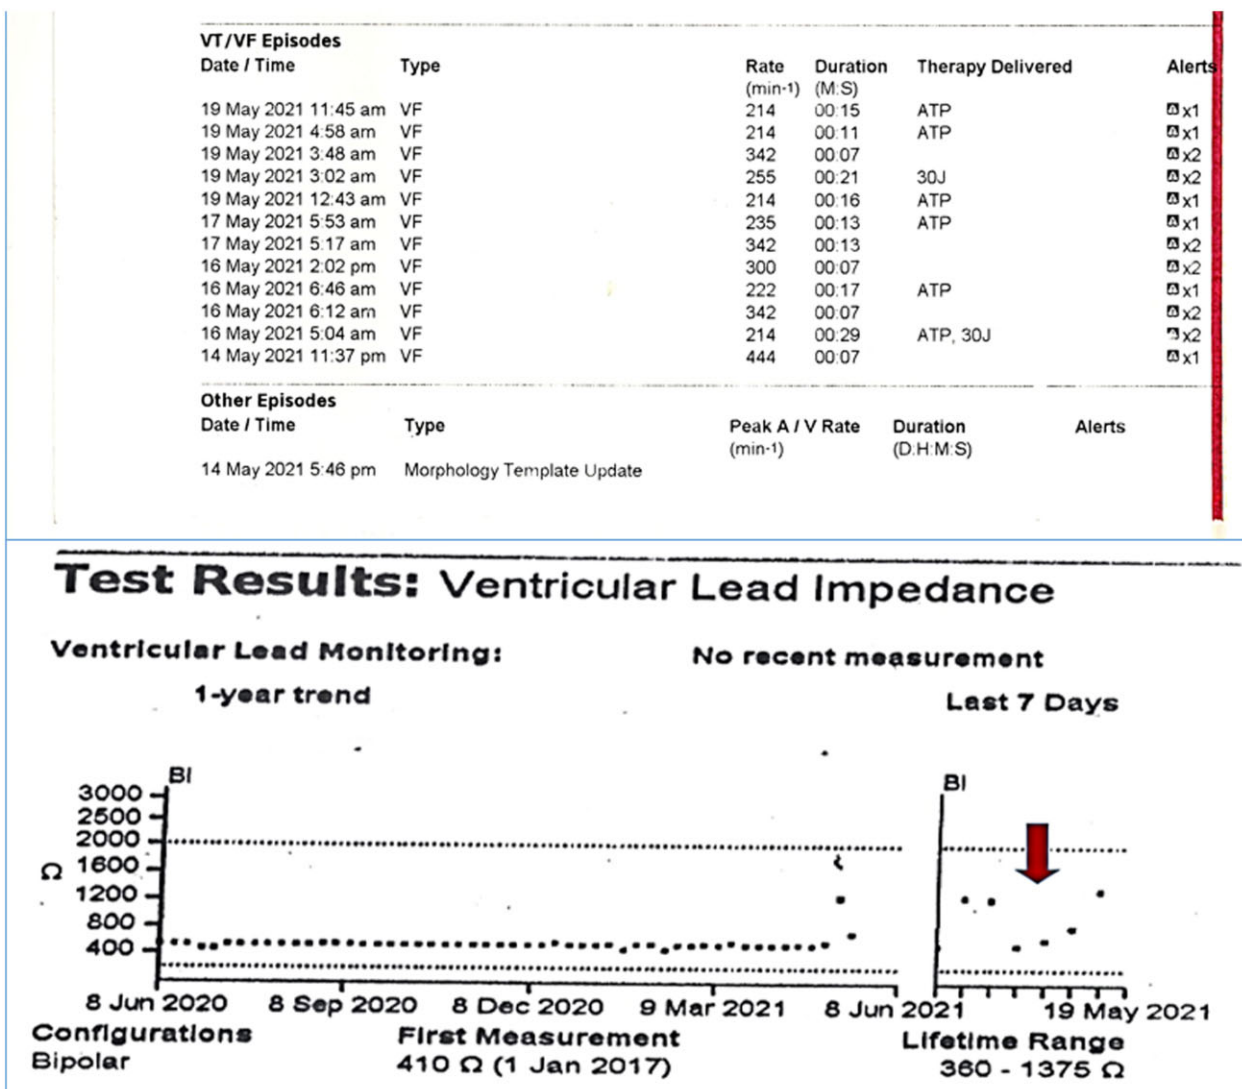
A careful study of EGMs suggested a normal atrial lead trace but a non-cyclic, non-physiological, high amplitude, high frequency signal was noted on ventricular EGM. This noise artefact with rate falling in VF zone had triggered the inappropriate ICD therapies (Figure 3). An impedance trend graph showed an abrupt and variable increase in impedance values over last 7 days (Figure 2).

Figure 2 Upper panel: Summary of ventricular arrhythmia episodes and the implantable cardioverter-defibrillator therapy delivered over last 6 days. A total of 12 shocks were aborted. Lower panel: Impedance trend chart of last 11 months shows abnormally high and variable impedance values for last 7 days (red arrow). Before this, the impedance values were within normal range.

The pacing and sensing parameters remained within normal range at initial evaluation in supine position (*Table 1*), while the lead impedance trend showed a sudden and abrupt rise in impedance values over the last 1 week (*Figure 2*). This prompted us to note any postural variation of these parameters. The results, shown in *Table 1*, signify the value of ICD interrogation in sitting posture in suspected cases of ELF in Riata leads with previous CE. The cause of such variation is unclear. We hypothesize that due to gravitational forces acting on the heart in sitting posture, the externalized lead components of the fixed ventricular lead are stretched which causes worsening of electrical parameters. This probably accounted for the discrepancy between impedance values in supine position and impedance trend chart.

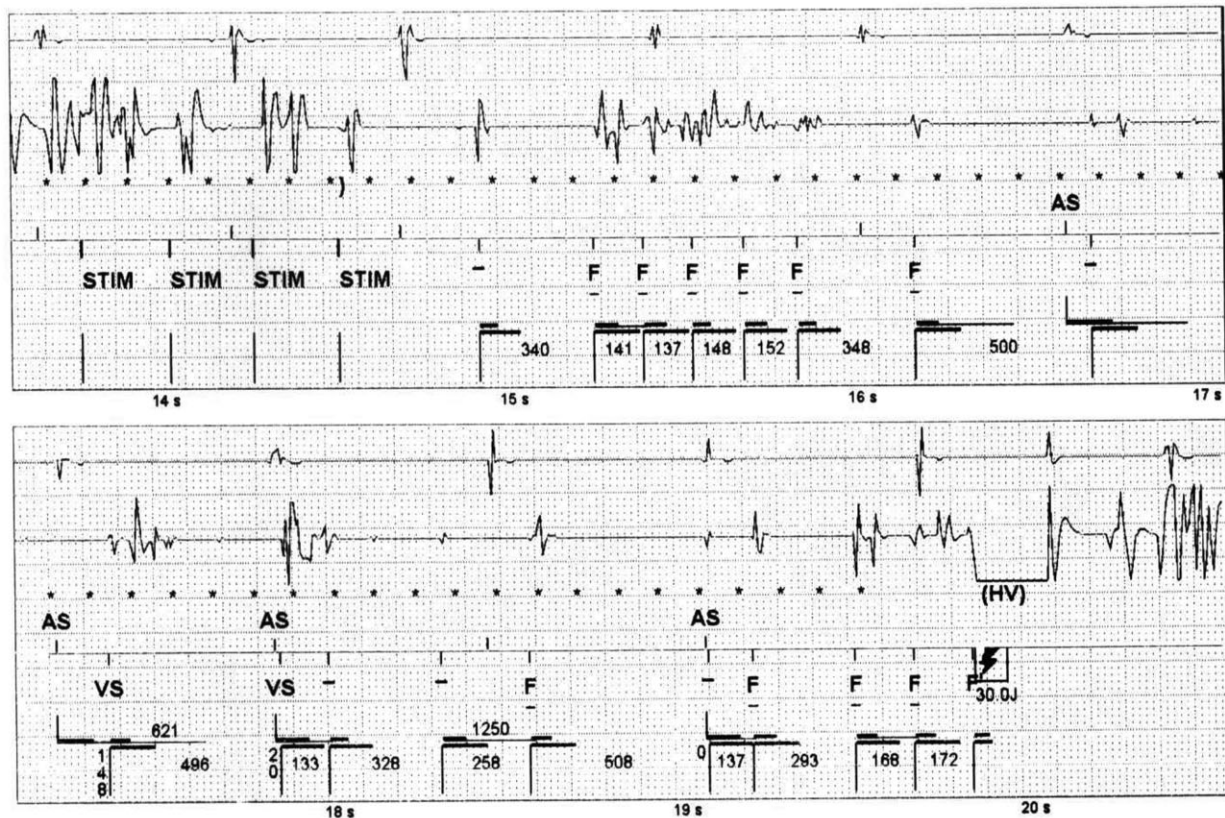
Figure 3 Electrogram recording showing high frequency, high amplitude noise signal on ventricular electrogram leading to an antitachycardia pacing therapy (shown as STIM annotation) which is then followed by 30J high voltage shock. No noise is detected on atrial electrogram trace.

Riata lead electrical dysfunction correlates with time since implant and impaired EF is an independent predictor of ELF in these leads.⁴ Our patient with ischaemic cardiomyopathy (EF—25%) developed ELF manifesting as inappropriate ICD therapy more than a decade after receiving the initial ICD implant. Noise oversensing, as seen in our case, is the commonest mode of presentation of ELF in Riata leads⁷ and may lead to inappropriate ICD therapy in 15–24% of patients.¹⁰

After the ascertainment of an electrical lead dysfunction, the ICD ATP/shock function was turned off. Following this, pre-procedure

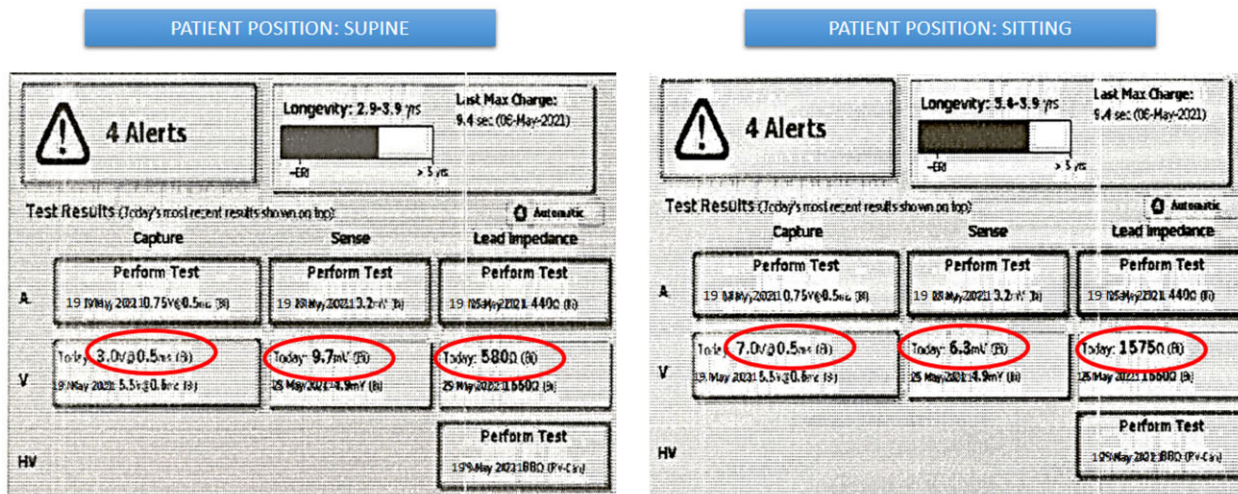
To address the discrepancy between the recent high impedance values in trend graph (Figure 2) and the normal value recorded in supine posture (Table 1, Figure 4, left panel), we performed lead interrogation in the sitting position. The ventricular pacing threshold, lead impedance and R-wave amplitude worsened dramatically in sitting posture while atrial lead parameters remained unchanged (Table 1, Figure 4, right panel).

Figure 4 Implantable cardioverter-defibrillator interrogation showing dramatic change in ventricular capture threshold, lead impedance, and sensed R-wave amplitude (red ovals) with change in posture from supine to sitting.
