## Case Report

# An Extremely Rare Case of Cementless Third Generation Corail Stem Neck Fracture With Fractographic Analysis

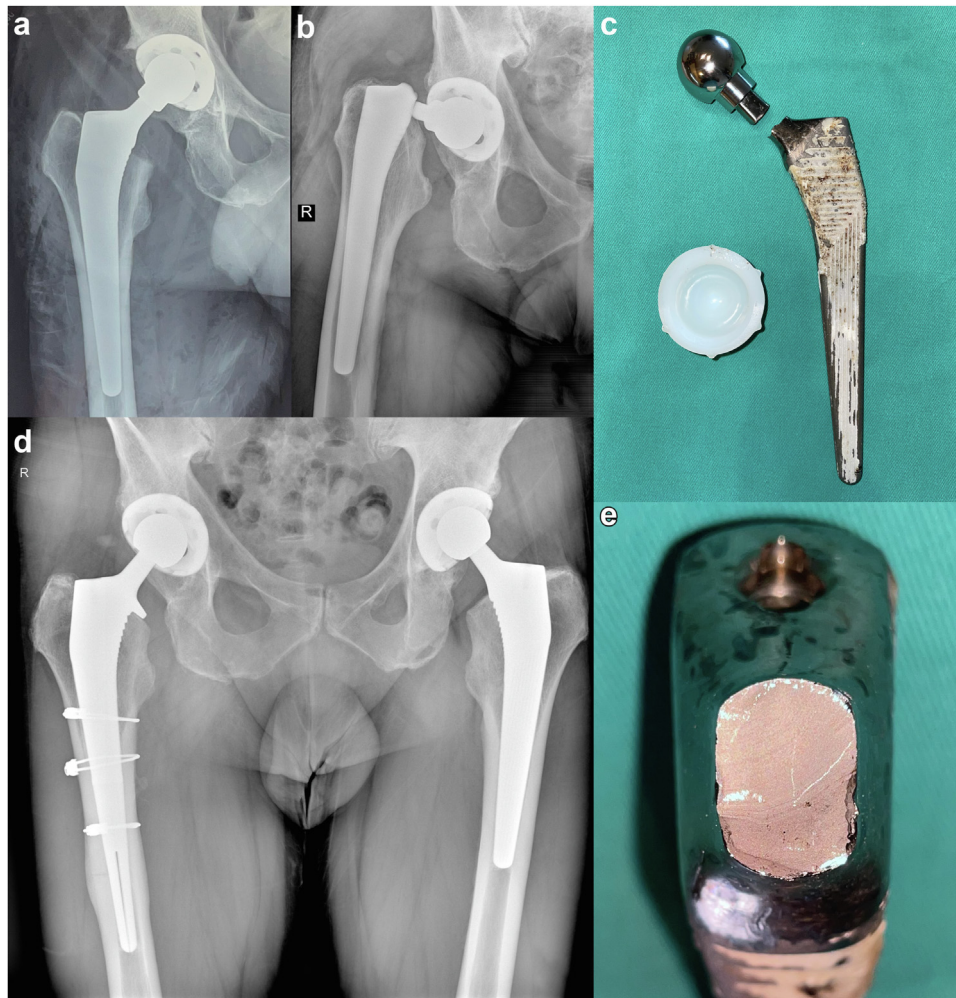
The physical examination revealed a completely healed surgical scar, moderate pain in the right groin, with shortening and external rotation of the right leg. Radiographs taken at that time showed a broken stem in neck region with transverse pattern (Fig. 1b).

**Figure 1.** (a) Anteroposterior radiography showing preinjury right hip arthroplasty; (b) transverse neck fracture; (c) position of the fracture on the neck of the extracted hip prosthesis; (d) 8-month postoperative radiograph; (e) photograph of the fracture surface on the stem side.

Figure 1c shows the failed hip prosthesis and the position of the fracture. A macroscopic overview of the fracture surface, shown in Figure 1e, reveals 2 distinct regions: the region covered with curved lines that occupy most of the fracture surface and the region with a granular appearance. In SEM images at low magnifications, shown in Figure 2a, 3 zones are distinguished. Curved lines that spread radially through the central zone of the fracture surface (marked as zone 2) are the traces of the fatigue crack propagation, known as beach marks. Beach marks are considered a clear indication of the fatigue fracture type. The curvature of the beach marks points back to the area of the fracture initiation placed at the edge of the

articular hematoma was found, along with the mentioned fracture of the stem neck with consequent marginal damage to the polyethylene liner. The acetabular and femoral components were firmly fixed to the bone and adequately oriented. No signs of periprosthetic infection, metallosis, or wear of the polyethylene liner were found. The stem was removed through a transfemoral approach with an extended trochanteric osteotomy. The bony femoral flap was secured using 3 cerclage cables (Zimmer-Biomet, Warsaw, IN). A Corail revision stem size 18 (De Puy, Synthes, Warsaw, IN) was implanted. A new polyethylene liner Pinnacle (De Puy, Synthes, Warsaw, IN) size 56 mm with 10 degrees of inclination was placed. A new CoCr +9/32 mm femoral head (De Puy, Synthes, Warsaw, IN) was used (Fig. 1d).

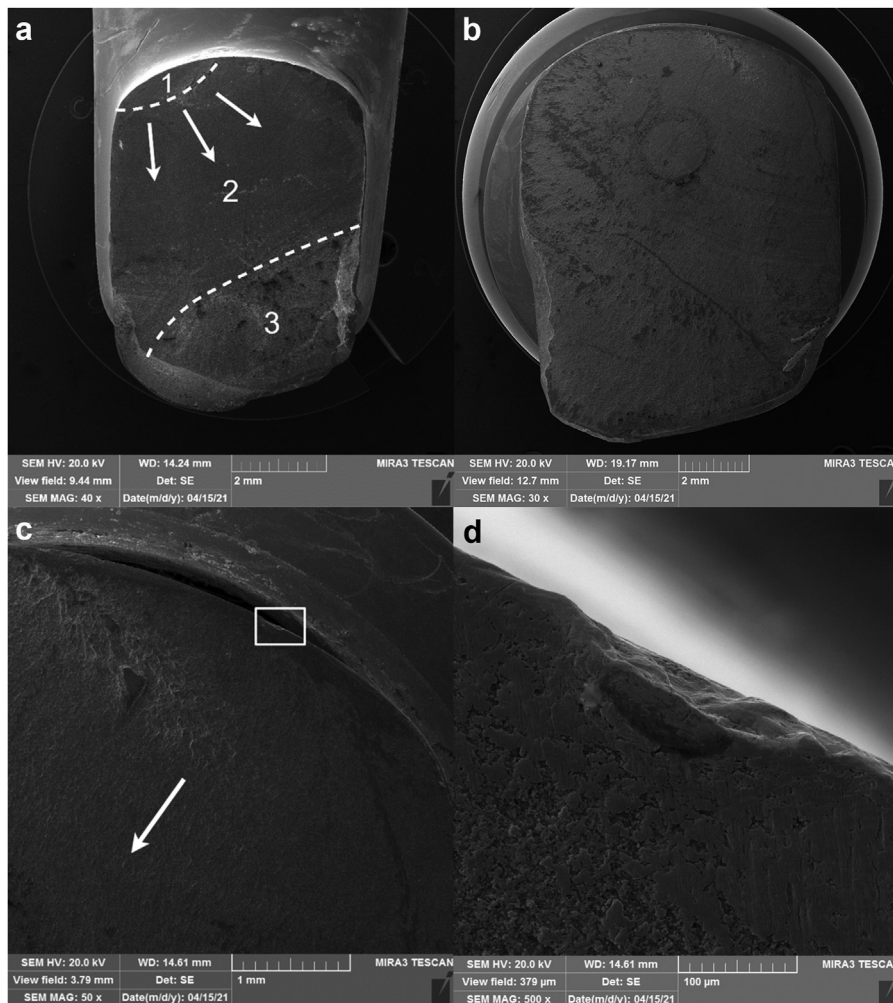
fracture area (Fig. 2a, marked as zone 1). The same features can be observed on the other, matching half of the fractured part (Fig. 2b). Traces at the fracture surface and the direction of the fatigue crack advance suggest that hip prosthesis has failed under the cyclic loading by unidirectional bending with fracture initiation on the anterolateral corner [8].

The ridge at the fracture surface up left in Figure 2a, also visible at matching surface up to the right in Figure 2b, is shown in Figure 2c under higher magnification and marked by a rectangle. This ridge is placed ahead of the fracture origin site, and it could be assumed that it was formed by the change in crack propagation plane in accordance with the acting tensile stress. The position of the fracture origin and the rotation of the fatigue crack propagation plane perpendicular to the direction of the acting tensile stress may suggest initial microcrack formation on the outer surface of the neck by the mechanism of dislocation slip (slip band formation), preferably in alpha grains [9]. However, many postfracture

**Figure 2.** (a) Macroscopic appearance of the fracture surface on the stem side with 3 distinct zones typical of the fatigue fracture; (b) matching fracture surface on the head side. Fracture surface near the origin of the fatigue fracture (head side); (c) damage at the edge of the fracture surface (rectangle) and crack propagation direction (arrow); (d) damage shown in micrograph enlarged.

damages formed at the contact between the 2 fracture surfaces prevent examination of the ridge in more detail. Similar flat areas with scratches on the surface can also be seen near the fracture origin, as shown in Figure 2d. Flattened areas were formed by the friction between the opposite fatigue fracture surfaces under the cyclic loading during the fatigue crack propagation.

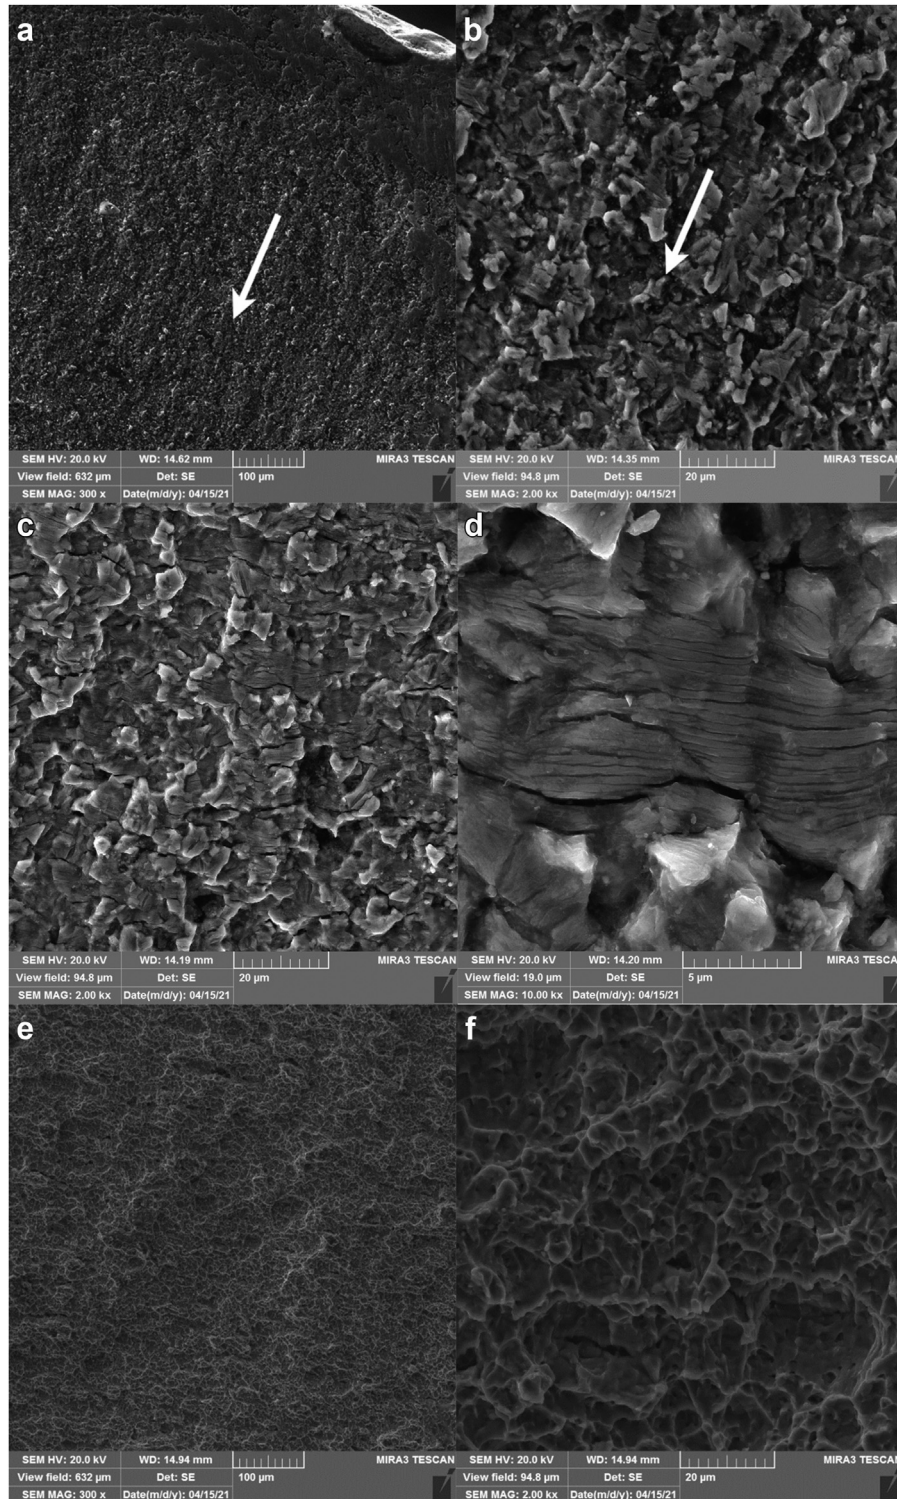
**Figure 3.** Fracture surface in the vicinity of the crack origin on the neck side: (a) granular structure of the fracture surface; (b) very fine fatigue striations and secondary microcracks. Fracture surface near the crack origin on the stem side: (c) irregular fatigue striations and many secondary microcracks; (d) fatigue striations and secondary microcracks alongside intergranular secondary microcracks. The zone of the final fracture: (e) overview of the fracture surface; (f) ductile dimples in the zone of the final fracture.

the formation of the microcrack at the anterolateral surface, and the mechanisms usually involve stress corrosion cracking or fatigue corrosion, fretting and fretting corrosion, crevice corrosion, and hydrogen embrittlement, besides already mentioned mechanism of dislocation slip bands formation [10]. Nevertheless, considering the fatigue fracture origin position, it could be assumed that the initial microcrack formed at the surface of the neck and propagated as the fatigue crack under the influence of the stress concentration at the outer anterolateral curvature of the stem.

Figure 3 displays SEM micrographs of the fracture surface in the zone of fatigue crack propagation (zone 2) in early stages, near the fracture origin (up to the right in Fig. 3a). The arrow in the pictures in Figure 3a and b indicates the direction of the fatigue crack propagation front. The fracture surface in this zone is coarse, granular, and contains many irregular voids. Fatigue striations are barely visible at the magnification of the micrograph in Figure 3b. At even higher magnification in Figure 3c, striations become observable. Striations are the microscopic traces of the fatigue crack propagation through the mechanism of opening and closing of the crack, and therefore they serve as the confirmation of the failure by fatigue fracture. Besides fine fatigue striations, there are many deep secondary cracks perpendicular to the fatigue fracture surface (Fig. 3c). Secondary cracks may indicate the brittleness of the material [8]. Irregular and wavy striation lines in SEM micrograph in Figure 3d were formed by changing the plane of propagation upon encountering the obstacles in structure [8]. Grains between fatigue striations look smooth, but at higher magnifications, it can be observed that the striations in those parts are actually less pronounced and barely observable (Fig. 3d, lower part of the image).

The fracture surface in the third zone (zone 3 in Fig. 2a) is characteristic of the final rupture stage of the fatigue fracture. Ductile dimples at the fracture surface, visible in SEM images in Figure 3e, indicate the ductile type of the final fracture. Higher magnification reveals an equiaxed shape of ductile dimples (Fig. 3f), which indicate tensile stress acting perpendicularly to the fracture surface [8]. Therefore, the final fracture was due to the overload of the remaining cross-section area under the influence of tensile stress.
