Assessment of Sinkholes Investigations in Jangseong-Gun Area, South Korea, and Recommendations for Similar Studies

Abstract: This paper reviews the site investigation field data and access work performed between 2016 and 2019 in the study area located close to Gun-dong mine. The research was aimed at defining the cause of sinkholes and their relationship with the underlying karstic limestone bedrock and nearby mining activities. Only a limited number of small sinkholes appeared in 2014, 2016, and 2018 in the agricultural land close to the limestone mine. The previously open pit mine started its underground operations in 2007. Since then, the mine has developed, and is now comprised of, large underground excavations at several levels below the surface. The studies carried out concluded that the appearance of sinkholes may be related to a general lowering of the groundwater table because of nearby agricultural and mining activities and also due to over-extraction of water due to increased urban use. Whilst these are the best determinations, this paper identifies missing elements of the previous investigations mentioned above, some issues with the interpretation of poorly prepared bo

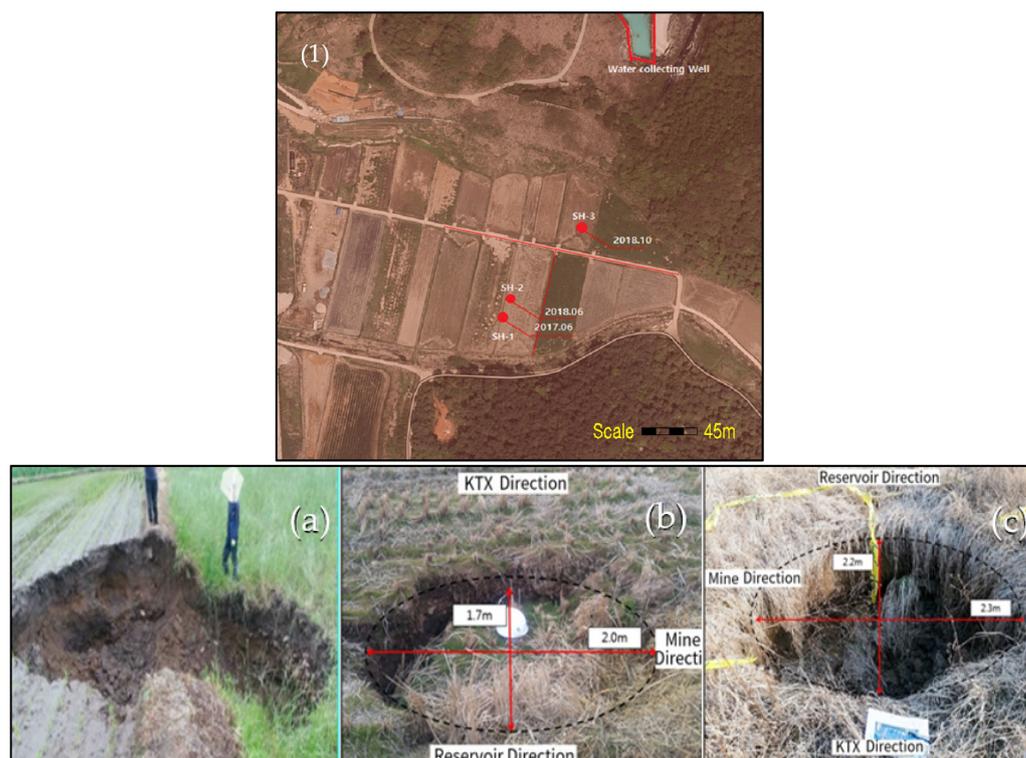
The periodic appearance of sinkholes goes back to before 2014. Recent ground subsidence occurred in the farmland in the Jangseong-gun area, three times in the last three years (Jun. 2017, Jun. 2018, Oct. 2018) within the land parcels 36-18, 36-19, and 35-21, raising fears about the acceleration in the incidence of sinkholes in the area. The recent sinkholes were of small scale and relatively shallow, with largest being in the land parcel 36-18. There has been no survey record of these sinkholes, and these were backfilled, apparently without monitoring their activity; i.e., development into larger and deeper sinkholes. The location and photographs of the sinkholes are given in Figure 6.

Figure 6. Sinkhole locations and close-up photographs of sinkholes in agricultural land adjacent to Gun-dong mine, (1) Sinkhole locations, (a) 2017.06 (Sinkhole-1), (b) 2018.06 (Sinkhole-2), (c) 2018.10 (Sinkhole-3).

5. Unfortunately, sinkholes were backfilled without collection of pertinent monitoring data, such as continued subsidence, soil profile determination, and appearance of further concentric cracks, etc. It is recommended to install and monitor geodetic survey elevation targets on steel rods in similar situations at the location of the sinkholes.

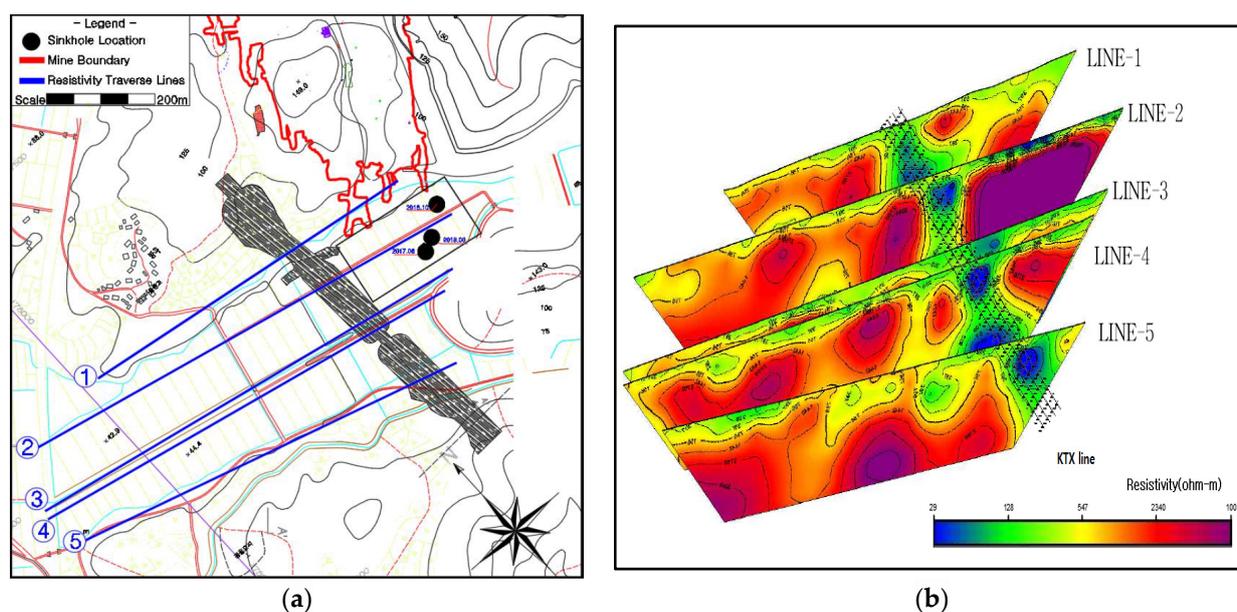
A plan of geophysical traverses is given in (a), and an interpretation of resistivity data is given in (b) of Figure 12. When analyzing the investigation conducted by Chosun University, the results show a strong image of a low non-resistance group, which are more reliable than in the Korea Railroad Research Institute's exploration work.

Figure 12. (a) Chosun University resistivity traverse lines in relation to the mine footprint and sinkholes (b) resistivity data of Chosun University, in railway embankment Area 2016.

- There also seems to be problem whereby the resistivity profiles show potentially large clay-filled cavities and caverns below the rockhead, which normally would not have shown up in a resistivity survey.
- The borehole’s data also do not support the resistivity profile in the same area.

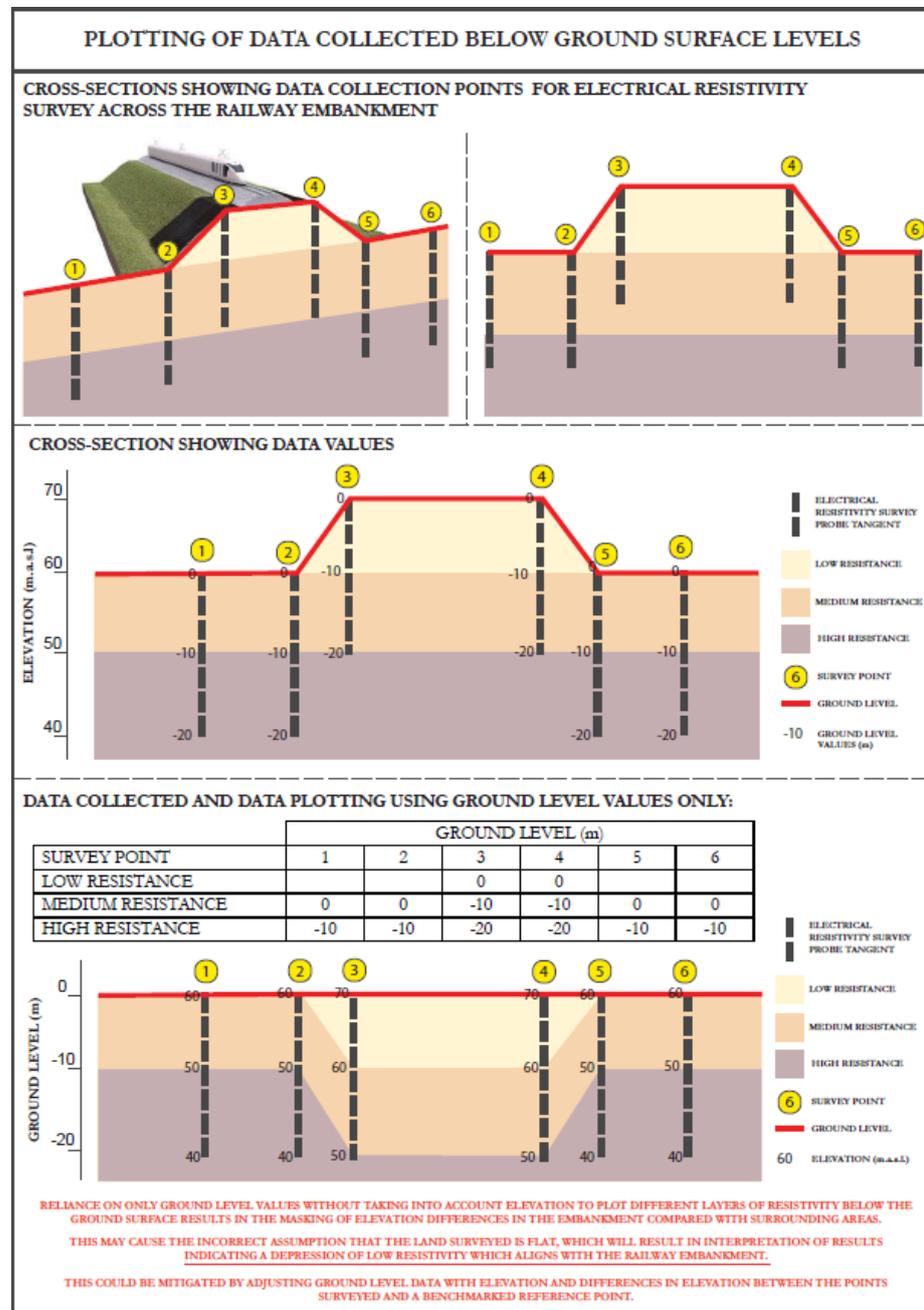
Figure 13. Explanation of apparent depressions below ground surface level, when embankment profile is ignored.

In line with the above comments, the authors have had similar experiences with electrical resistivity surveys elsewhere. In such cases, difficulties were overcome by using additional geophysical tools in conjunction with resistivity profiling. Very low frequency (VLF) equipment is much better suited for the detection of major faults. In addition, the use of ground radar is also valuable for the detection of near surface openings and cavities.

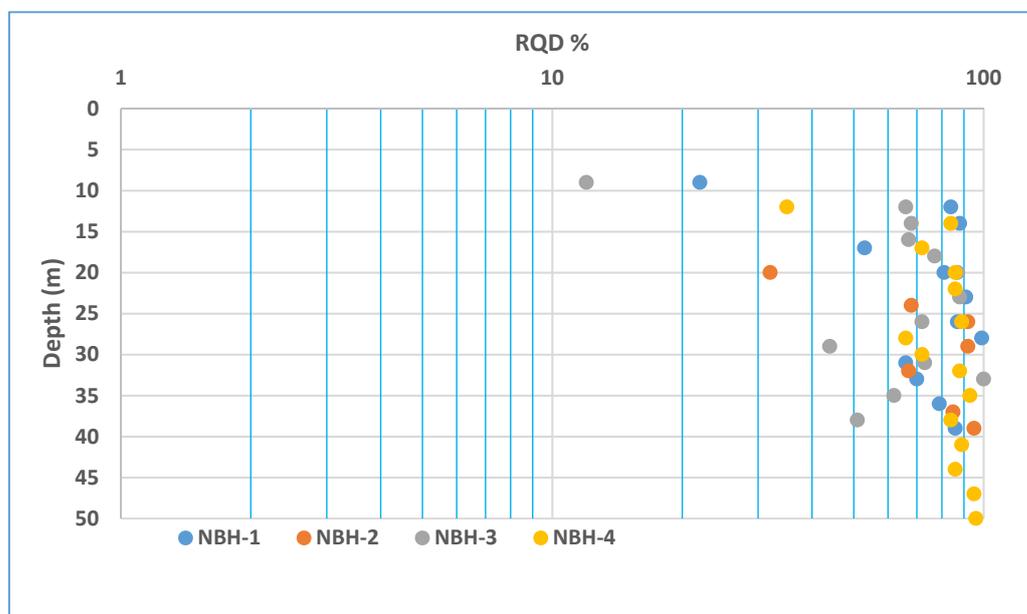
RQD values for the NBH series boreholes drilled in 2014 indicate normal rock mass conditions, with RQD values reaching between 70 and 100% with increasing depth, as shown in Figure 17. This is normal and does not suggest the presence of cavities or zones of high weathering at depth.

Figure 17. RQD values recorded in NBH-series boreholes.

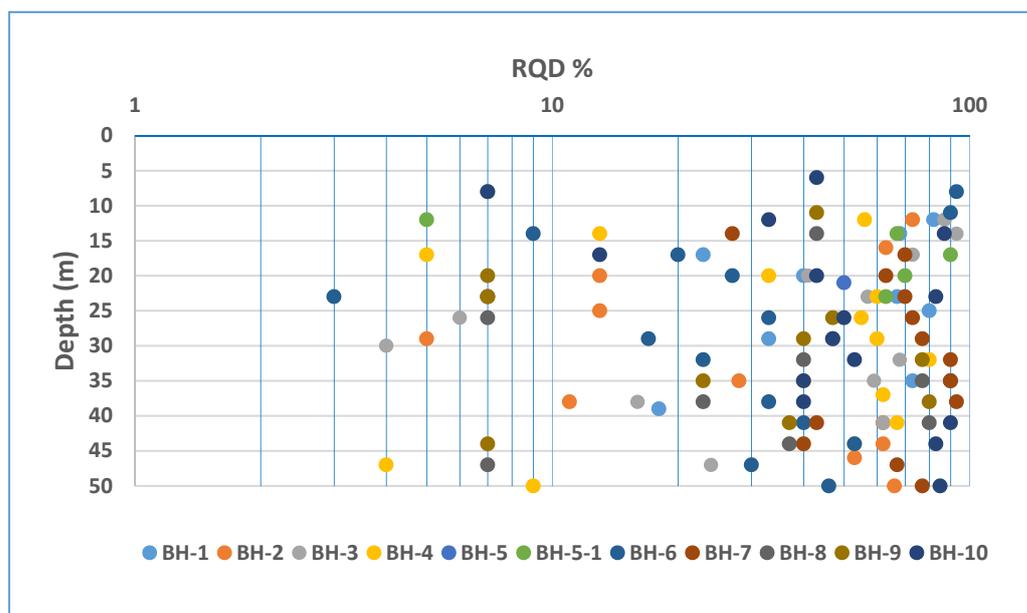
In comparison, the RQD values recorded in the 2019 drilling investigation in the adjacent area have a high scatter with no trend, as shown in Figure 18. The lack of trend indicates a poor drilling methodology and equipment use, resulting in the loss of core samples and grinding; thus, giving a relatively pessimistic impression, leading to a poor assessment of the rock mass conditions, which is not the case.

Figure 18. RQD values recorded in BH-series boreholes.

In addition, the inspection of core boxes from the 2019 drillings indicates better rock conditions of the recovered cores than the previous interpretation results. A reevaluation of the RQD values was not possible, due to the absence of location records of the core samples removed for laboratory testing.

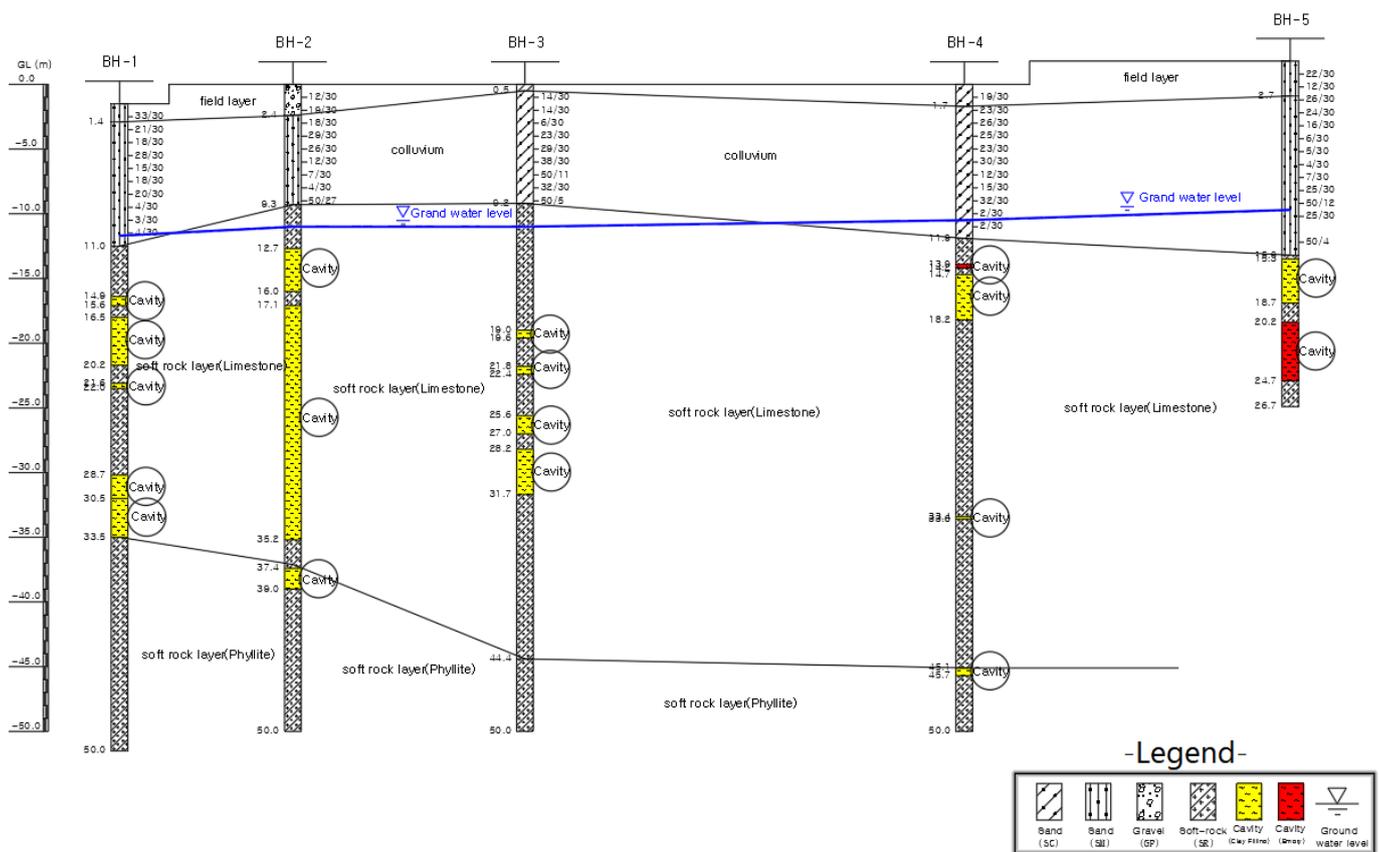
Borehole BH-5 was drilled near Sinkhole-3. By adding Boreholes BH 5-1 and BH-6 in the section, it appears that there is only limited deeply weathered zone in this area, due to a major joint set (N112E). There appears to be steep hydraulic gradients in the immediate proximity to BH-6, due to potential groundwater flow towards the Gun-dong mine.

Figure 20. Developed geological section from 2018 drilling investigations (2019).

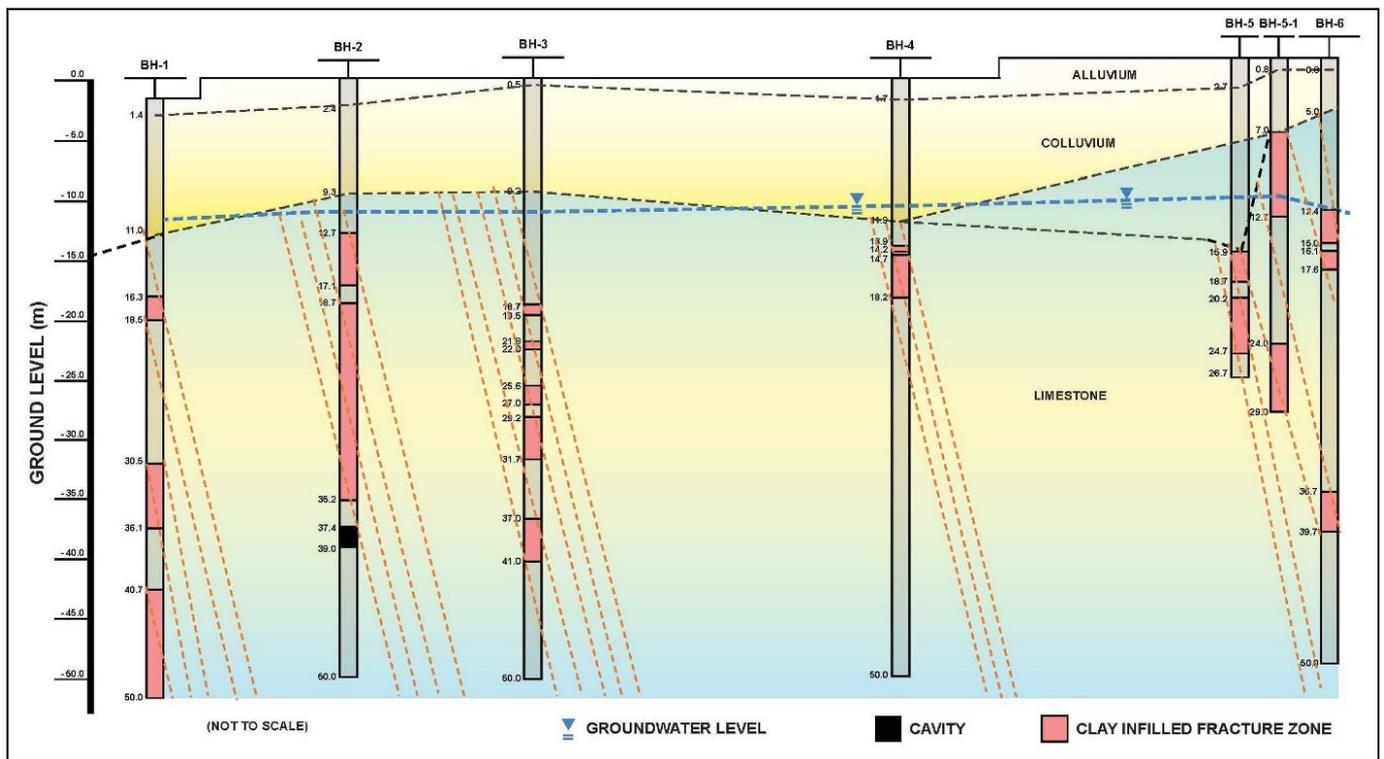
The core box photographs show slightly different rock conditions than those described in the borehole logs. This is due to the way core boxes were prepared and pessimistically interpreted. The main factors leading to the pessimistic interpretation may be summarized as follows:

Figure 21. Reinterpreted geological section along BH-1 to BH-5.

In view of the above comments, the borehole investigation results are not conclusive and do not support the conclusions (presence of large-scale karst cavities) reached in the previously submitted reports.

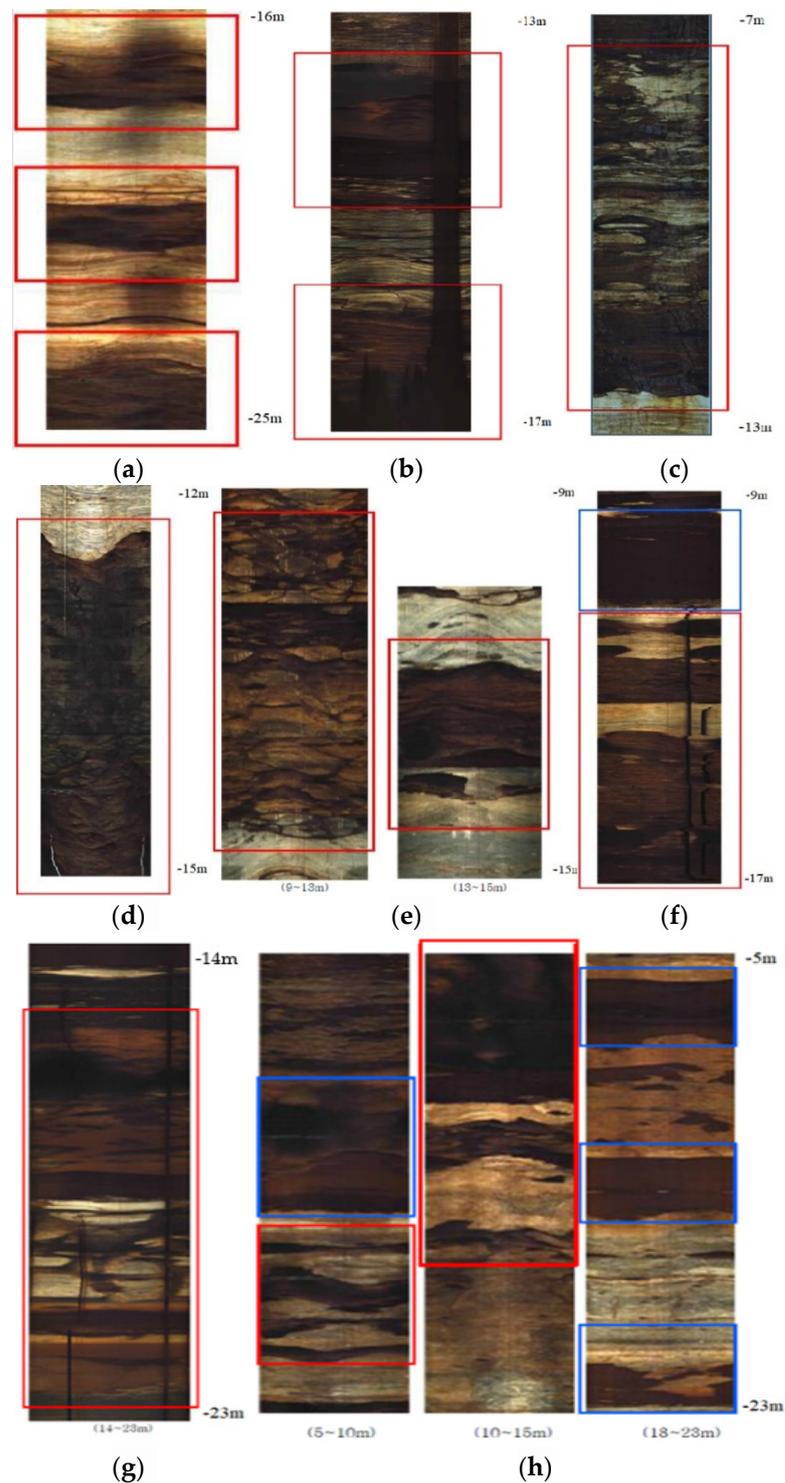
Most of the available BIPS images show the presence of inclined fractures or joints and bedding joints with limited openings or thickness. Most of these are infilled with clayey silt material rock debris, including large rock fragments. In certain boreholes, there was a significant loss of cores which could be mistakenly considered as large fracture zones or an open cavity. However, the above BIPS images show this to be damage incurred and samples lost during drilling.

Notwithstanding the above, the BIPS scans are incomplete, as images lack directional orientation data, which could have supplemented and improved the understanding of underground rock mass conditions and the improvement in borehole log data. Loss of information is a reminder that trained staff familiar with investigation objectives should be deployed to obtain useful and meaningful results. The interpretation of BIPS images should be done at site using drilling information and recovered core samples. In return, the information, thus, obtained from visual inspection of BIPS images should be used for the enhancement and completion of borehole logs.

Figure 24. BIPS images showing clay filled fracture zones and potential cavities, (a) BH-3, (b) BH-4, (c) BH-5-1, (d) BH-6, (e) BH-7, (f) BH-8, (g) BH-9, (h) BH-10.

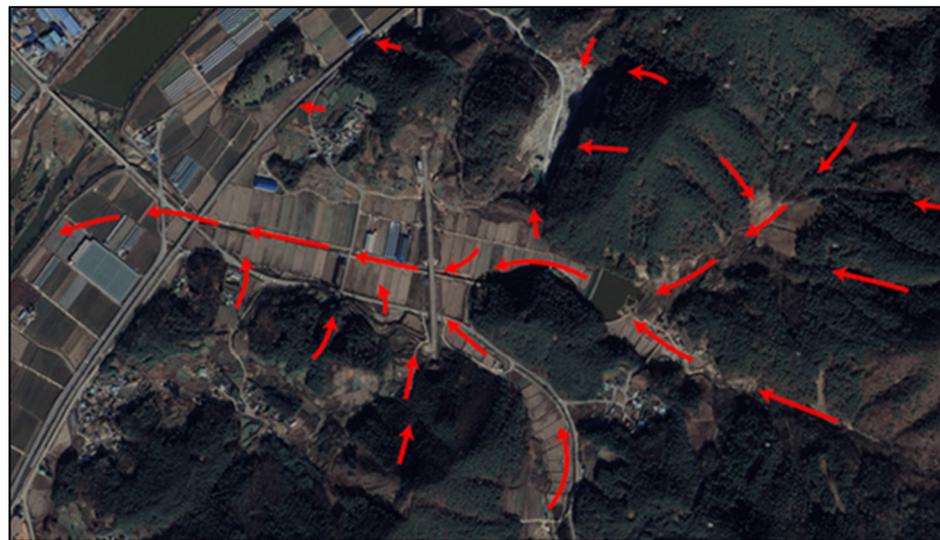
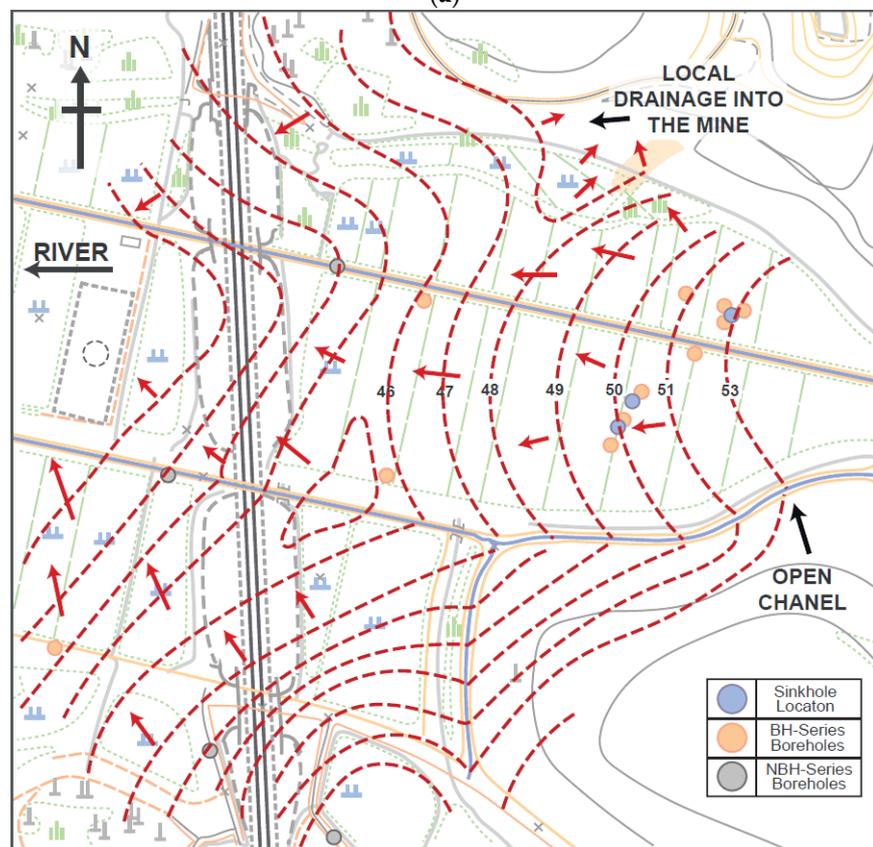
Only a rough interpretation of the groundwater conditions can be made by short term monitoring of the boreholes. Based on this general pattern of groundwater flow, except in the immediate vicinity of the mine in borehole BH-6, piezometric contours show subsurface flow away from the mine in a south-easterly direction, towards the river (Figure 26).

Figure 26. (a) Groundwater flow direction towards Hwangnyong river. Note the minor local inflow in the mine. There is no indication of any soil leaching, (b) interpreted groundwater flow direction-based groundwater contours. For base map information, see Figure 14.

3. Future extraction of groundwater and its use for the local area will result in further lowering of the groundwater table in the area, with a possible increased incidence of subsidence in the future. A comprehensive groundwater monitoring system can prove this trend and changes in aquifer conditions. This will require a well-planned network of piezometers for the determination of groundwater gradient and flow direction.
