# Difficulty Using Smart Pump Logs to Recreate a Patient Safety Event: Case Study and Considerations for Pump Enhancements

**Abstract** The authors present a case in which a physical anomaly with an infusion pump resulted in an unforeseen fault that the nurse's attempts to resolve unknowingly exacerbated. This case study presents the first report in the literature to detail the difficulty in recreating a patient safety event using smart pump logs, support server continuous quality improvement (CQI) data, and the drug order entry system to elucidate the clinical scenario. A 75-year-old male patient presented to a major teaching hospital and was admitted to the intensive care unit (ICU) with a massive gastrointestinal bleed and myocardial infarction, then stabilized. One of the patient's pumps alarmed "communication error" on the display. The display gave no explicit instructions about how to resolve the issue, and resolution was not intuitive. Attempts to clear the alarm failed, so the module was disconnected to reprogram the infusion, causing an interruption in the dopamine. Over the course of approximately 2 min of troubleshooting, the patient's blood pressure decreased from 109/

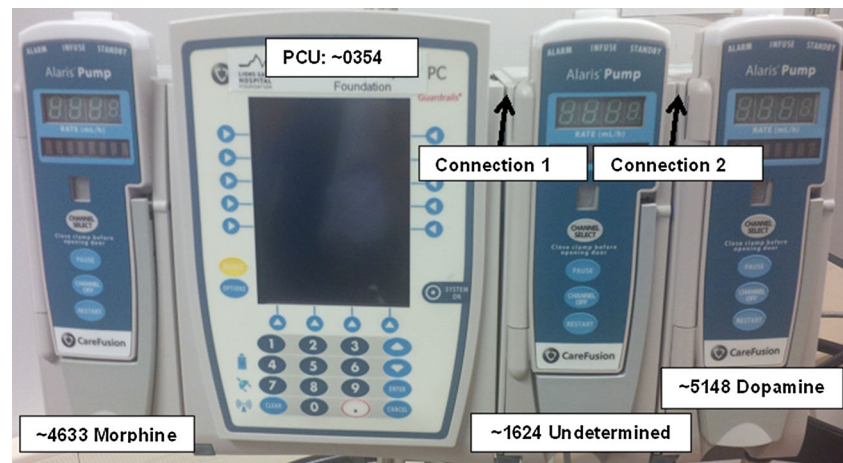
**Fig. 3** Reconstruction of the relational position of the modules and their connections prior to the “communication error”
