A case report of inappropriate inhibition of ventricular pacing due to a unique pacemaker electrogram storage feature

London Health Sciences Centre, University of Western Ontario, 339 Windermere Road, London, ON N6A 5A5, Canada

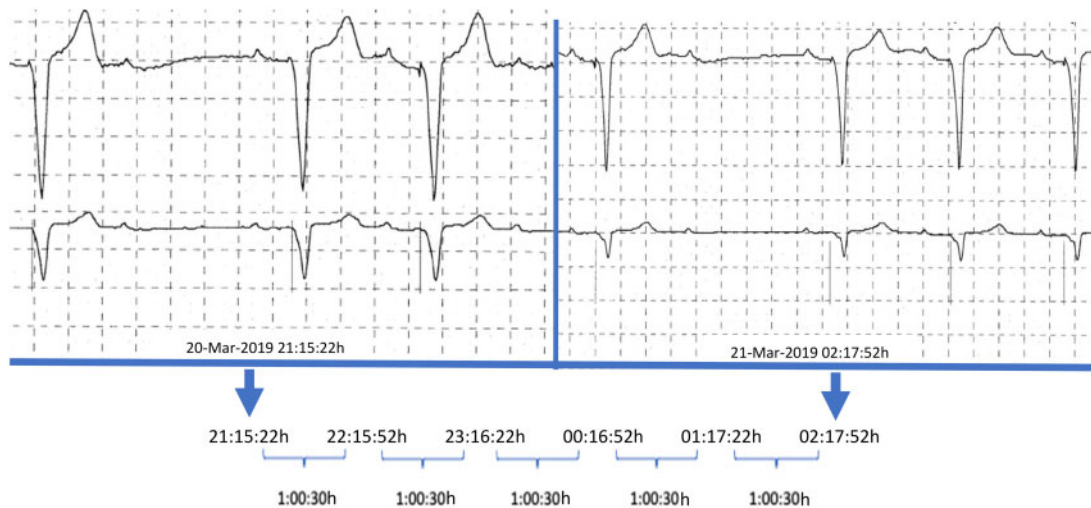
Since she was stable and had no syncope, she was ultimately sent home with an ambulatory Holter monitor. She had intermittent ventricular pacing inhibition, as shown in [Figure 1](#) documented only on the Holter monitor. Ventricular pacing inhibition was seen with sinus rate tracking of ≤ 75 b.p.m., was not preceded by any visualized artefact, and did not correspond to standard device features such as Managed Ventricular Pacing or Capture Management. AV delay remained the same during ventricular capture, excluding AV hysteresis.

The pacing inhibition's recurrent and predictable nature every 1 h and 30 s suggested a device feature as opposed to a hardware malfunction. This was reported to the device manufacturer and discussed with a technical expert from the company. In this case, it was caused by an internal function of the Advisa™ series of PPMs that attempts to store an electrogram (EGM) every 1 h and 30 s. During EGM storage, an amplified signal from the storage capacitor can result in oversensing by the ventricular channel and inappropriate ventricular pacing inhibition. To rectify the issue, the ventricular lead sensitivity value was increased from 0.9 mV to 1.2 mV. No further instances of inappropriate ventricular pacing inhibition were noted on the follow-up ambulatory monitor at 3 months, and the patient's symptoms resolved.

Figure 1 Holter monitor showing two time points of pacing inhibition related to intermittent oversensing in the ventricular lead. This was due to a repetitive feature of electrogram collection every 1 h and 30 s.

The Advisa™ model of PPMs also has a feature that collects EGMs every 1 h and 30 s, resulting in intermittent ventricular pacing inhibition as recorded on the Holter monitor in our patient (Figure 1). As the EGM storage feature turned ON and OFF every 1 h and 30 s, there were instances of an amplified signal generated from the storage capacitor resulting in ventricular oversensing when the self-adjusting sensitivity feature of the ventricular channel approached 0.9 mV in late diastole. The EGM storage feature cannot be

programmed OFF in the Advisa™ model and therefore the device manufacturer needs to be made aware of this to fix the underlying problem. The only immediate solution to ventricular oversensing was increasing the ventricular sensitivity value from 0.9 mV to 1.2 mV. This change in sensitivity was possible without any adverse impact on device function as the patient was pacing-dependent, and the ventricular-sensed amplitude was 18 mV. A repeat Holter monitor was performed after 3 months, and there were no further episodes of pacing inhibition.
