Extraction of radiolucent fractured wire components using intracardiac ultrasound during pulmonary vein isolation procedure

KEYWORDS Electrophysiology study; Intracardiac ultrasound; ProTrack wire complication; Radiolucent foreign body; Wire complication; Wire fracture (Heart Rhythm Case Reports 2019;5:256–259)

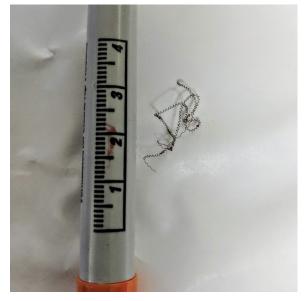
One of the pressing concerns for the authors is why the wire components were not visible to fluoroscopy. The Pro-Track wire is constructed of grade 304 stainless steel (personal communication of author J.L. with Baylis Medical), a composite of iron, nickel, chromium, manganese, and

Figure 2 Same fragment of wire from Figure 1 after removal. The very thin diameter of this stainless steel wire likely explains why it could not be seen with fluoroscopy.

carbon. This allows for unique properties, including corrosion resistance, strength, and flexibility. It is also naturally radiopaque, though it lacks the radiodensity of higheratomic-weight compounds such as barium. The radiopacity of an object on fluoroscopy depends upon 4 factors⁴: depth of use in the body (shallow use in the dermal region able to attenuate radiation better vs the deeper coronary vasculature), the width of the artificial surface visualized, the energy of the imaging radiation source, and the atomic weight of the artificial surface. When one considers the 0.025 ProTrack wire, the diameter of the coil component is many times thinner than the normally radiopaque wire; hence the radiolucency of the coil wire fragments likely rests on its extremely small diameter alone. Fortunately, the visibility of the metal components on ultrasound was not affected and ICE remained an effective tool to properly address this complication.

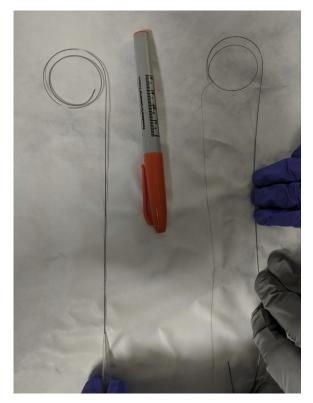
Another item of concern was the apparent involvement of the side port of the Mobi sheath in wire entanglement. We believe the ProTrack wire did not get entangled in the side port during antegrade passage into the body, as the ProTrack wire was always advanced through the lumen of the dilator component. However, after the wire fractured and the dilator was removed, the remaining wire fragments were then exposed to the side ports and presumably became entangled as the mapping and ablation catheter was advanced through the sheath to advance the Mobi sheath back to the SVC for a second pass, which ultimately was aborted when the dilator component over a standard J wire failed to advance to the fully forward and locked position (remaining about 5 mm short of its final position, indicating that our standard J wire had not exited out the side port, as this would have resulted in at least 2 cm of the dilator remaining outside the body). It is our belief that some ProTrack wire fragments became entangled in the side ports, which fortunately

Figure 3 Photographs of a normal ProTrack wire (Baylis Medical, Toronto, Canada) (*left*), and the fractured ProTrack wire (*right*). Note extensive unraveling of the distal coil component portion of the wire.

prevented further embolization of wire fragments, but this also complicated removal, as the piecemeal extraction of the wire fragments through the SL1 sheath could not completely remove the hardware that was entangled with the Mobi sheath side port. We also believe that the use of the angioplasty balloon, to attempt to entrap the metal fragments and allow for extraction of the wire fragments as a single unit with removal of the sheath, actually ruptured the side port; however, in doing so, it then allowed the fragments to be pulled back into the body and out the ipsilateral access SL1 sheath by manual traction, as the binding point had now been released (Supplemental Figure 3). Caution regarding side port cannulation with curved wires is worth mention here, particularly in no-fluoroscopy cases, when wires are advanced into a sheath with side ports exposed in advance of the dilator component. The clue in these situations is generally the inability to advance the dilator component to the fully forward and locked position. Forcing the dilator forward typically will tear the side port to make it unusable for transseptal passage owing to the sheath deformation. This finding would also be readily apparent on ultrasound.
