Case report

Metallosis and Corrosion Associated With Revision Total Knee Arthroplasties With Metaphyseal Sleeves

Joshua P. Rainey, MD, Jeremy M. Gililland, MD, Christopher L. Peters, MD, Michael J. Archibeck, MD, Lucas A. Anderson, MD, Christopher E. Pelt, MD *

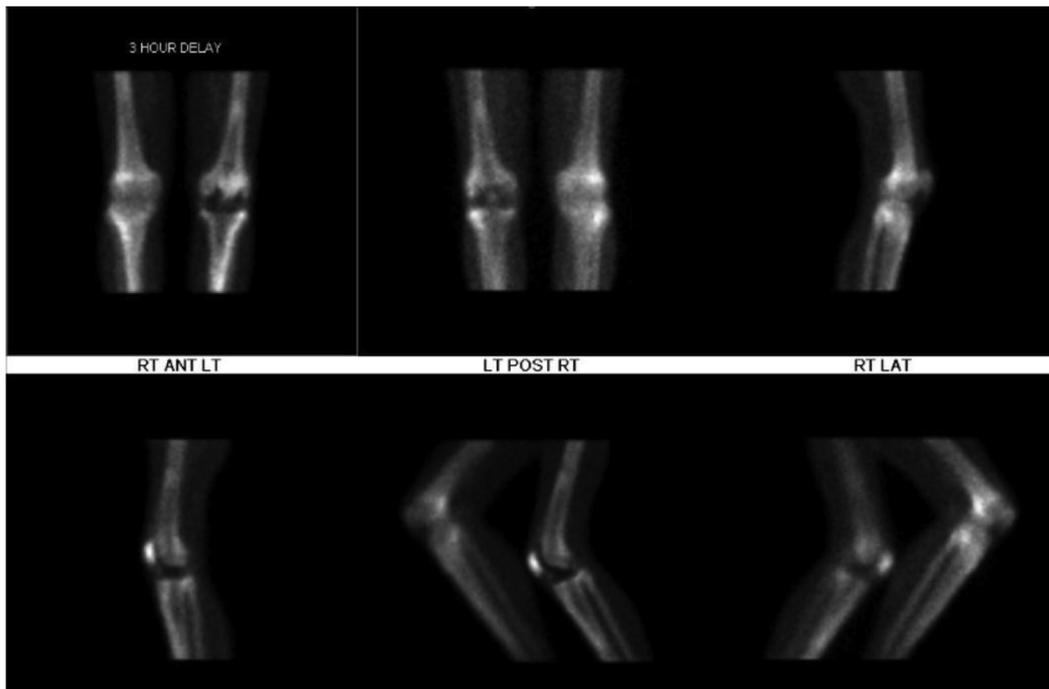
Figure 2. Triple phase bone scan demonstrating mild-to-moderate increased uptake at the lateral aspect of the femoral implant.

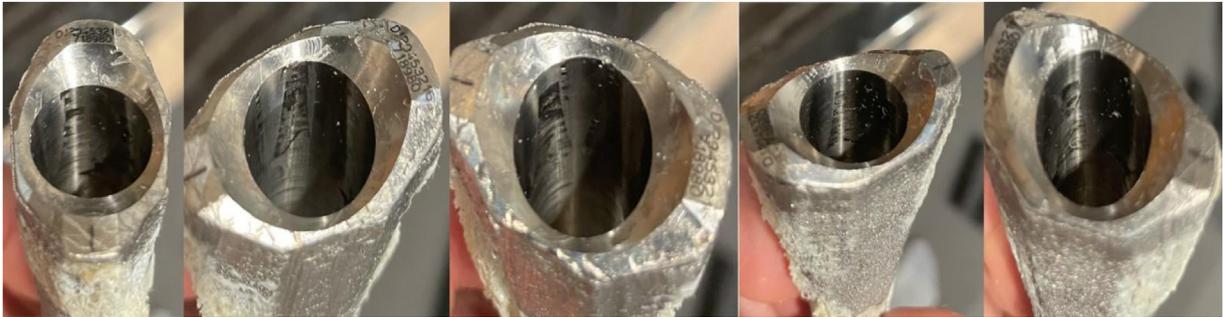
Figure 3. Each picture of the female taper demonstrates a view of each of the etches that corresponds to the flat geometry on the male taper.

adapter and locking bolt were intact, without fracture or loosening. Intraoperatively, the female bore of the metaphyseal sleeve had geometric mechanical etches/scoring with associated corrosion debris (Fig. 3). The male taper of the femoral component demonstrated a ring of wear and mild corrosion debris (Fig. 4). His tibial component was interrogated and found to be well fixed. Given the negative bone scan and intraoperative assessment, despite not being able to ensure a lack of corrosion at that taper as well, the tibia was retained. We proceeded with a femoral revision of his TKA with a short-cemented stem into a 3D-printed metaphyseal cone (Fig. 5). Over 1 year postoperatively, the patient was doing well with significant improvement in pain.

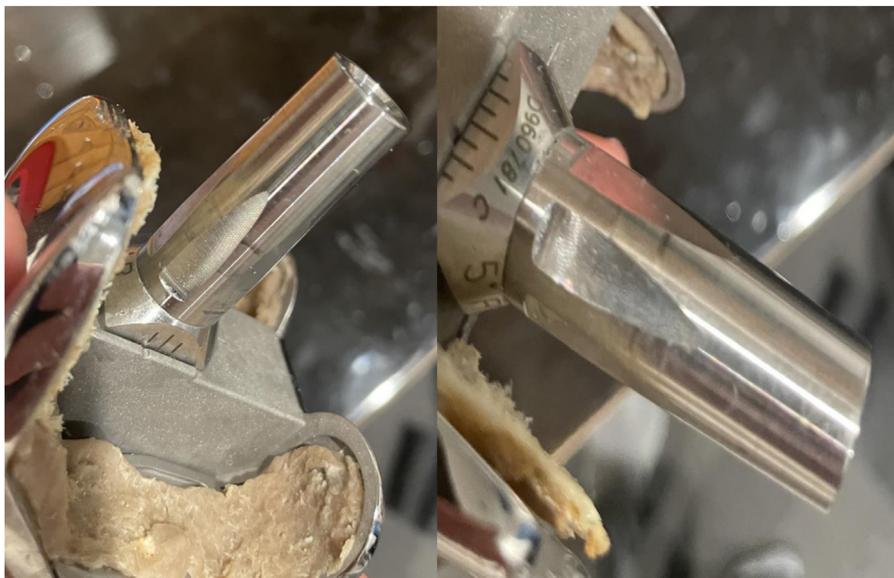
Figure 4. Male taper ring of wear and mild corrosion debris. The implant had been cleaned and sterilized since the explantation surgery.

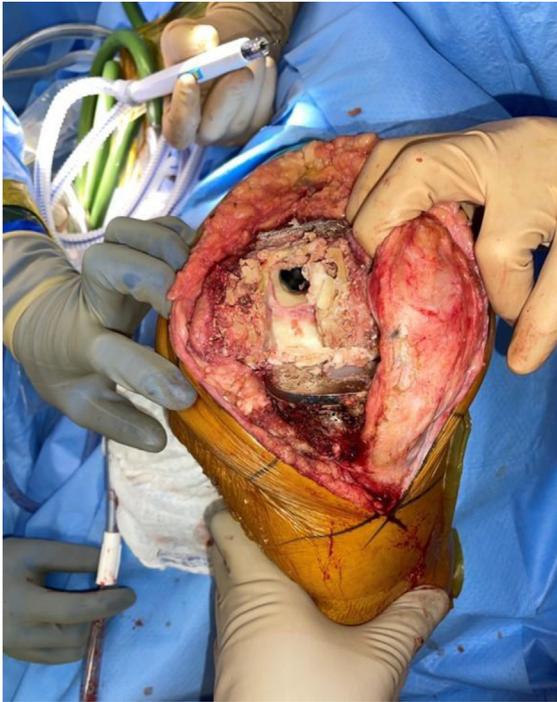
Figure 7. Abundant cement debris and fibrous tissue of a left revision total knee arthroplasty.

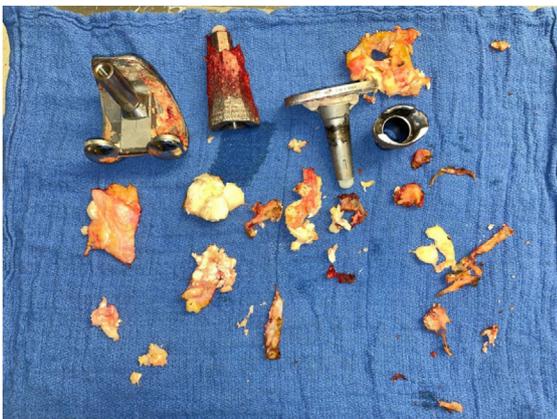
Figure 8. Explanted left revision TKA implants with excision of tissue and corrosion are most notable at the tibial tray stem.

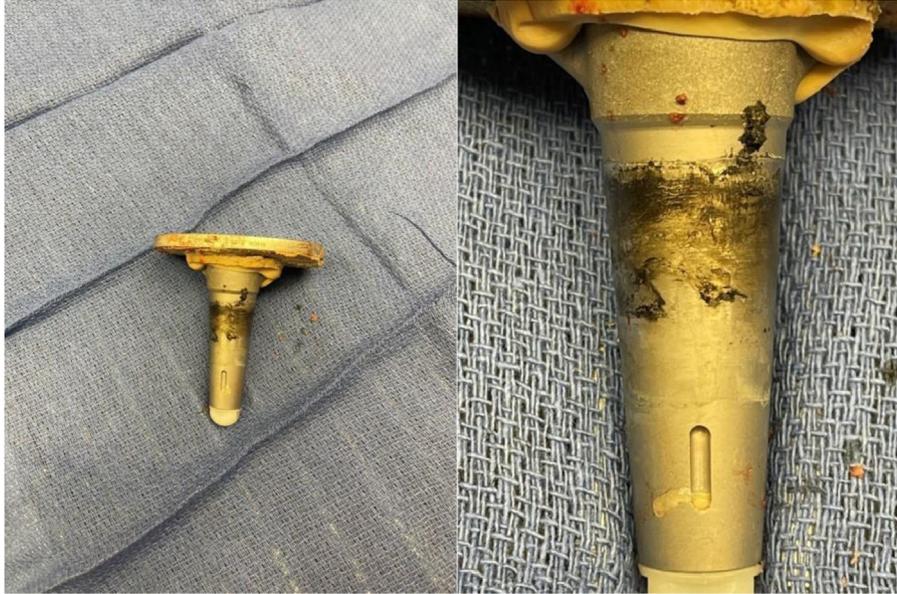
Figure 9. Tibial tray stem with abundant corrosion with associated magnified picture of corroded tibial stem.

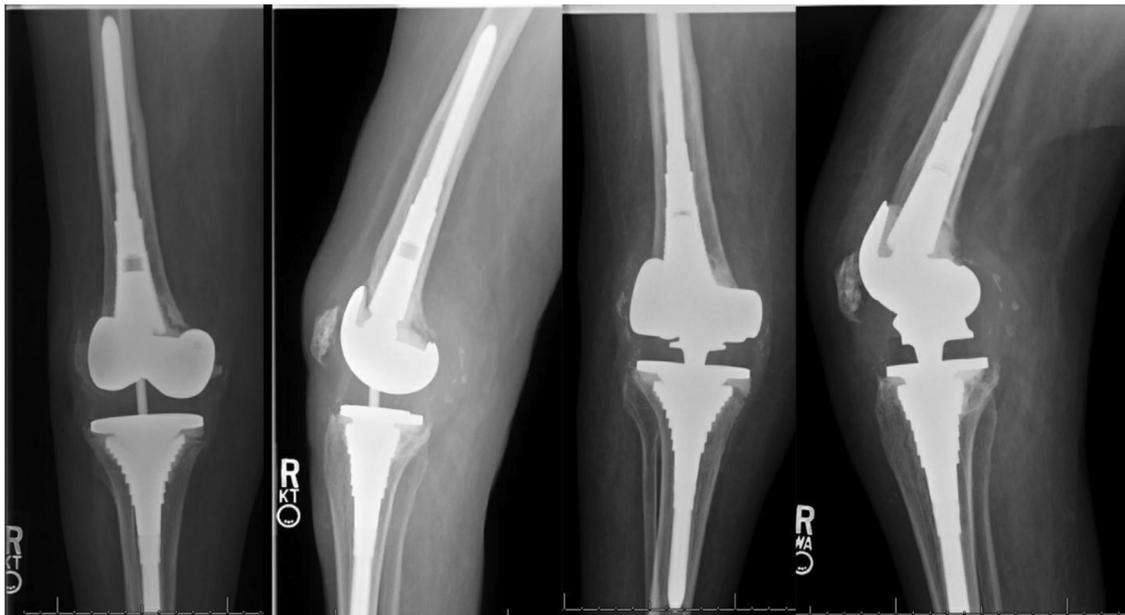
Figure 12. Preoperative and postoperative radiographs of the next revision TKA that was performed due to recurrent varus-valgus instability related to presumed wear of the constrained polyethylene post due to patient's arthrogyposis. The well-fixed MBT tibial baseplate, tibial sleeve, stem, and well-fixed femoral sleeve and stem were all retained. The constrained distal femoral component (Sigma TC3 femur) was removed and exchanged to an S-ROM Noiles Hinged Femoral Component. The femoral component was distally cemented, and the cleaned and dried female taper of the well-fixed femoral sleeve was reused, mating it with the new male taper of the hinged femoral component.

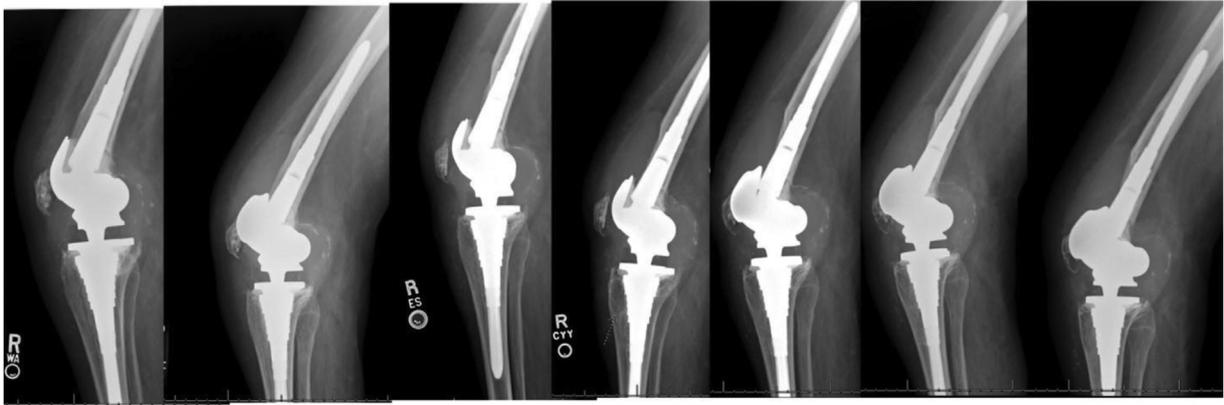
Figure 13. Serial lateral knee radiographs at 6 weeks, 1 year, 2 years, 3 years, 4 years, 5 years, and 6 years follow-up demonstrating a large effusion in the supratellar pouch along with adjacent progressive bone loss of the anterior cortex of the distal femur and an anterior tibial cyst, which became noticeable at year 2.

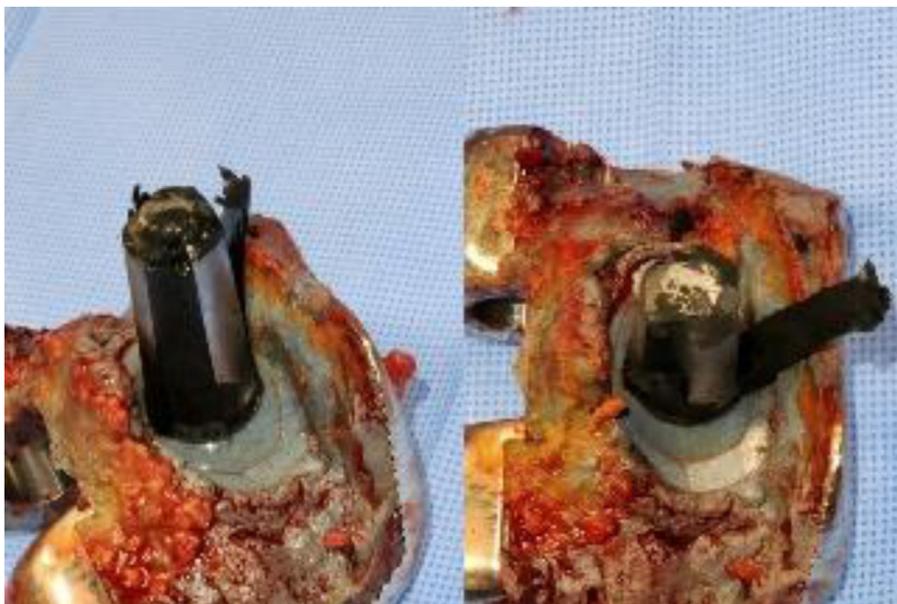
Figure 15. Explanted femoral component with all the grooves of the male taper filled with abundant black corrosion debris.

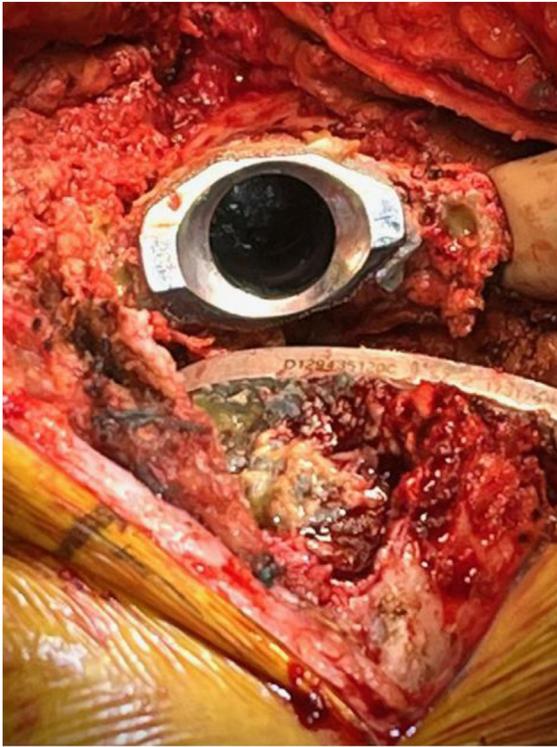
Figure 16. Abundant corrosion on the inner taper with black corrosion debris throughout. Anterior cortical bone loss was also present, leading to the anterior porous coating of the otherwise extremely well-fixed sleeve to be exposed.

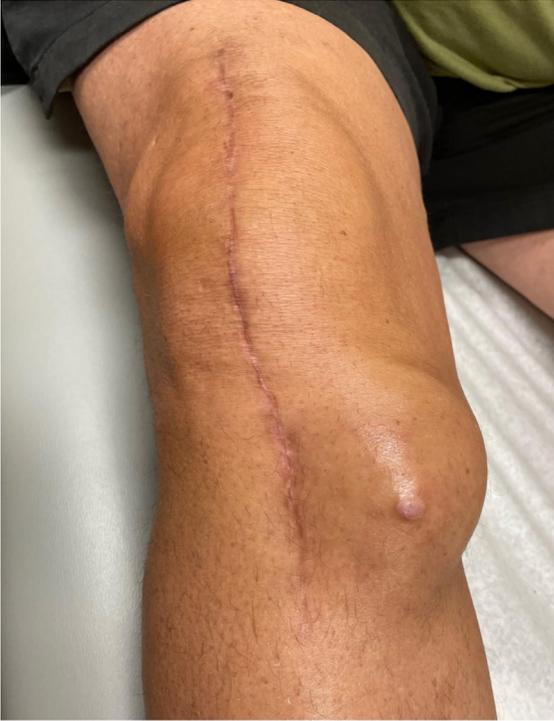
Figure 18. Clinical image demonstrating the medial proximal tibial/knee soft tissue mass with the central scar left from a prior punch biopsy.

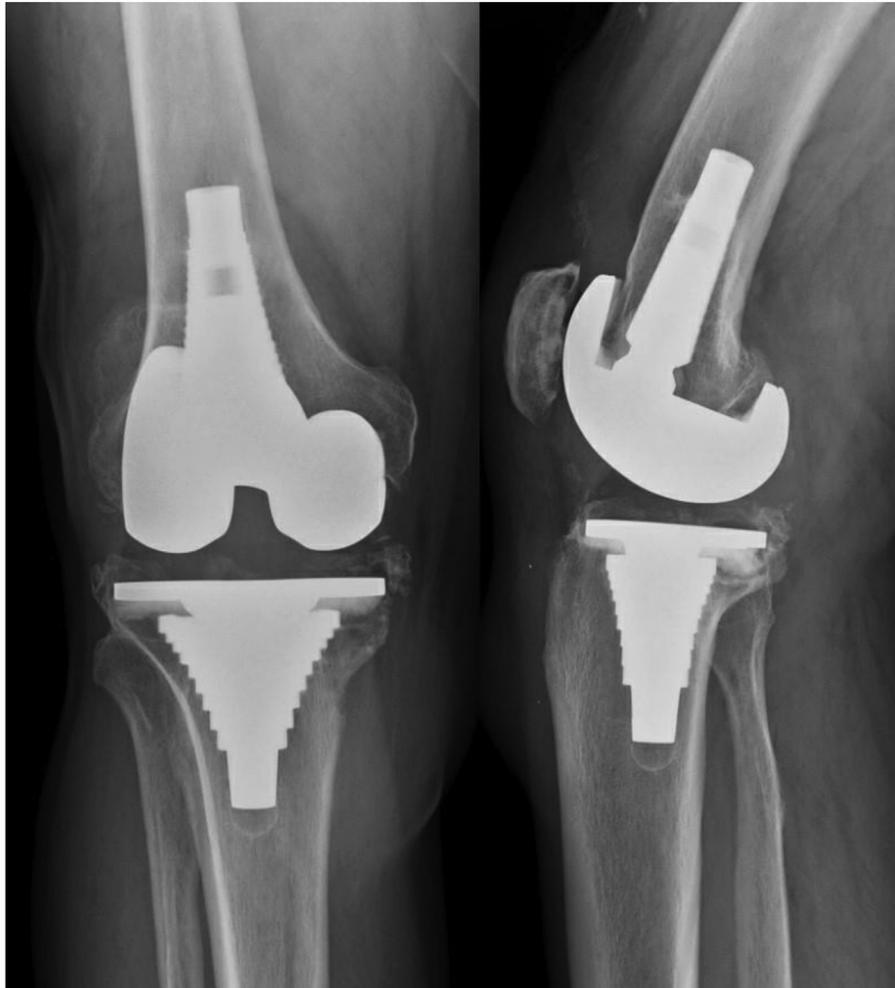
Figure 19. Radiographs of right revision TKA with Sigma PFC TC3 revision knee system with medial tibial plateau erosions.

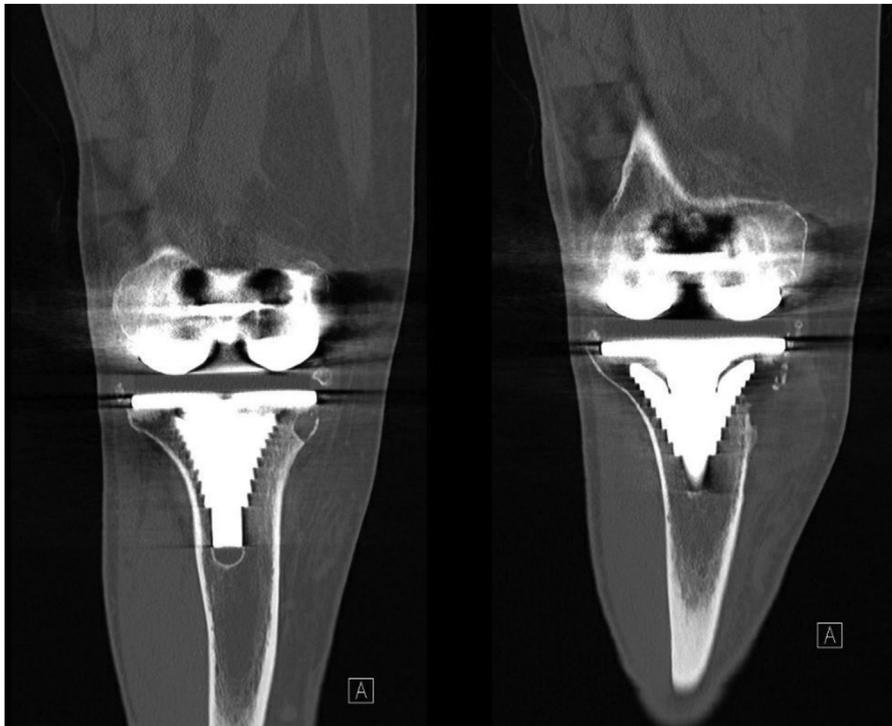
Figure 20. Computed tomography (CT) scan of right revision TKA with Sigma PFC TC3 revision knee system with medial tibial plateau erosions adjacent to the associated soft tissue mass at the medial tibial plateau.

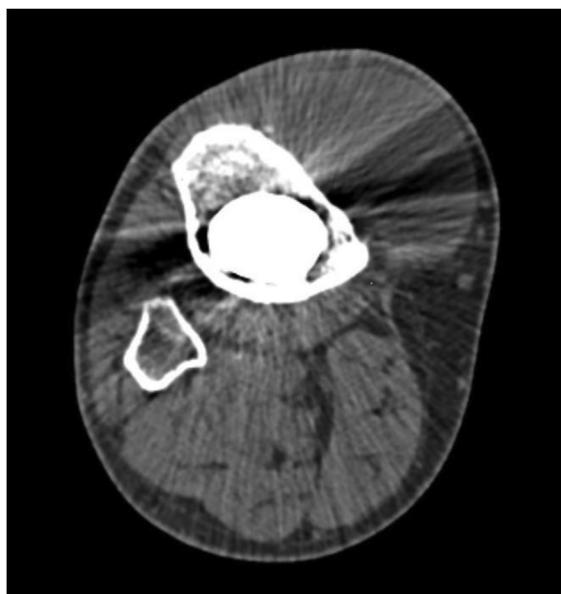
Figure 21. Axial cut of CT scan of the right knee, which demonstrates the soft tissue mass observed at patient's medial tibial plateau.

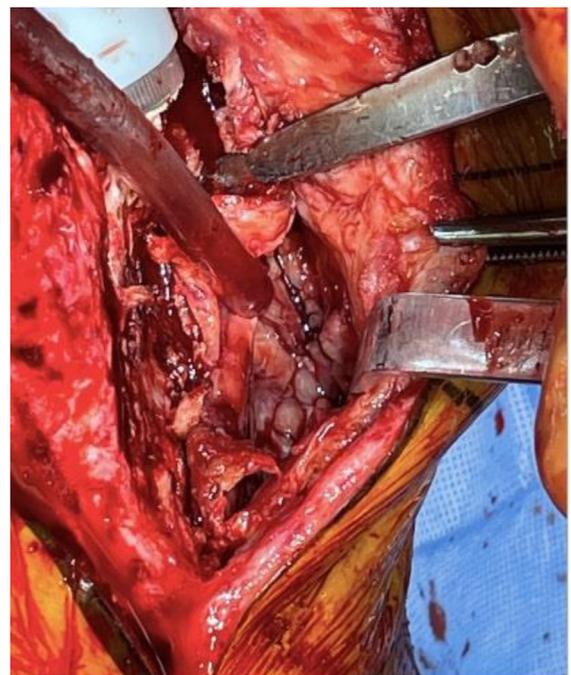
Figure 22. Clinical image demonstrating the intraoperative appearance of the pseudotumor-like medial tibial soft tissue mass.

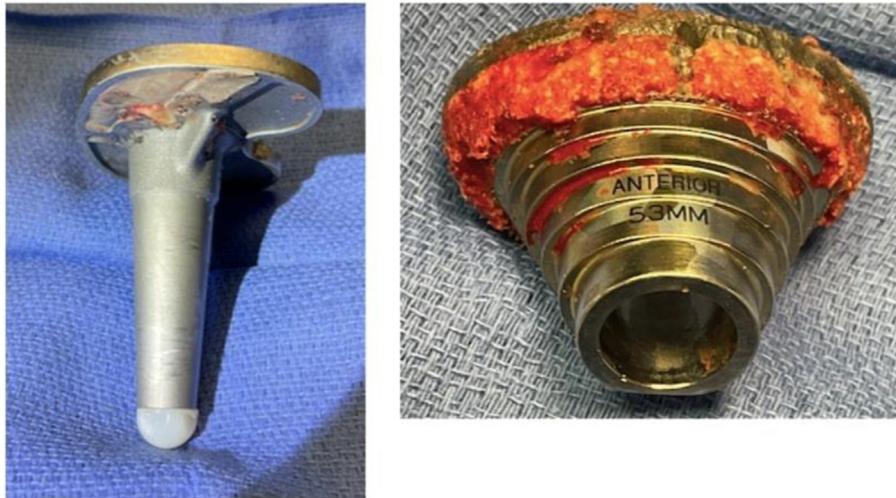
Figure 23. Corrosion debris at the most distal end of female bore of the prior well-fixed tibial sleeve, as well as the tibial tray stem.

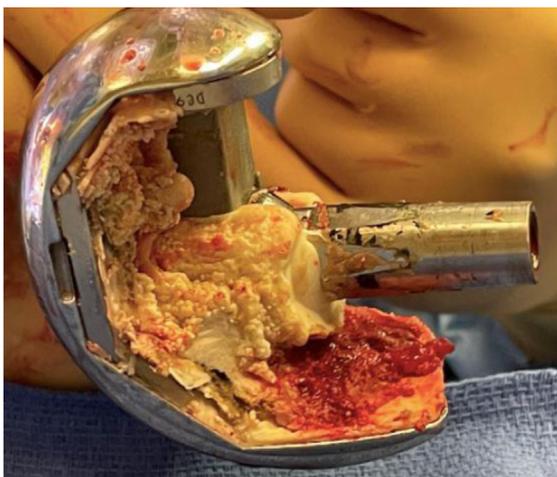
component also demonstrated corrosion at the femoral trunnion and sleeve (Figs. 24 and 25). The femoral offset adapter and locking bolt were intact, without fracture or loosening. Three months later, he was taken for stage 2 reimplant. His prior medial tibial mass had completely resolved. Short, cemented stems and cones with an oxidized zirconium (Oxinium, Smith and Nephew, Memphis, TN) femoral component were used for his revision TKA (Fig. 26). He was doing well at his 15-month postoperative visit.

Figure 24. Removed femoral component with corrosion debris evidence at the trunnion.

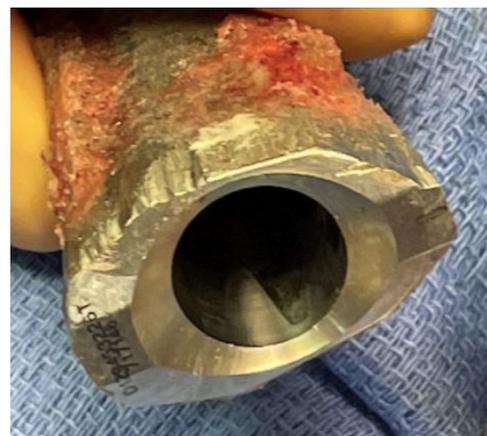
Figure 25. Black etchings and corrosion debris within the bore of the well-fixed femoral sleeve after removal.

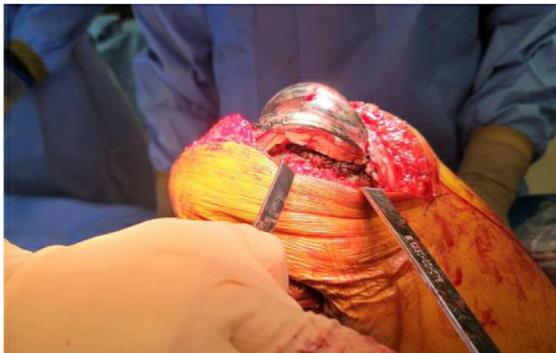
Figure 27. Example of the lack of zone 1 epiphyseal segment cement fixation of femoral component.

component to clean and dry the taper, to diligently add fully pressurized cement where possible while also avoiding getting cement interposed into the sleeve interface, and to engage the taper with significant force to seat the taper. The detectable smell after disengaging the taper may suggest that the taper indeed had been fully engaged, creating an isolated environment for the corrosion to occur. Finally, the implant design of the male trunnion of the S-ROM Noiles Hinge has a different scalloped design than the geometric flat machining edges of the Sigma TC3 male trunnion design (Fig. 15). Each of the scallops at the time of recent explant were full of black metallic debris. The scallops on the male trunnion machined taper may have some design characteristics that attempt to achieve improved rotational lock of the taper but may also allow for increased mechanical fretting and damage, an area of interest in further investigations. Finally, there was no failure of a modular offset adapter or locking bolt in this particular case, as the hinged femoral component is monolithic and does not have the modular adapter that can fail, as has been described in the constrained revision failures previously published in the literature. Our experience detailed in Case 3 has led us to approach reusing these tapers, even in the scenario of a well-fixed sleeve, with extreme caution.
