CASE REPORT

Massive osteolysis due to galvanic corrosion after total knee arthroplasty: a rare cause for early revision?

Mark Johannes Maria Zee^{1,*}, Barbara Catharina van Bommel², and Jos Jacobus Arnoldus Maria van Raay¹

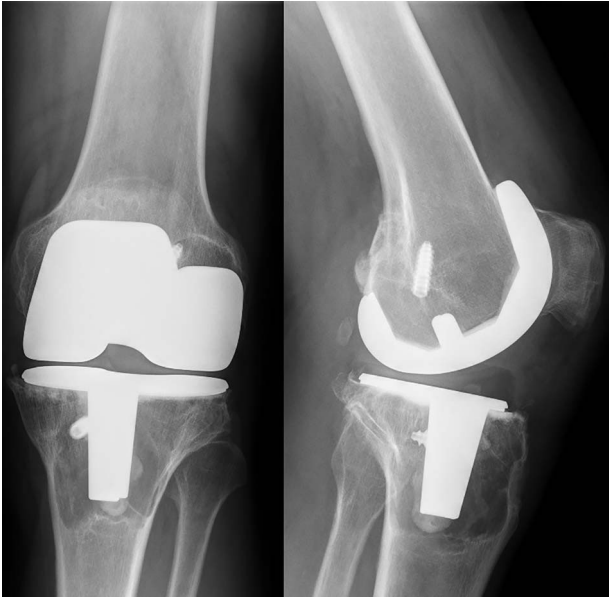
Figure 1: Preoperative standing X-ray of the left knee. A large lytic lesion is seen surrounding the tibial component.

was a thickening of the soft tissue present over the anteromedial side of the proximal tibia, which was painful on palpation. Axial load was painful. An X-ray of the left knee showed the titanium interference screw in direct contact with the tibial stem of the prosthesis (see Fig. 1). Additional imaging consisted of a computed tomography (CT) scan and Technetium⁹⁹ bone scintigraphy. Both revealed a large lytic, sclerotic lined, lesion surrounding the tibial stem. The direct contact between the interference screw and the tibial stem was confirmed by CT. Serum inflammatory markers were normal as well as serum levels of cobalt and chromium. Diagnosed with aseptic loosening of the tibial component, the patient was scheduled for revision surgery.

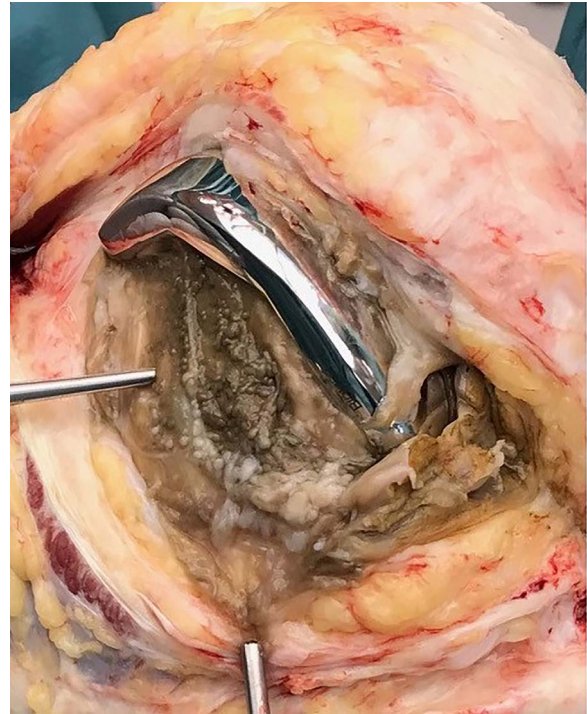
Intraoperatively, the synovium was stained gray (see Fig. 2). The tibial component was loose and easily extracted. Wear of the polyethylene bearing was present, mainly involving the posterolateral part of the fixed polyethylene bearing (see Fig. 3). No wear through or metal on metal contact was observed. The femoral component was well-fixed. After removal of the tibial component, a large cavity was opened that was filled with a yellow jelly-like substance (see Fig. 4). The titanium screw could easily be removed. Circumferential cortical support was present. The cavity was filled with a cancellous bone allograft. After bone impaction grafting was completed, a stemmed tibial and femoral component using the LEGION revision total knee system (Smith and Nephew, London, UK) was cemented in place. Intraoperative cultures remained negative. Histologic analysis of the synovium showed extensive reactive changes with giant cells reacting to foreign material, as seen in polyethylene wear disease. No metal particles were seen. There were no signs for the presence of a tumor or metastasis. The aforementioned yellow-like substance showed no remnants of cells.

Figure 2: Intraoperatively gray staining of the synovium was encountered.

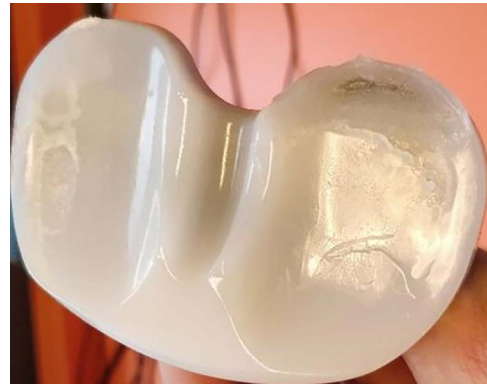
Figure 3: The tibial bearing showed wear mainly involving the posterolateral corner.

In this case, there was no wear through of the bearing and no metal on metal contact between the femoral and tibial component present.

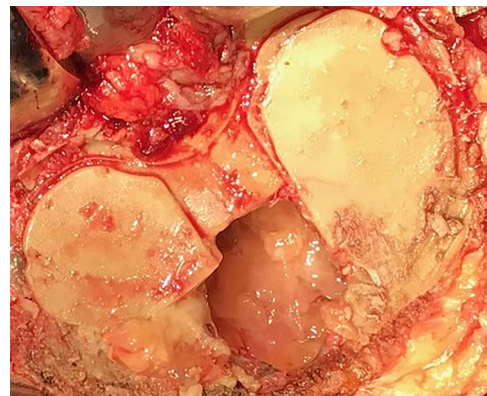
Figure 4: After removal of tibial component a large pseudotumor was observed in the proximal tibia.

Although hypothetically, in this case the massive osteolysis most likely was the result of the combination of galvanic corrosion and polyethylene wear of the bearing.

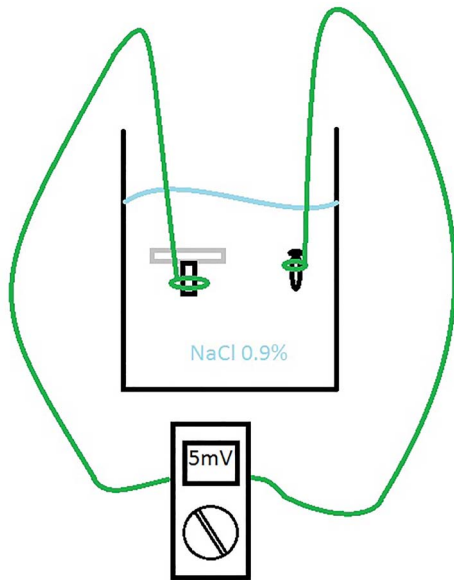
The explanted prosthesis was retrieved for further analysis. To support the diagnosis of galvanic corrosion both the tibial component and the interference screw were placed in a 0.9% sodium chloride solution and connected to a voltmeter (see Fig. 5). A current of 5 mV was measured, supporting the theory

of an electrochemical reaction that had taken place, possibly leading to galvanic corrosion.

Figure 5: Test setup analyzing for a microcurrent between the tibial component and titanium interference screw.
