Lead-to-lead interaction leading to left bundle branch area pacing lead failure

Ankit Mahajan, MD, Parash Pokharel, MD, Pugazhendhi Vijayaraman, MD, FHRS

From the Geisinger Heart Institute, Geisinger Commonwealth School of Medicine, Danville, Pennsylvania.

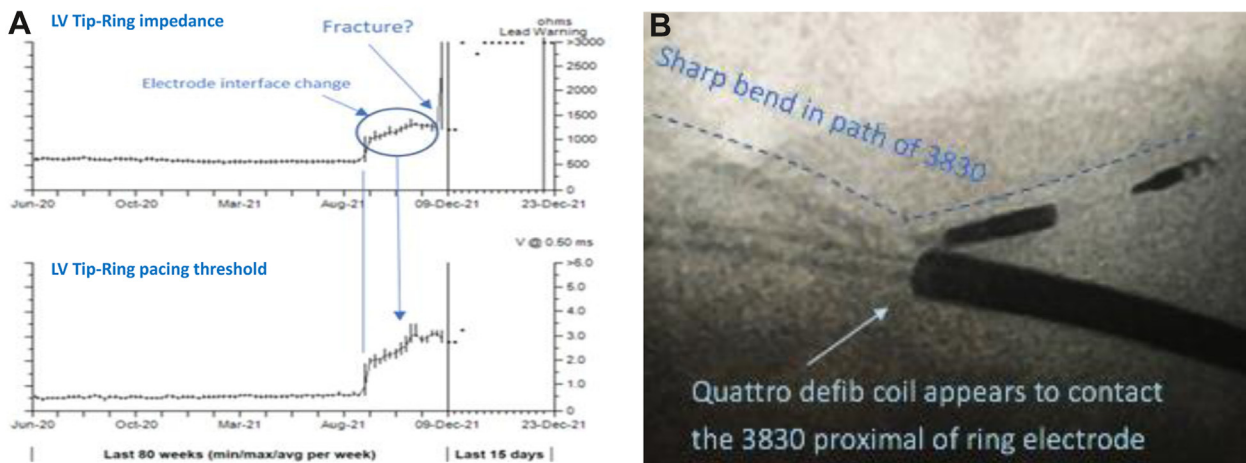
Figure 1 Impedance and threshold trend. **A:** Impedance and threshold rise in 3830 SelectSecure lead (Medtronic Inc, Minneapolis, MN), followed by open circuit and loss of capture. **B:** Fluoroscopic image demonstrating the defibrillator lead coil in contact with the proximal end of the ring electrode of 3830 SelectSecure lead. A sharp bend in the 3830 SelectSecure lead is seen where the defibrillator lead coil appears to make contact.

Twenty months after implant, he was seen in the heart failure clinic for dyspnea on exertion and fatigue. Acute rise in impedance and threshold with loss of capture of LBBAP lead was recorded on device check (Figure 1A), suggestive of lead fracture. Both the right ventricular defibrillator and atrial leads showed stable threshold and impedance (pacing and shocking) parameters. The patient was scheduled for LBBAP lead extraction and implantation of a new LBBAP lead. Preprocedural cinefluoroscopy of the system (Supplemental Video 1) revealed lead-lead interaction with the defibrillator coil sliding against the LBBAP lead near the ring electrode. Fluoroscopic images (Figure 1B) showed a sharp bend in the 3830 SelectSecure lead where the defibrillator coil appears to make contact. The LBBAP lead was easily extracted with manual traction and a new 3830 SelectSecure lead was placed deep in the mid septum away from the defibrillator coil with nonselective left bundle branch capture threshold of 0.6 V @ 0.4 ms. The patient tolerated the procedure well, without any complications.

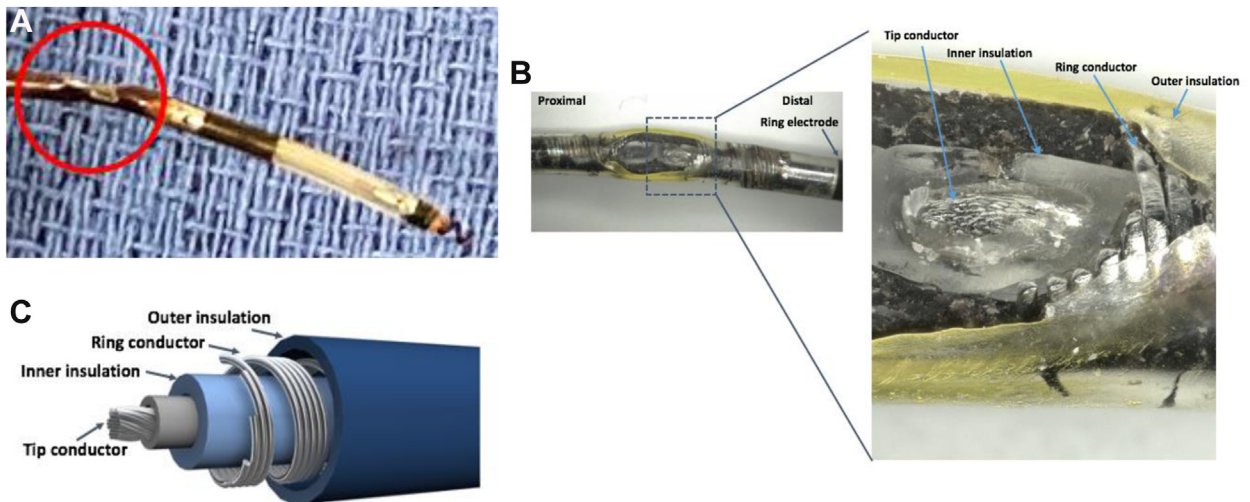
Gross inspection of the extracted LBBAP lead showed a break in insulation and conductor where the lead was in contact with the defibrillator coil (Figure 2A). Detailed analysis of the lead showed wear and tear through the outer insulation, outer coil, ethylene-tetrafluoroethylene on the tip conductor, and the tip conductor (Figure 2B). The source of the lead abrasion was determined to be the defibrillator coil. A longitudinal and 3-dimensional schematic (Figure 2C) of the

SelectSecure lead provides a reference to compare the damage on the various components of the lead.

Figure 2 Macroscopic image of the lead fracture. **A:** Apparent visible wear and tear on the 3830 SelectSecure lead (Medtronic Inc, Minneapolis, MN) after explantation. **B:** Wear through the outer insulation, outer coil, ethylene-tetrafluoroethylene on the tip conductor, and the tip conductor. **C:** Longitudinal and 3-dimensional schematic of the 3830 SelectSecure lead. (Images used with permission from Medtronic, plc © 2022.)

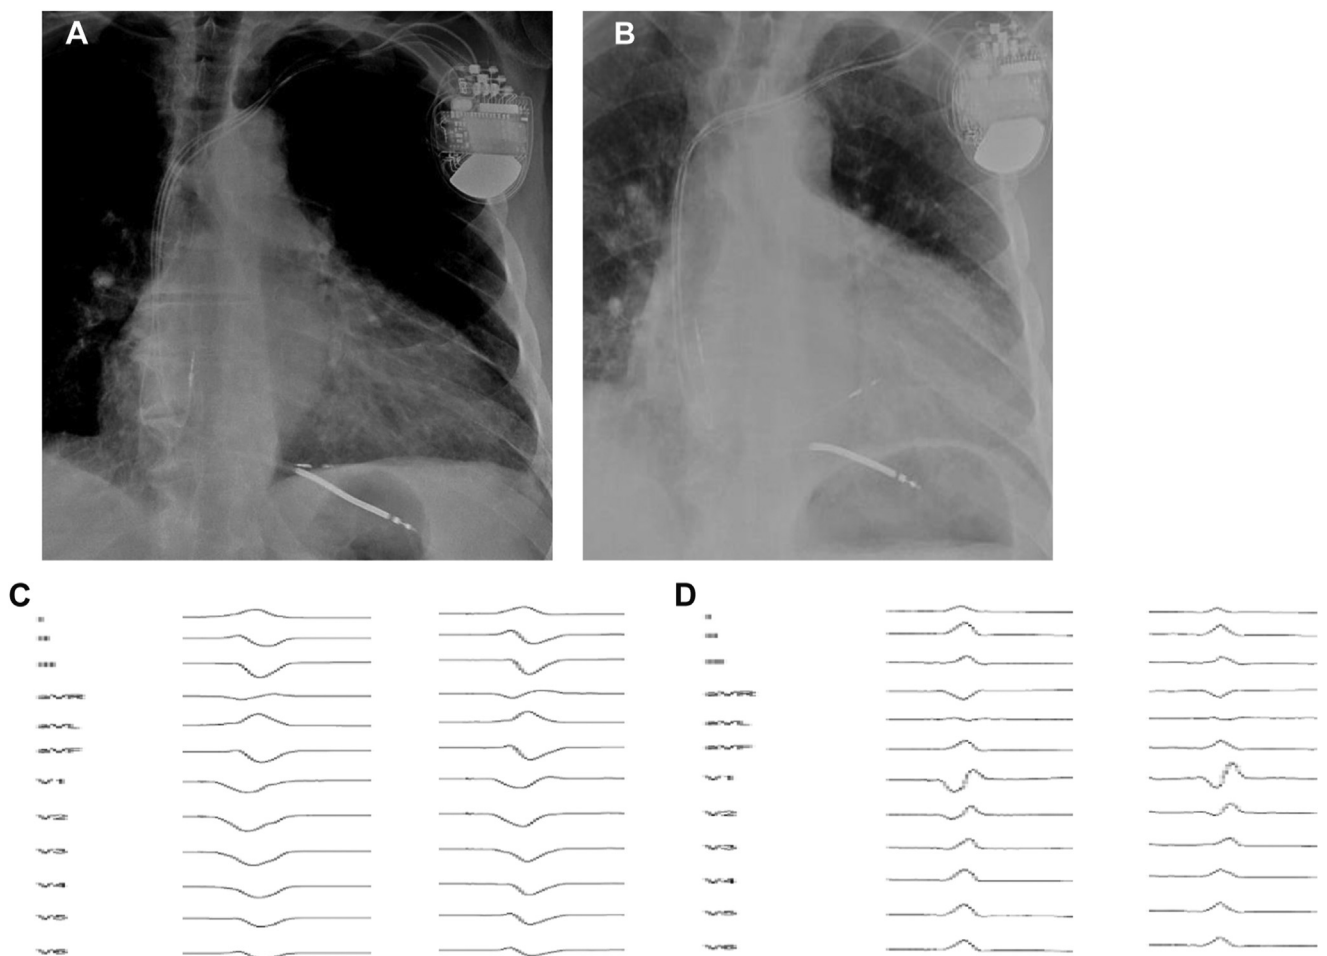
Figure 3 Chest radiography and electrocardiogram of initial and final lead position. **A:** Chest radiograph showing the posterior location of the left bundle branch area pacing (LBBAP) lead after initial implantation with proximity of the ring electrode to the defibrillator lead coil. **B:** Chest radiograph showing a more anterior location of the LBBAP lead after reimplantation with adequate distance from the defibrillator lead. **C:** Pacing morphology of initial implant with anodal capture and nonselective left septal capture. **D:** Pacing morphology of new implant with anodal capture and nonselective left bundle selective capture.

extracted with gentle traction. There was no significant fibrosis at the lead tip or insertion site. Reimplantation of a new LBBAP lead was done at a more anterior part of the septum (Figure 3B) to maintain adequate distance between the hinge point of the LBBAP lead and the ICD lead coil. Our case report highlights the possible risk of lead-lead interaction of the LBBAP lead with the defibrillator lead. Care should be taken to maintain adequate distance between the hinge-point of the LBBAP lead and the defibrillator coil.
