# Ceramic Liner Fracture Caused by an Impingement between the Stem Shoulder and the Ceramic Liner

Sunhyung Lee, MD, Seung Won Jeon, MD, Jeong Joon Yoo, MD, PhD, Hee Joong Kim, MD, PhD  
*Department of Orthopaedic Surgery, Seoul National University Hospital, Seoul, Korea*

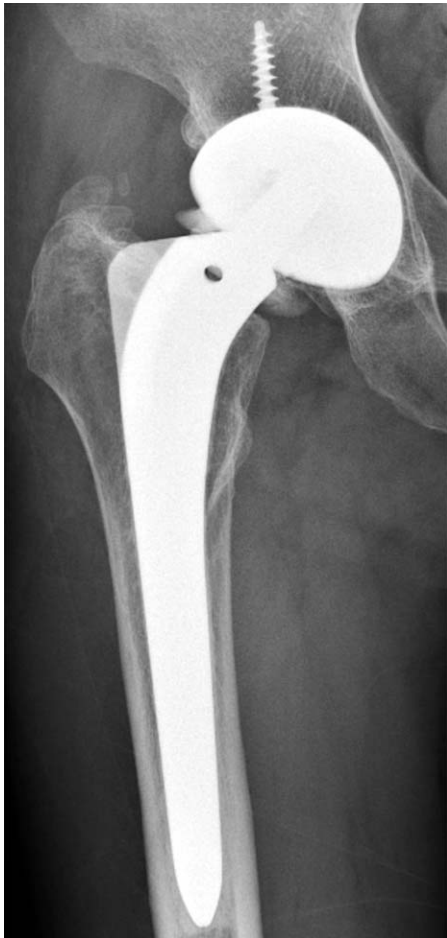
At 14 years after surgery, the patient heard a pop in his right hip while pulling heavy luggage and visited the emergency room because of sustained pain and a clicking sound. Plain radiographs revealed a ceramic head fracture (Fig. 1). Revision surgery through trans-trochanteric approach was performed. During the revision surgery, ceramic liner fractures at multiple sites of its outer edge were identified in addition to the ceramic head fracture (Fig. 2). After meticulous removal of the fractured ceramic fragments, the remaining main body of the ceramic liner was extracted. After copious irrigation, a new ceramic liner and a 32 mm head with short neck were inserted. Both were made with the 4<sup>th</sup> generation alumina, BIOLOX<sup>®</sup> delta, and the head was coupled with a metal sleeve.

Fig. 1. Simple radiograph reveals the ceramic head fracture.

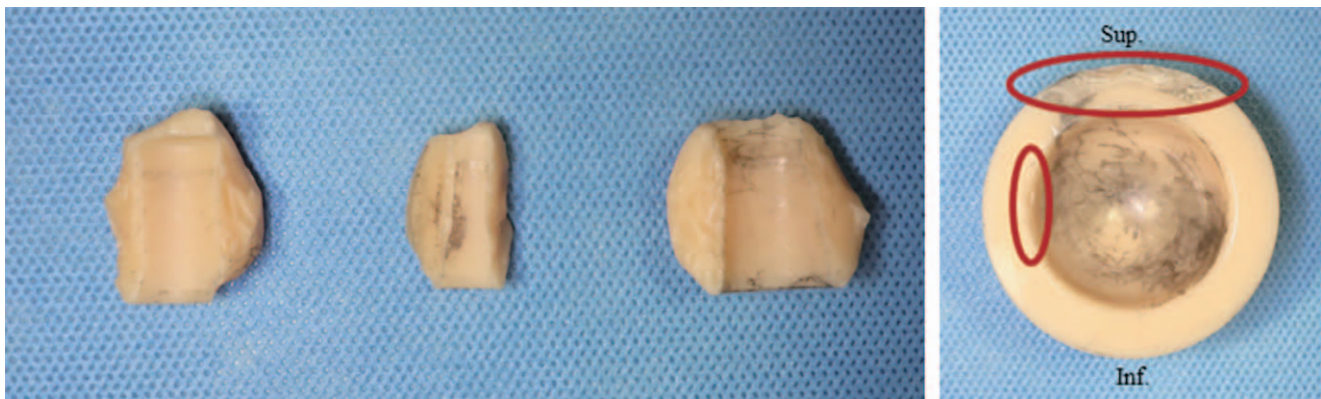
Fig. 2. Fragmented ceramic head fractures (left). The outer edge chip fracture is at the superior (Sup) portion of the liner and inner edge chip fractures are at the Sup and posterior (inferior, Inf) portion of the liner (right).

In the first event, the head fracture occurred 14 years after the initial operation while the patient was pulling heavy luggage, though it was not so forceful as to cause fracture of the ceramic head. The 28 mm head with short neck has been known to be a risk for ceramic head fracture. During the operation, chip fractures were identified on the edge of the ceramic liner and the stem neck and shoulder were noted to be damaged. However, the liner fracture and scratches on the stem neck and shoulder were thought to be inevitable results of the head fracture having caused the inter-component impingement. Thus, it was not initially considered that the initial impingement occurred between the stem shoulder and the edge of the ceramic liner.

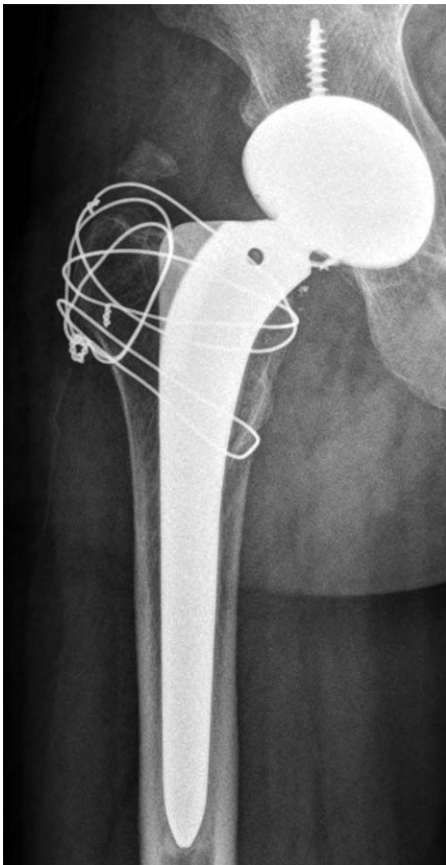
Postoperatively, the patient returned to normal activity after using crutches for eight weeks. At approximately 10 weeks after the operation, the patient experienced remarkable pain in his right hip immediately after falling resulting from a sudden forceful crush by a stranger while sitting in the squat position. The crushing force caused the right hip in the squatting position to be more flexed and abducted. He experienced persistent pain and crepitus in the right hip and visited the outpatient clinic at postoperative 12 weeks. Simple radiographs revealed multiple ceramic fragments presumed to be from the ceramic liner (Fig. 3). Re-revision surgery to exchange the ceramic head and liner with new ones was performed. During the operation, eight fractured segments and multiple smaller flakes of ceramic

**Fig. 3.** Simple radiograph reveals a ceramic liner fracture and liner particles.

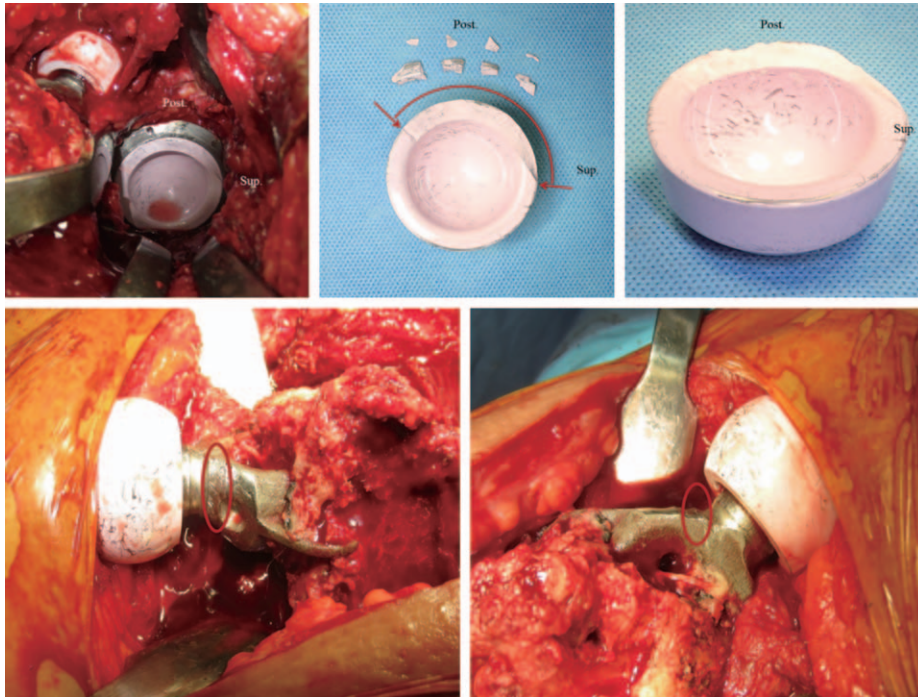
were identified originating from the edge of the ceramic liner. The fracture site occurred between 8 and 12 o'clock of the liner. When engaging in passive range of motion (ROM) of his right hip joint, impingement between the outer margin of the liner and the shoulder of the stem was observed. A notch on the shoulder-side of the stem was also observed (Fig. 4). All detected fragments were removed and the head and liner were exchanged after copious irrigation. The new head and liner were made of 4<sup>th</sup> generation BIOLOX<sup>®</sup> delta and a long neck head was used to prevent impingement between the stem shoulder and the liner. The patient is currently in satisfactory condition three years after re-revision surgery.

**Fig. 4.** (Upper row) Medical photo reveals a peripheral rim fracture at approximately 8-12 o'clock on the ceramic liner. (Lower row) Intraoperative medical photos reveal a notch on the stem shoulder. Post: posterior, Sup: superior.

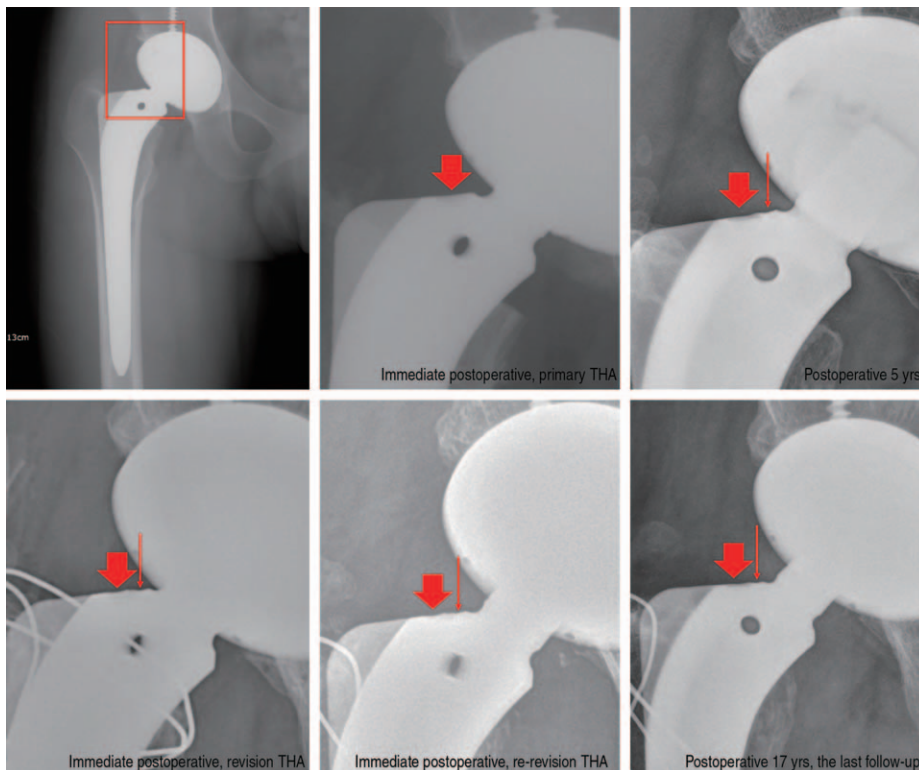
We retrospectively reviewed the patient's serial simple radiographs to detect signs of impingement between the ceramic liner and the stem shoulder. The notch on the medial side of the stem shoulder was continuously observed starting at 5 years after the initial operation (Fig. 5).

After surgery, plain radiographs were retrospectively analyzed; no signs suggestive of malseating (e.g., protruded edge) were observed, and a notch at the medial end of the impression site for the stem impactor was first observed at 5 years after the operation. We typically recommend patients avoid squatting or kneeling after THA, however this patient was engaging in stretching exercises to full ROM, sitting cross-legged on the floor and squatting after THA. We advised the patient to avoid excessive ROM after re-revision surgery to help prevent further impingement between the stem shoulder and ceramic liner.

**Fig. 5.** Serial postoperative simple radiographs. The lateral shoulder notch (narrow arrow) on the BiCONTACT<sup>®</sup> stem is observed on the medial end of the impression site for stem impactor (broad arrow). THA: total hip arthroplasty.

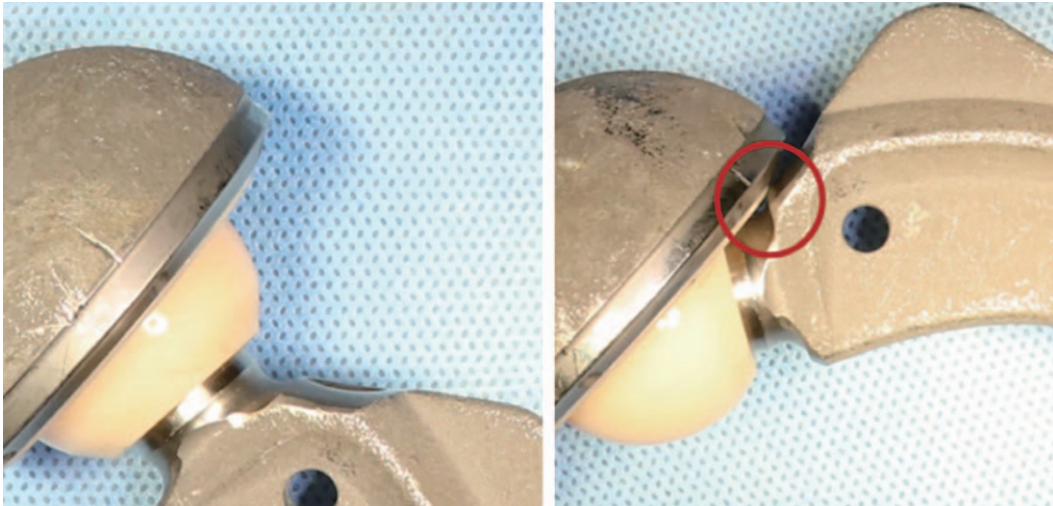
In the second event, the patient's right hip was suddenly flexed and abducted forcefully. Thus, collision between the stem neck and liner edge was first suspected as the cause of the liner fracture. However, no scratch on the stem neck was observed and the fracture site was not at the inner edge of the liner, but rather the outer edge. If the impingement with the stem neck was the cause of the liner fracture, the inner edge of the liner would have been fractured. Based on these findings, we reasoned that impingement between the stem shoulder and the outer edge of the liner had occurred. This type of impingement was confirmed intraoperatively with wide abduction of the hip joint. With wide abduction, the medial end of the impression site for the stem impactor collided with the outer edge of the ceramic liner (Fig. 5). To avoid this impingement, we exchange the short neck ceramic head to the long neck head with an optional metal sleeve. When we combined the BiCONTACT<sup>®</sup> stem with a short neck head, a liner and a cup *ex vivo*, there was a collision between the stem shoulder and outer margin of the liner like the intraoperative findings (Fig. 6).

**Fig. 6.** Impingement occurs between the stem shoulder and outer margin of the ceramic liner. A PLASMACUP SC® and BiCONTACT® stem with a 28 mm short neck head were used in the simulation.

a predisposing factor for subsequent impingement between the stem shoulder and ceramic liner. The BiCONTACT® stem is designed for maximum preservation of the existing bone substance, therefore, the level of neck cutting will be much higher and the length of the stem neck is shorter compared with other implants. Additionally, the neck length is fixed, regardless of the stem size. These attributes make the level of the stem shoulder higher and closer to the edge of the cup as the larger the stem, the closer it is to the cup. These characteristics of BiCONTACT® stem design seem to make the stem vulnerable to impingement on the shoulder site.

This case reveals that impingement between the stem shoulder and ceramic liner can occur, thus leading to liner fracture. This type of impingement should be considered when designing stems. For BiCONTACT® stems, it is recommended that clinicians avoid the use of short-necked heads if possible.
