Localized Corrosion Occurrence in Low-Carbon Steel Pipe Caused by Microstructural Inhomogeneity

Abstract: In this study, the cause of failure of a low-carbon steel pipe meeting standard KS D 3562 (ASTM A135), in a district heating system was investigated. After 6 years of operation, the pipe failed prematurely due to pitting corrosion, which occurred both inside and outside of the pipe. Pitting corrosion occurred more prominently outside the pipe than inside, where water quality is controlled. The analysis indicated that the pipe failure occurred due to aluminum inclusions and the presence of a pearlite inhomogeneous phase fraction. Crevice corrosion occurred in the vicinity around the aluminum inclusions, causing localized corrosion. In the large pearlite fraction region, cementite in the pearlite acted as a cathode to promote dissolution of surrounding ferrite. Therefore, in the groundwater environment outside of the pipe, localized corrosion occurred due to crevice corrosion by aluminum inclusions, and localized corrosion was accelerated by the large fraction of pearlite around the aluminum inclusions, leading to pipe failure.

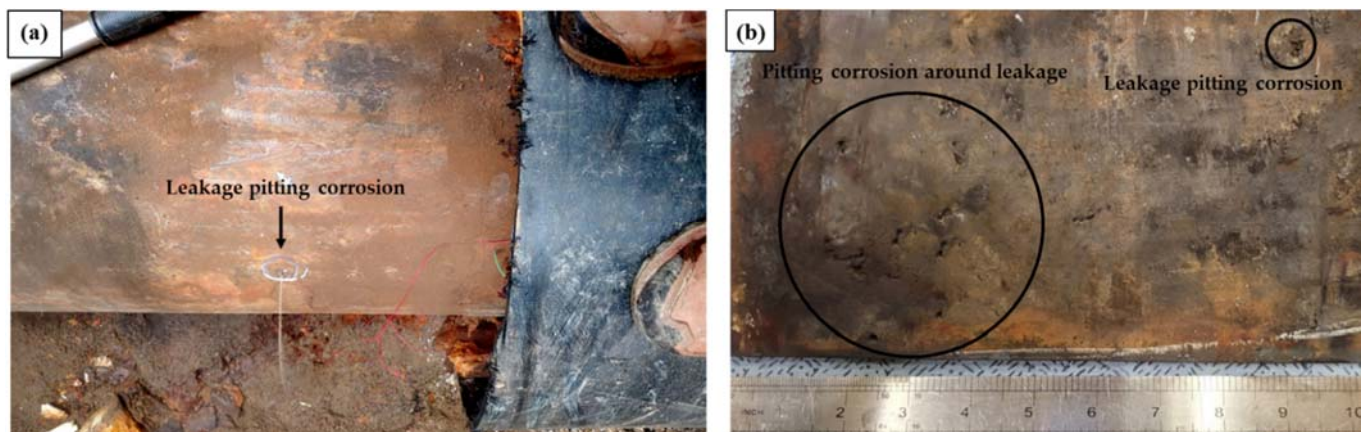
Based on visual inspection of the failed pipe, leakage occurred in the form of pitting, and the severe pitting corrosion occurred near the part of the pipe where the leaking occurred (Figure 2). Figure 3 shows surface images of the pitting corrosion part where leakage occurred, as well as pitting corrosion near the leakage. Figure 4 shows cross-sectional images of the pitting corrosion part where the leakage occurred and the pitting corrosion near the leakage. As stated previously, pitting corrosion occurred on both the exterior and interior of the failed pipe wall. However, since low-carbon steel is a material that does not have passivation, pitting corrosion cannot occur due to the failure of passivation. In low-carbon steel, localized corrosion can be caused by crevice corrosion by specific inclusions, galvanic corrosion between dissimilar metals, and under deposit corrosion (UDC) by solid particles (sand, debris, and iron oxides) [14,19]. In other words, it is necessary to investigate the above possibilities openly.

Figure 2. Photographs of the failed pipe: (a) water leakage resulting from pitting in the failed pipe, (b) external surface of the failed pipe around the leakage area.

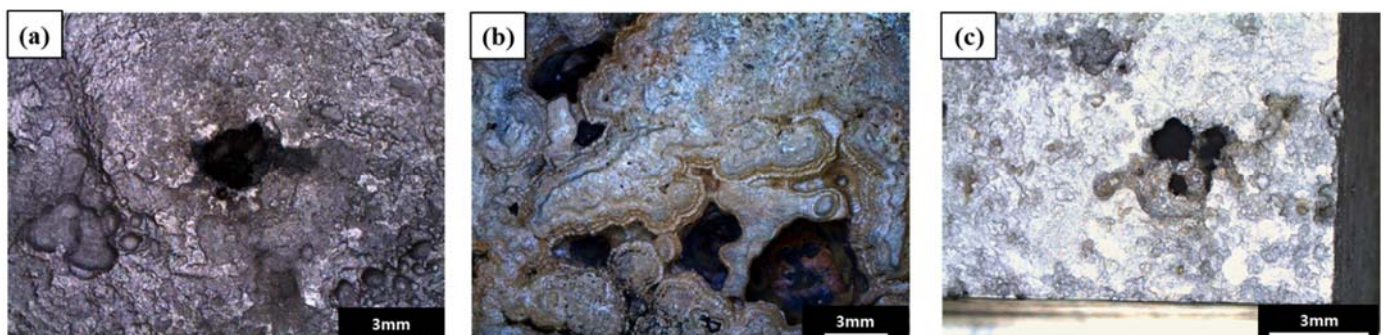
Figure 3. Surface image of the pitting part: (a) pitting corrosion area of the leakage (the outside of the pipe), (b) pitting corrosion area near the leakage (the outside of the pipe), and (c) pitting corrosion area near the leakage (the inside of the pipe).

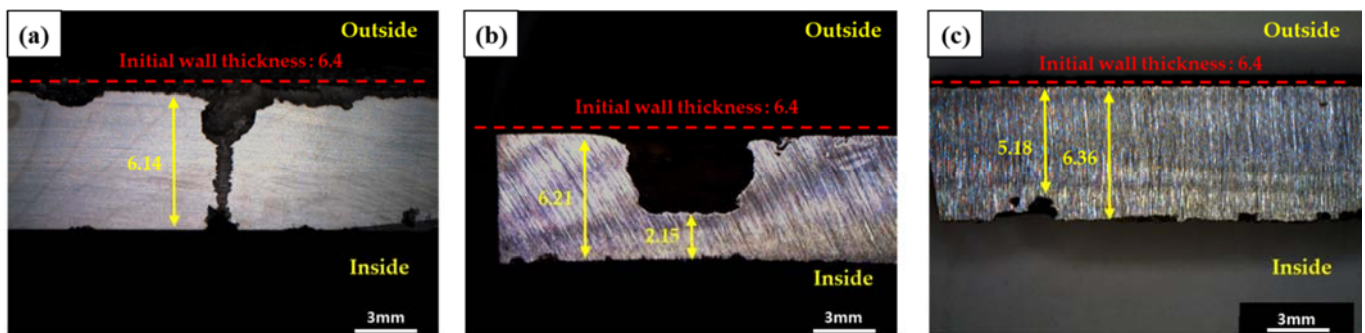
Figure 4. Cross-sectional images of the pitting part: (a) pitting corrosion where the leakage occurred, (b) pitting corrosion near the leakage, and (c) pitting corrosion near the leakage.

Moreover, the depth of the pitting corrosion on the exterior of the failed pipe was significantly deeper than the interior. It is considered to have been due to the difference between the environment of the inside and outside of the pipe (Tables 1 and 2). In addition, to reduce the risk of corrosion, the DH water that flowed through the pipe was maintained at a dissolved oxygen level below 200 ppm through periodic water quality management [15]. In low-carbon steel, localized corrosion hardly occurs when the concentration of dissolved oxygen is low [20]. In addition, in the case of the exterior of the pipe, localized corrosion may be further accelerated due to the non-uniform distribution of groundwater penetrating into the heat insulator. Therefore, it is considered that the corrosion perforation of the pipeline is induced by the external corrosion.

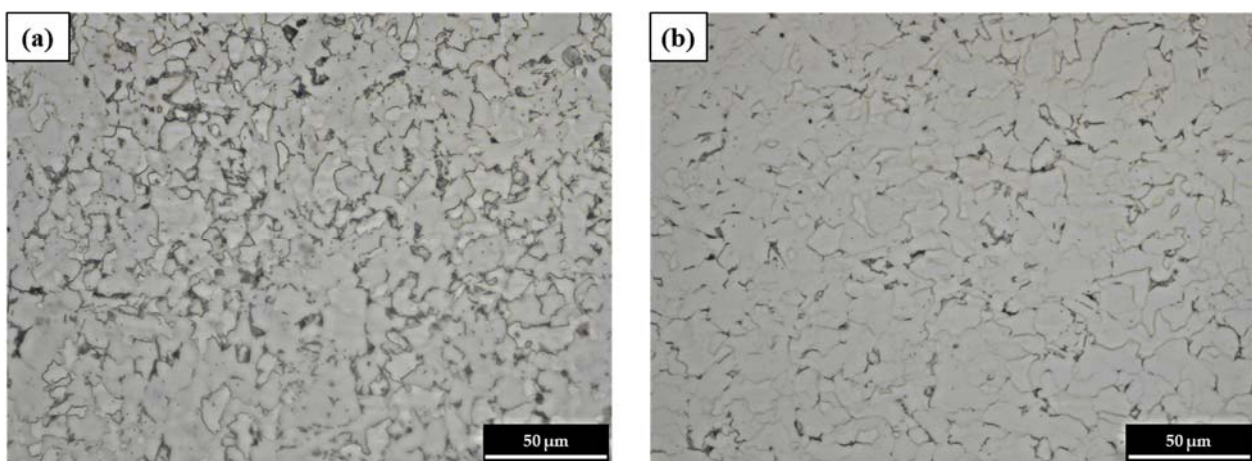
Figure 5 shows the microstructure of the pitting corrosion region (specimen A) and the uniform corrosion region (specimen B) of the failed pipe. The darker-colored section is pearlite, which is a layered structure composed of ferrite and cementite, and the brighter-colored section is ferrite [21]. Figure 5 and Table 4 show that there is a larger fraction of pearlite in specimen A than in specimen B. Pearlite is susceptible to corrosion as its constituent phases, ferrite and cementite, have dissimilar electrochemical potentials that cause microgalvanic corrosion when exposed to corrosive electrolytes [21–23].

Figure 5. The optical microstructures of specimens: (a) specimen A (pitting corrosion region), and (b) specimen B (uniform corrosion region).

Therefore, the inhomogeneity of the microstructure forces a difference in corrosion rate. A pipe section exhibiting pitting corrosion with a lot of pearlite experiences severe corrosion, whereas a uniform corrosion section of the failed pipe with a low pearlite phase incurs only minor thickness reduction.

- It is recommended that the uniform distribution of fine-sized pearlite and Al inclusions be produced through proper liquid steel homogenization and heat treatment during the steelmaking process.
- It is recommended that a standard for the chemical composition of Al be established within the existing KS D 3562 standard.

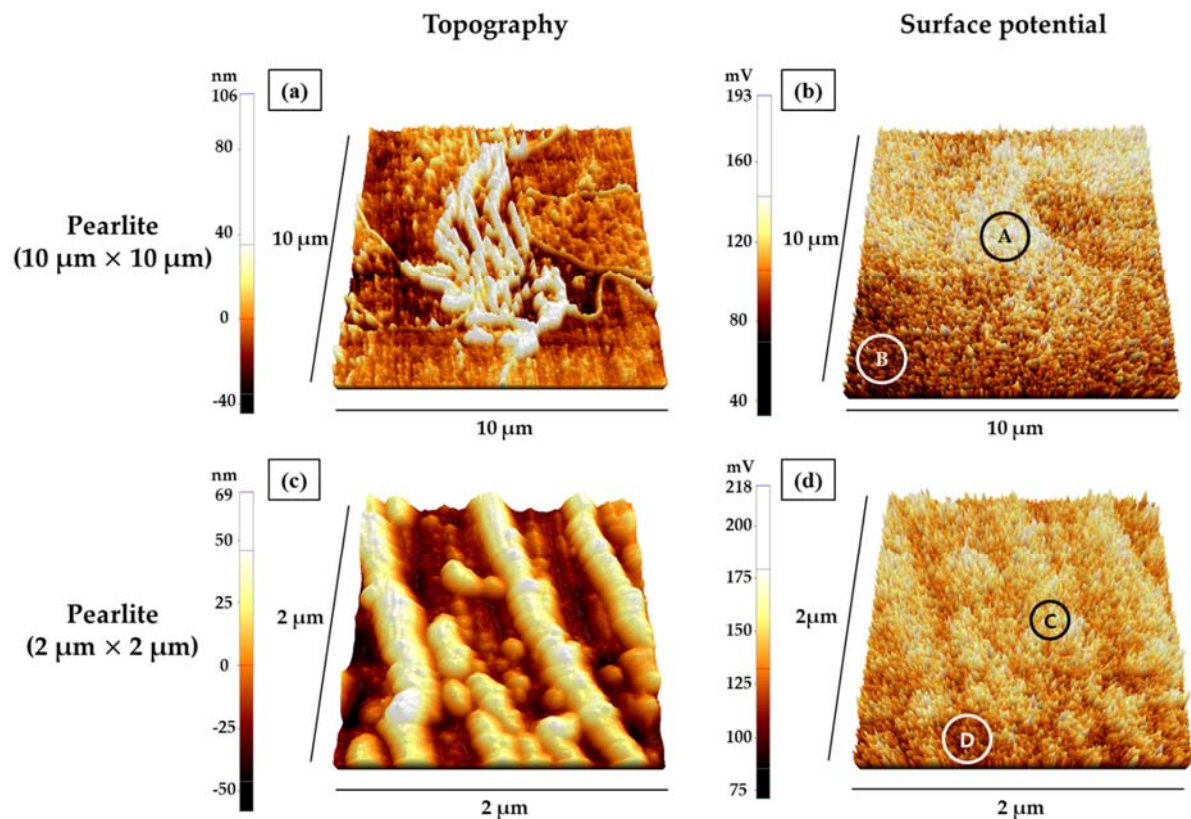
Figure 6 shows the AFM and KPFM analyses of the pearlite section of the failed pipe. Figure 6a,b show the correlation between pearlite and the surrounding pro-eutectoid ferrite by measuring topology and surface potential within a size of $10 \mu\text{m} \times 10 \mu\text{m}$, respectively. In Figure 6a, pearlite has a lamella structure, and the surface potential of pearlite (A site) is approximately 44.4 mV higher than that of the surrounding pro-eutectoid ferrite (B site) in Figure 6b and Table 5. This indicates that the corrosion of pro-eutectoid ferrite is locally accelerated by microgalvanic corrosion between pearlite and the surrounding pro-eutectoid ferrite [19,24]. Figure 6c,d show the correlation between cementite and ferrite in the pearlite by measuring topology and surface potential within a size of $2 \mu\text{m} \times 2 \mu\text{m}$, respectively. Figure 6c shows the lamella structure of pearlite, indicating that the bright protrusions are cementite while the dark region is the ferrite [25]. This is because the corrosion of ferrite was more corroded than that of cementite during the etching process using 2% Nital etching solution. Figure 6d and Table 5 show that the surface potential of cementite in the pearlite (C site) is approximately 34.78 mV higher than that of ferrite in the pearlite (D site). Thus, the corrosion of ferrite is locally accelerated by microgalvanic corrosion between ferrite and cementite in the pearlite [19,24].

Figure 6. Topography and surface potential of pearlite (specimen A): (a) topography of pearlite, (b) surface potential of pearlite, (c) topography inside of pearlite, and (d) surface potential inside of pearlite.

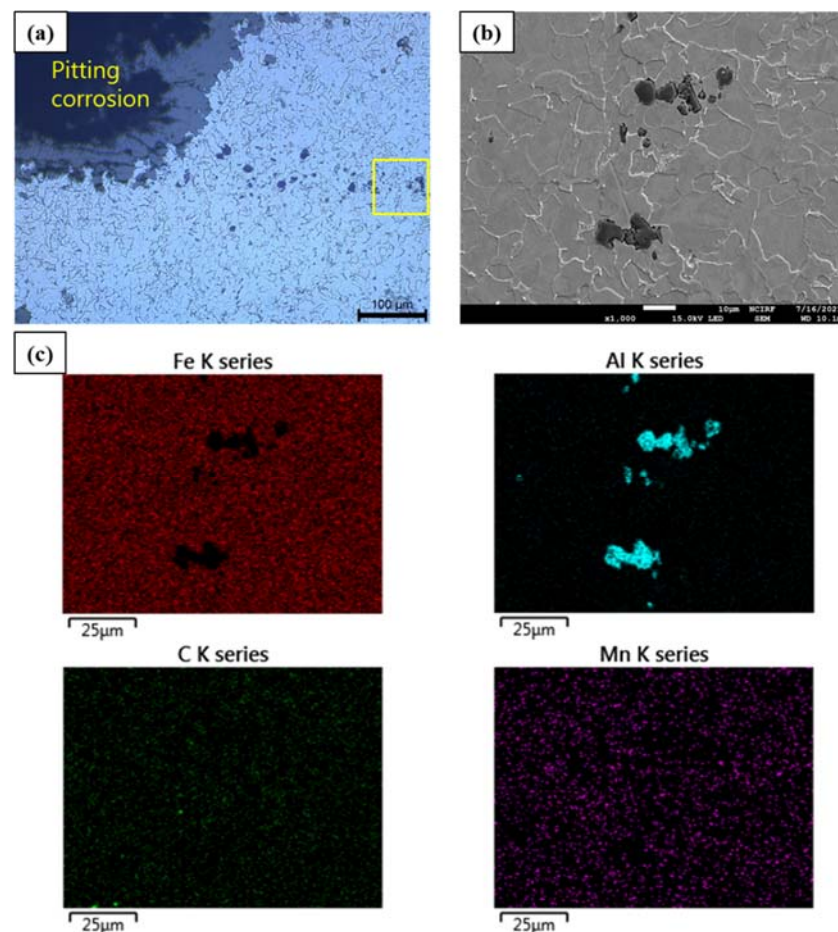
To identify the cause of severe pitting corrosion, microscopic analyses were performed on the pitting corrosion near the leakage area using SEM/EDS and EPMA (Figure 7). Figure 7a,b showed several inclusions around the pitting corrosion site. The EDS elemental mapping of the inclusions in Figure 7c reveals that the particle is primarily composed of Al. The size range of these Al inclusions is 10–20 μm . In the chemical composition analysis, 0.04% Al was contained in the failed pipe, as shown in Table 3.

Figure 7. The OM, and SEM/EDS analyses of the pitting corrosion near the location of the leakage; (a) OM analysis, (b) SEM analysis (yellow box), and (c) EDS mapping analysis (yellow box).

Al inclusions were considered to have been the result of Al use as a deoxidizer in the steelmaking process [26]. Al is known to have uniform distribution and fine particle size (less than 2 μm) upon proper heat treatment; accordingly, inclusions typically have little influence on corrosion behavior [27]. However, the failed pipe appeared to have larger-sized Al inclusions as well as an uneven distribution compared with the results in the literature [27,28]. This may have been the result of improper or incomplete homogenization during the steelmaking process. Furthermore, during the pipe manufacturing process, microcrevices formed at matrix–inclusion interfaces due to dissimilarities in the strain values and thermal expansion coefficients, which may have caused crevice corrosion, thereby accelerating localized corrosion [19,29].

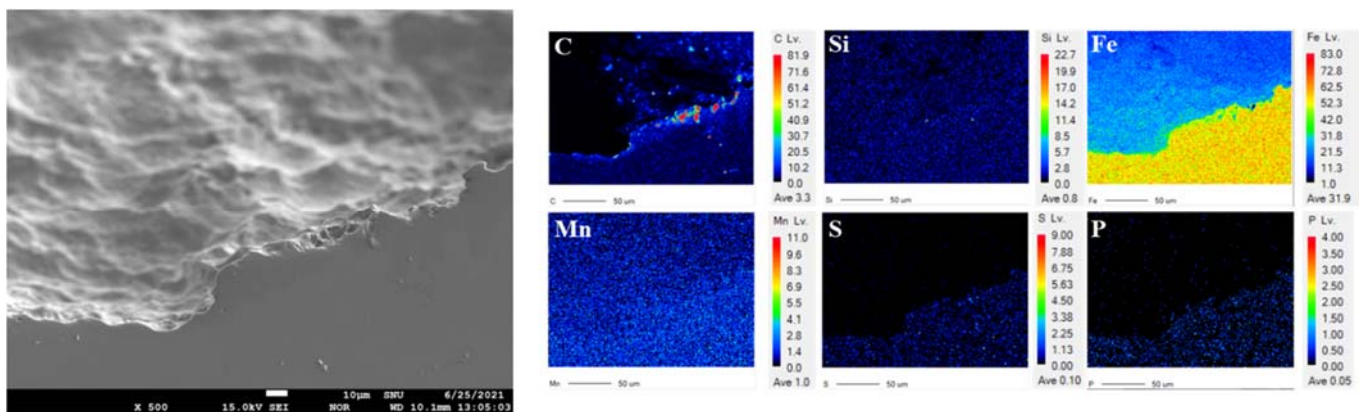
Figure 8 shows the EPMA analysis of a cross section where pitting corrosion occurred in the failed pipe. Carbon agglomerations were partially observed in the pitting corrosion part. It appeared that the pitting corrosion region had a larger pearlite fraction than the uniform corrosion region in the failed pipe. Accordingly, the carbon agglomerations occurred due to the high fractional presence of cementite in the pearlite. As shown in the AFM and KPFM analyses results (Figure 6 and Table 5), when there are many pearlite phases, the material is vulnerable to corrosion due to microgalvanic corrosion between pearlite and surrounding pro-eutectoid ferrite, ferrite, and cementite [19,24,30]. The ferrite is corroded locally by microgalvanic corrosion around cementite.

Figure 8. The EPMA analysis of a cross section where pitting corrosion occurred in the failed pipe.

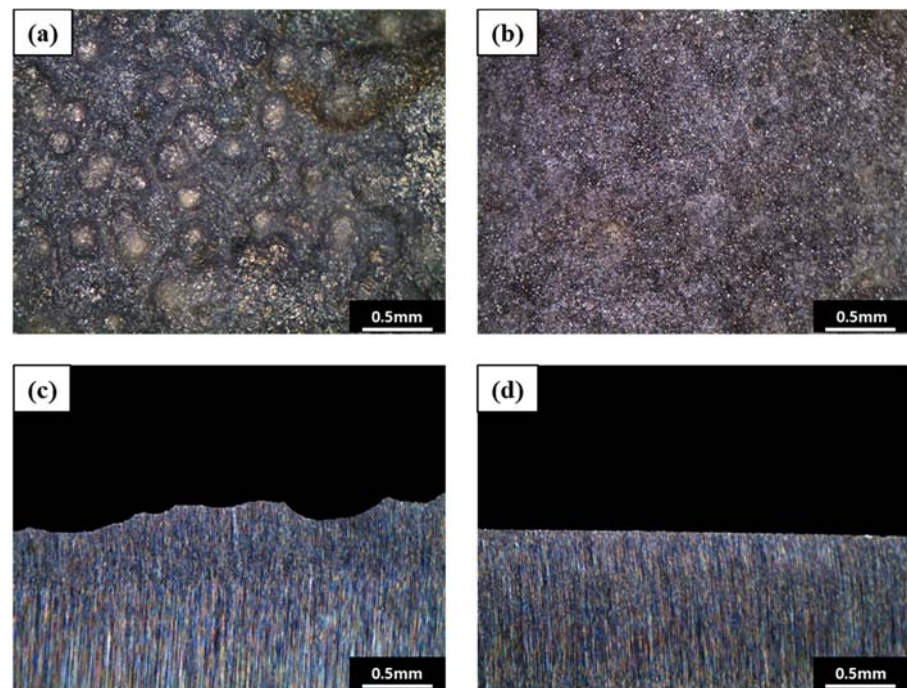
where m is the reacted mass (g), i is the current density (A/cm²), t is the time (s), a is the atomic weight (g/mol), F is the Faraday's constant (96,500 C/mol), and n is the number of electrons exchanged. The same coulombic charge was applied to observe the corrosion behavior for the same amount of corrosion. The total coulombic charge was 143.86 mAh, and the applied current was 5 mA/cm². Figure 11 shows surface and cross-sectional images of specimen A and specimen B after galvanostatic polarization test. Pitting corrosion occurred in specimen A, and uniform corrosion occurred in specimen B. This indicates that pitting corrosion is related to the presence of Al inclusions and inhomogeneity of the pearlite.

Figure 11. Surface and cross-sectional images of the specimens after galvanostatic polarization test: (a) surface image of specimen A (pitting corrosion region), (b) surface image of specimen B (uniform corrosion region), (c) cross-sectional image of the specimen A, and (d) cross-sectional image of the specimen B.
