## Case report

## Disassembly of the inner head of a bipolar hip prosthesis

Department of Orthopedic Surgery, Nagano Matsumuro General Hospital, Nagano, Japan

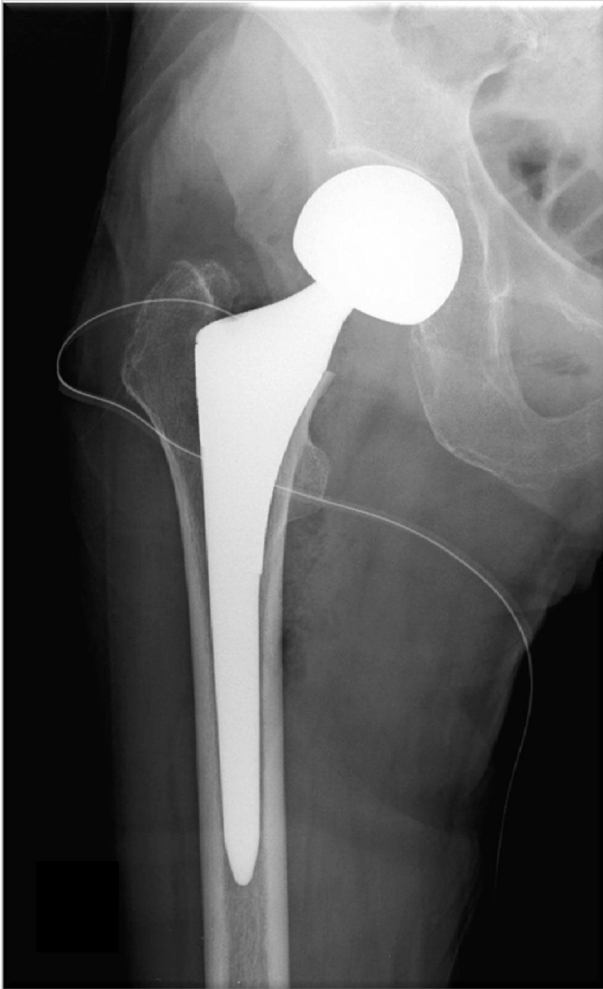
Then, reduction of the hip joint was performed, and the posterior joint capsule was repaired as completely as possible. There were no problems related to surgery (Fig. 1). The patient was mobilized on the next day and commenced walking with full weight bearing.

**Figure 1.** Anteroposterior radiograph film obtained immediately after implantation of the right bipolar hemiarthroplasty. There are no obvious abnormalities.

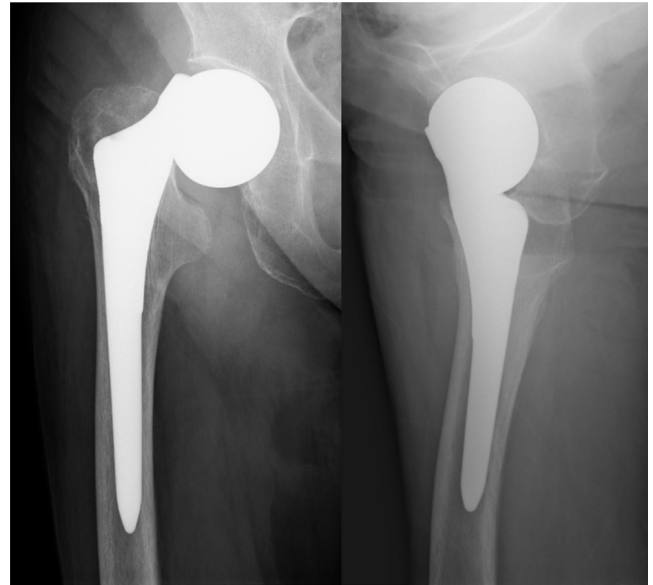
However, at 12 days postoperatively, she developed severe pain in the right hip joint when lying in the right lateral decubitus position after walking. A plain radiogram film revealed displacement of the inner head of the BHP from the neck of the stem as well as sinking of the stem by about 8 mm relative to its postoperative position (Fig. 2). Tomographic imaging and computed tomography scanning (Fig. 3) confirmed displacement of the inner head of the prosthesis from the stem. It was considered that closed reduction would be impossible, so reoperation was performed 2 days later (14 days after initial surgery). The posterior joint capsule showed no significant changes from the initial operation, without any new damage. The bipolar cup was removed and carefully checked, revealing no foreign bodies or macroscopic damage to the inner head, polyethylene bearing, or neck of the stem. However, a

**Figure 2.** Displacement of the inner head from the neck of the stem. Sinking of the stem compared with the primary surgery was also observed.

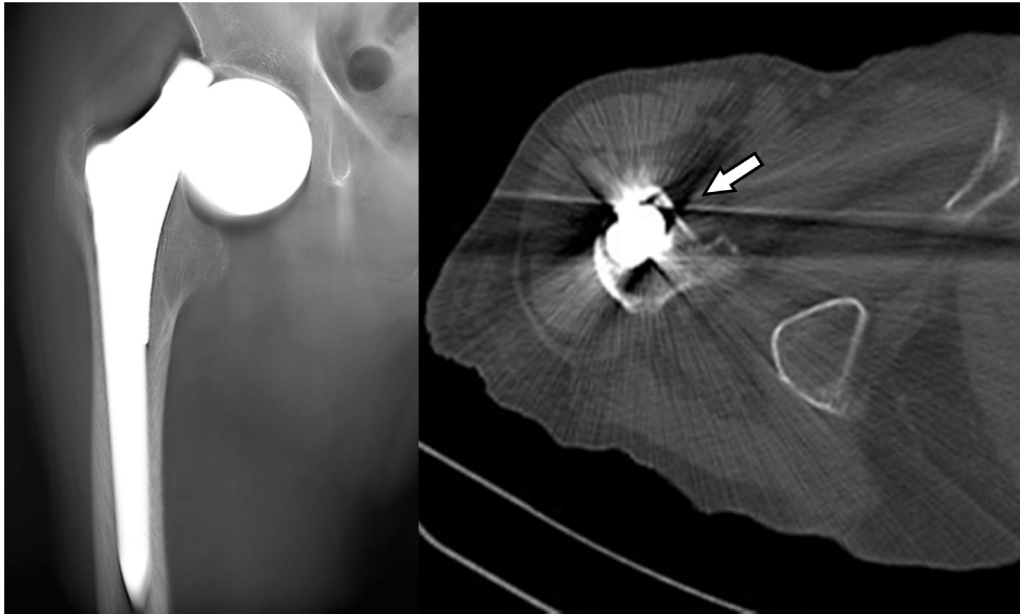
**Figure 3.** Tomographic image and computed tomography scan. The inner head is displaced from the stem. There is a crack in the lesser trochanter, suggesting a fracture (arrow).

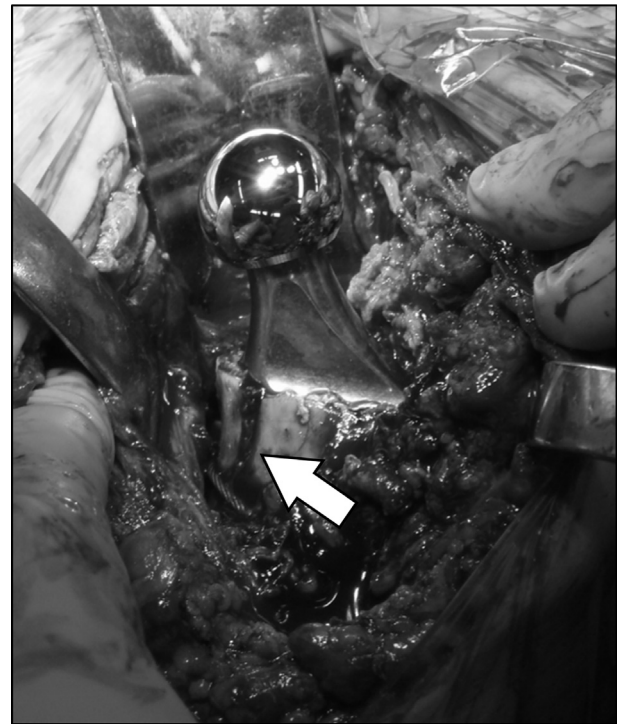
fracture line was identified trending in the axial direction toward the lesser trochanter, and sinking of the stem was observed (Fig. 4), leading to a diagnosis of Vancouver type A1 fracture around the stem. Sinking of the stem had occurred without rotation, and it was still fixed firmly with no notable instability. Therefore, wiring of the fracture site was done using a Dall-Miles cable (Stryker, Mahwah, NJ). We tried  $\pm 0$ -mm inner head at the trial of reposition. However, it was so tight for extension of the hip, so we recognized that an inner head of  $-2.0$  mm was suitable. Then, a new Zimmer metal inner head ( $-2.0$  mm and 22 mm diameter, same size as the initial surgery) and bipolar cup were fitted to the stem, after carefully confirming that there were no foreign bodies, blood, or fatty tissue in the neck or within the operating field (Fig. 5). At revision, we did not see any evidence of impingement of outer head and greater trochanter. It indicates that the impingement-related stem subsidence has not occurred.

Accordingly, it seems most likely that the fracture around the stem led to displacement of the inner head in our patient. It is assumed that the fracture caused sinking of the stem and induced micromovement, after which repeated telescoping of the stem might have dislodged the taper lock between the inner head and the neck. The Morse-type taper lock used in the present BHP is designed so that the components can be disassembled by removing the inner head from the stem through repeated tapping on the neck side. Therefore, the inner head could possibly be displaced by slight external force if micromovements were generated as described previously. To our knowledge, this is the first report about displacement of the BHP inner head due to fracture around the stem. In previous reports by Woolson and Pottorff [5] and Pellicci and Haas [6], disassembly of the inner head from the stem was due

**Figure 4.** Intraoperative photograph. A fracture line (arrow) runs toward the lesser trochanter, and sinking of the stem is evident. (The inner head has been fitted into the stem neck for confirmation.)

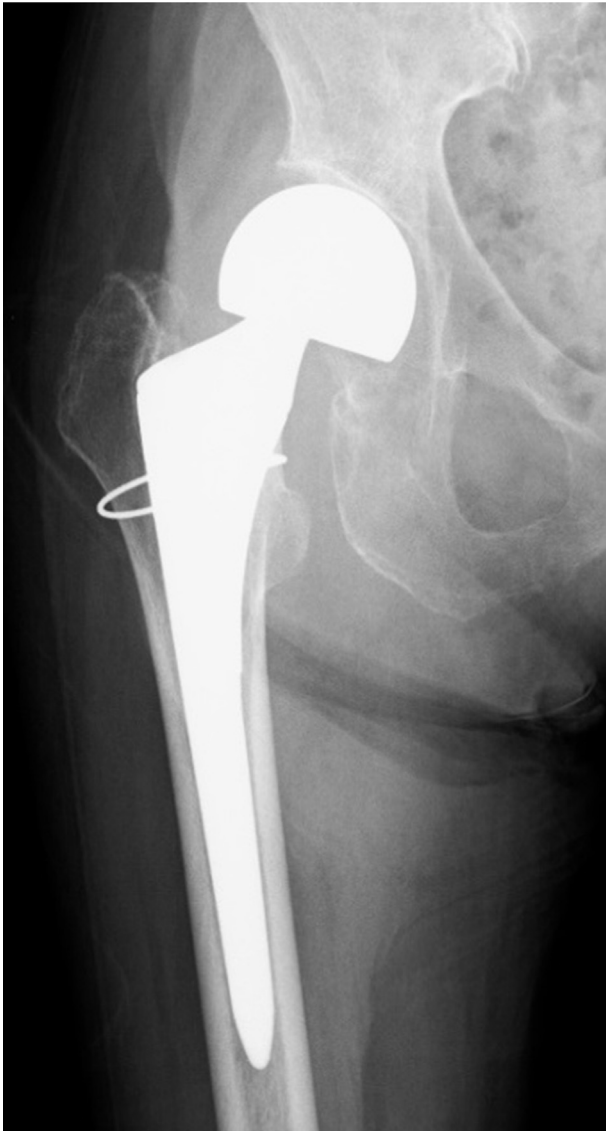
**Figure 5.** Postoperative radiograph. Wiring of the fracture site was performed with Dall-Miles cable. Then, a new inner head and bipolar cup were fitted into the stem.
