Case report

Nontraumatic Tibial Polyethylene Insert Cone Fracture in Rotating-Platform Total Knee Arthroplasty

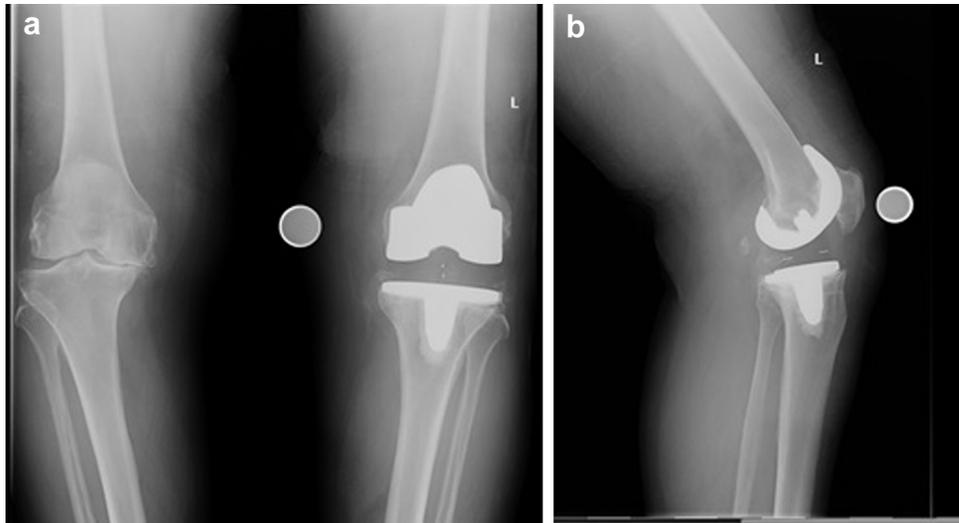
Figure 1. (a) Anteroposterior and (b) lateral radiographs of left TKA at presentation 10 years after index surgery showing loosening on the lateral aspect of the tibial tray.

In January 2015, 10 years and 4 months after the index procedure of primary RP left TKA, a 64-year-old lady re-presented to her primary orthopedic surgeon complaining of new symptoms of pain and a feeling of giving way in the left knee which progressed over a period of 4 months. Plain film radiographs of her left knee suggested loosening on the lateral aspect of the tibial tray with satisfactory alignment and no evidence of spinout (Fig. 1a and 1b). Serum laboratory markers for infection were all within normal limits. This was further investigated with an isotope bone scan performed in May 2015 using technetium 99m-methyl diphosphonate. This showed increased radiotracer uptake under the medial and lateral aspects of the tibial plate which confirmed loosening.

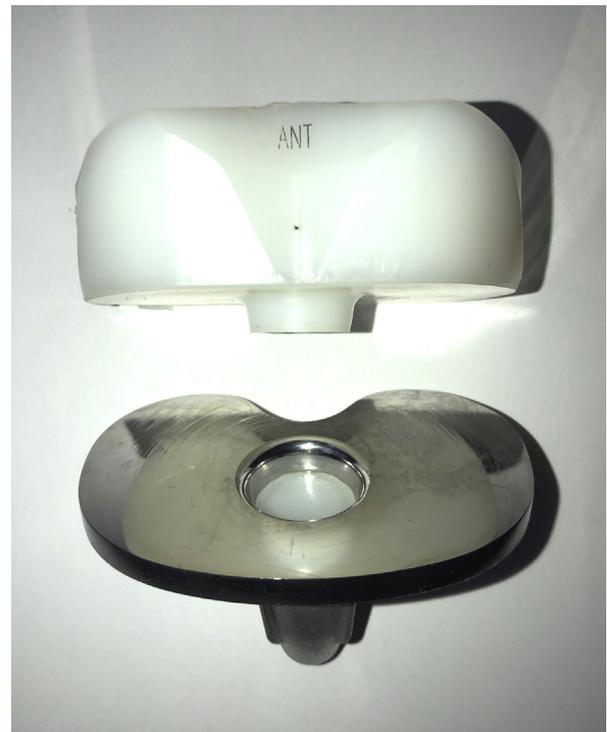
On October 7, 2015, the patient underwent revision left TKA for symptomatic aseptic loosening. At the time of revision, the PE insert cone was found to have fractured 10 mm from the inferior surface of the PE liner (Fig. 2). A complete separation of the cone from the insert had occurred such that the cone itself remained lodged within the tibial tray. The tibial component was loose, and there was metal staining (metallosis) in the soft tissues. There was a moderate amount of delaminated wear on the posteromedial aspect of the inferior surface of the PE insert (Fig. 3a and 3b).

Figure 2. Fracture of the polyethylene insert cone 10 mm from the inferior surface of the polyethylene liner.

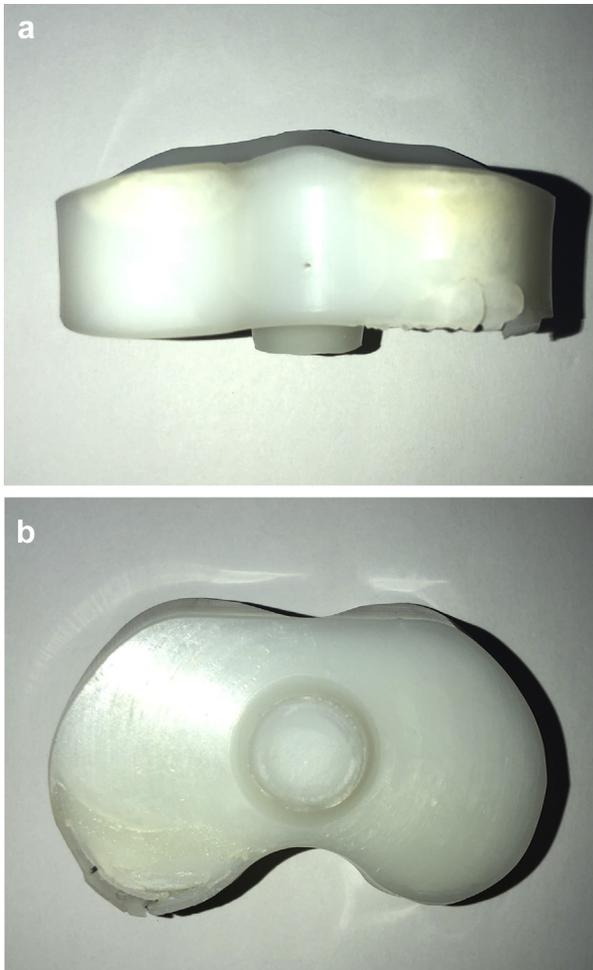
Figure 3. (a) Posterior view and (b) inferior view of PE insert showing a moderate amount of delaminated wear on the posteromedial aspect of the inferior surface.

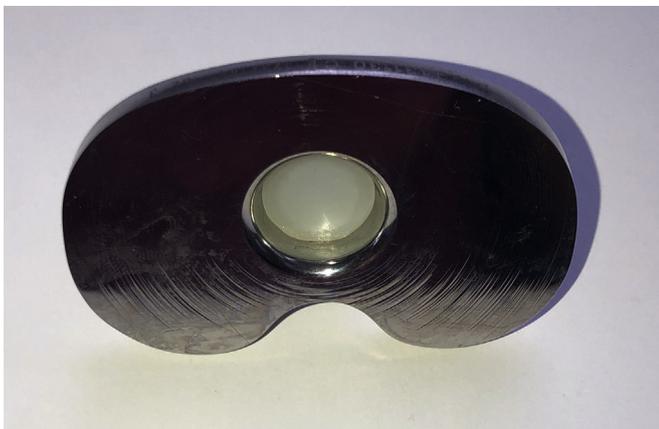
Scratches were also noted on the tibial tray surface forming concentric rings aligned with rotational movement around the center of the tray (Fig. 4). A single-stage revision was performed using a stemmed cemented Triathlon (Stryker, Kalamazoo, MI) Total Stabilizer revision knee system with 10 mm tibial augments, 10 mm distal femoral augments, and 5 mm posterior femoral augments (Fig. 5a and 5b). She complained of some mild discomfort

Figure 4. Scratches on the tibial tray surface forming concentric rings.

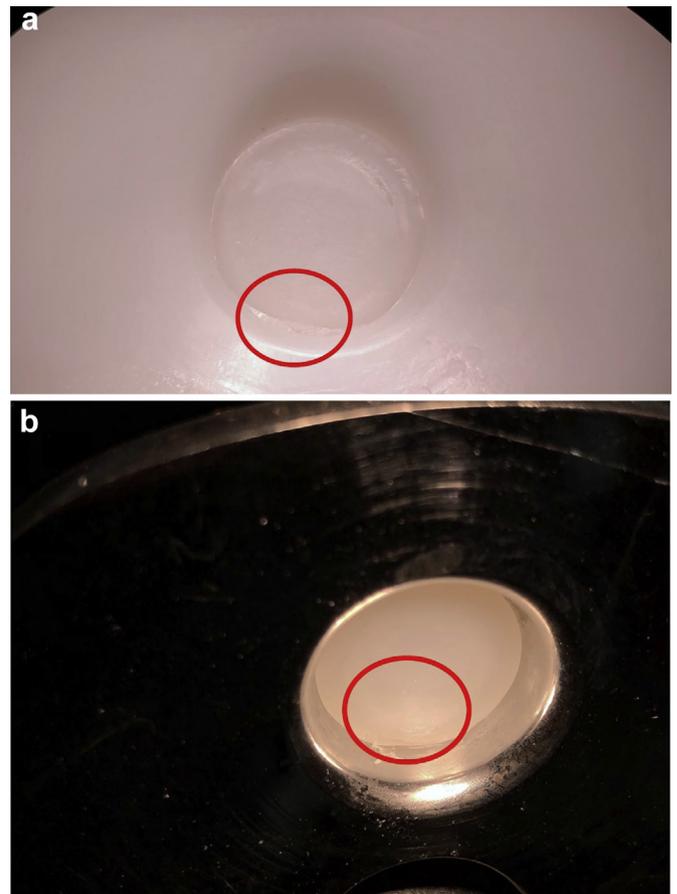
Figure 6. Macroscopic imaging revealed a region of great deformation at the edge of the fracture site (red circle). This was seen on the inferior aspect of the PE liner (a) and on the cone insert fractured in the tibial tray (b).

Visual inspection and macroscopic imaging revealed evidence of a deformation on the cone at the edge of the fracture site on the posterior side of the insert (Fig. 6a). A corresponding change of shape was observed on the portion of the cone still lodged within the tray (Fig. 6b). This region is believed to be the fracture initiation site. A variability in the surface of the fracture site was macroscopically evident with a rougher topography emanating from the fracture initiation site and transitioning into a visibly smoother region and then a slightly raised lip on the anterior side, at the suspected point of separation (Fig. 7a and 7b).

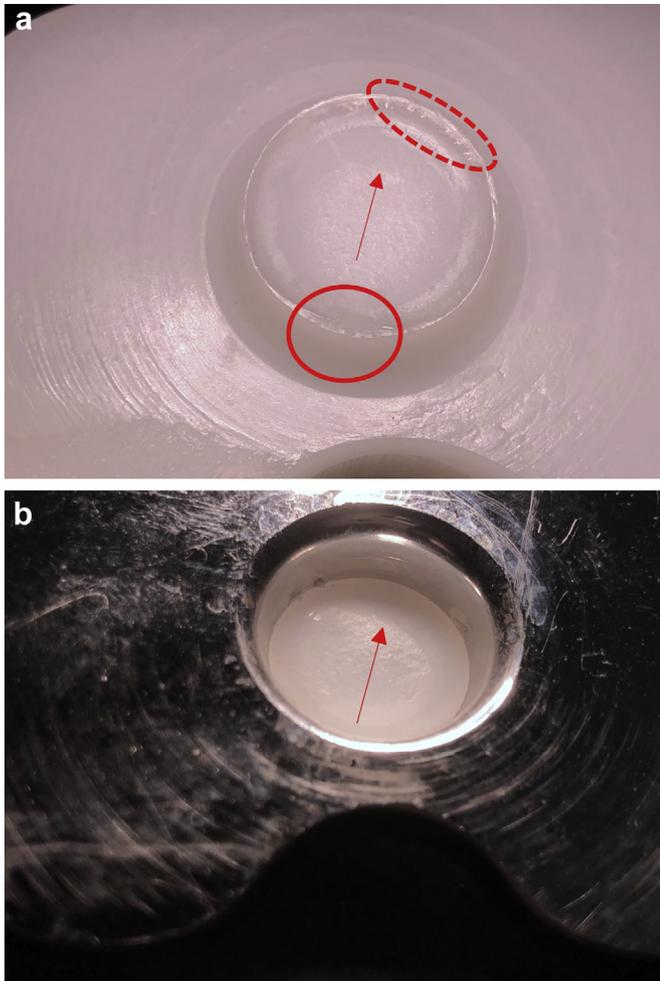
Figure 7. The red arrow signifies the direction of the fracture propagation with final separation in the region indicated by the dashed ellipse. The arrow head indicated the region at which the speed of fracture progression slowed down. This was seen on the inferior aspect of the PE liner (a) and on the cone insert fractured in the tibial tray (b).

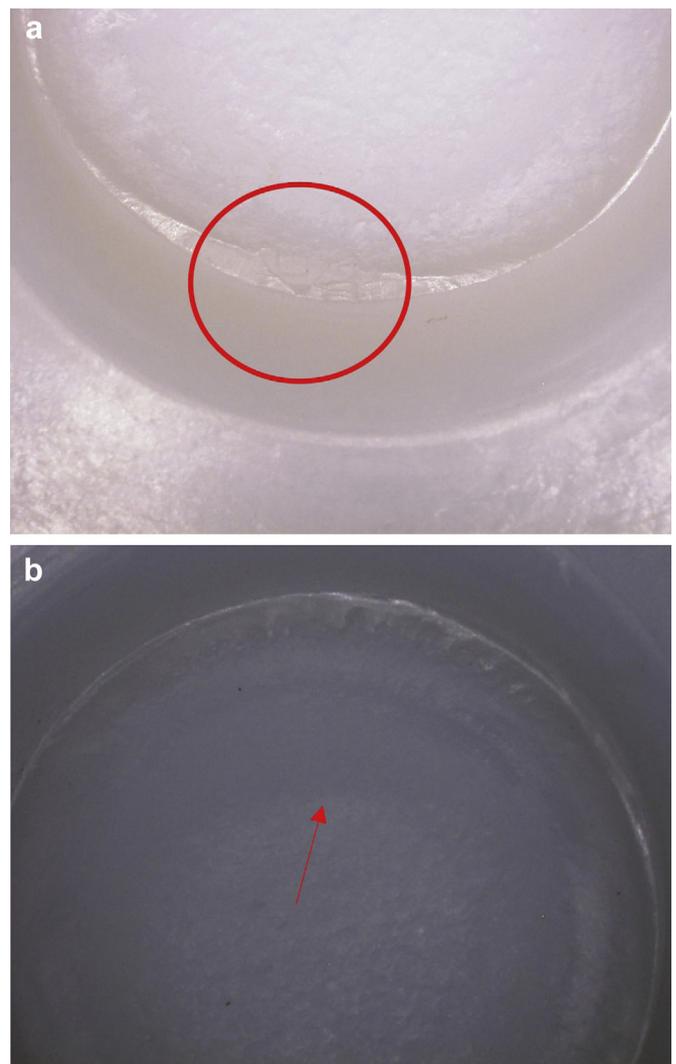
Microscopic imaging confirmed clear pronounced surface damage localized at the suspected fracture initiation site (Fig. 8a) and a transition in the fracture mode (Fig. 8b). In order to perform SEM analysis, the surfaces under investigation were first gold coated to allow a clearer visualization of the surface details. The component was reimaged macroscopically with the coating applied, and some evidence of beach marks characteristic of fatigue fractures were

Figure 8. Microscopic imaging confirmed the presence of deformation at the fracture initiation site (red circle) (a) and a transition in the fracture mode (red arrow) (b).

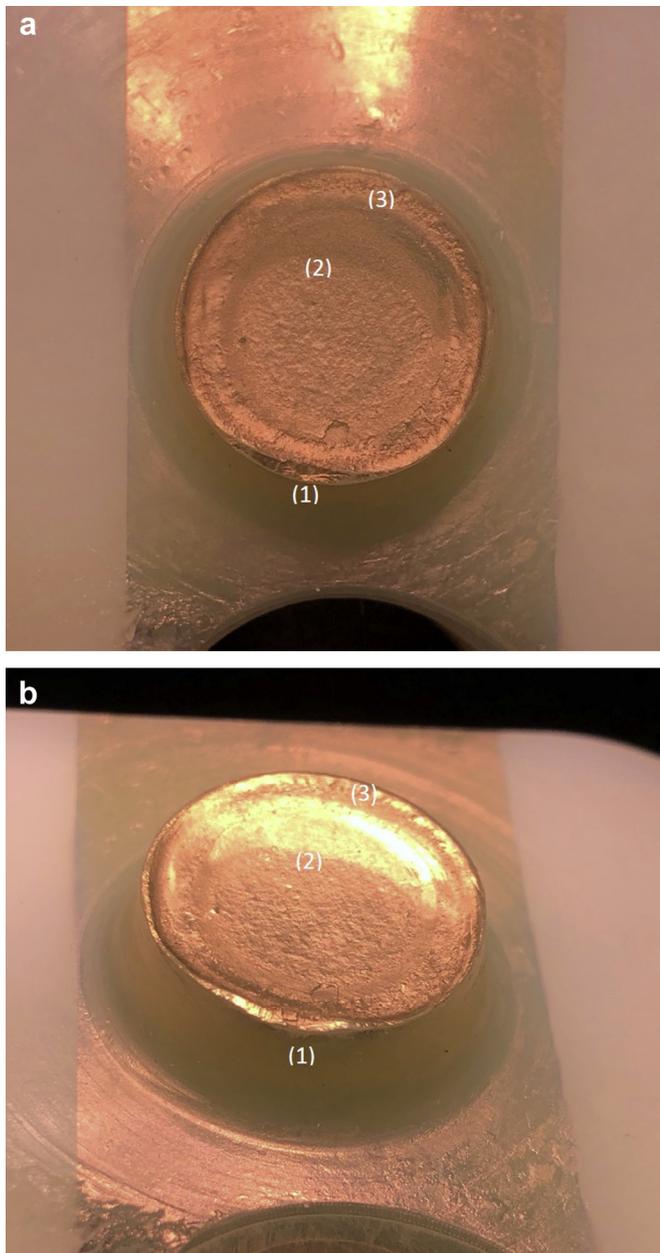
evident (Fig. 9a and 9b). It is of note however that these beach marks were not prominent and not highly prevalent, as may be normally expected in cases where a fatigue fracture has occurred. Indeed, the rougher surface topography is more characteristic of a rapid brittle fracture. SEM imaging also confirmed a clear difference in the surface damage patterns at the fracture initiation site with some slight but not very prominent beach marks (Fig. 10).

Figure 9. Macroscopic imaging of the gold coated surfaces of the inferior aspect of the PE liner at (a) and (b) showed clearly the (1) fracture initiation point, (2) the transition point of the mode of fracture from a rapid progression to a slower fatigue fracture and (3) the point of final separation of the cone due to ductile fracture, characterized by a raised lip in this side anteriorly. There were some indicators of beach marks following the transition at (2) however these were not at all prominent.

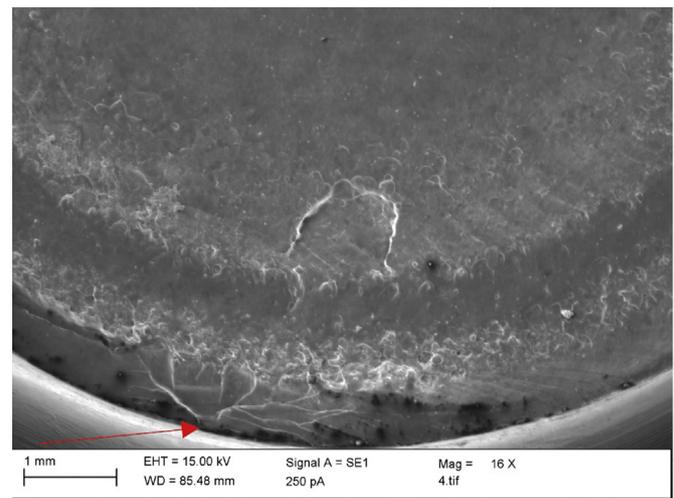
Figure 10. SEM imaging confirmed a clear difference in the surface damage patterns at the fracture initiation site (red arrow). This high magnification imaging did not reveal clear beach marks that are characteristic of fatigue fracture.

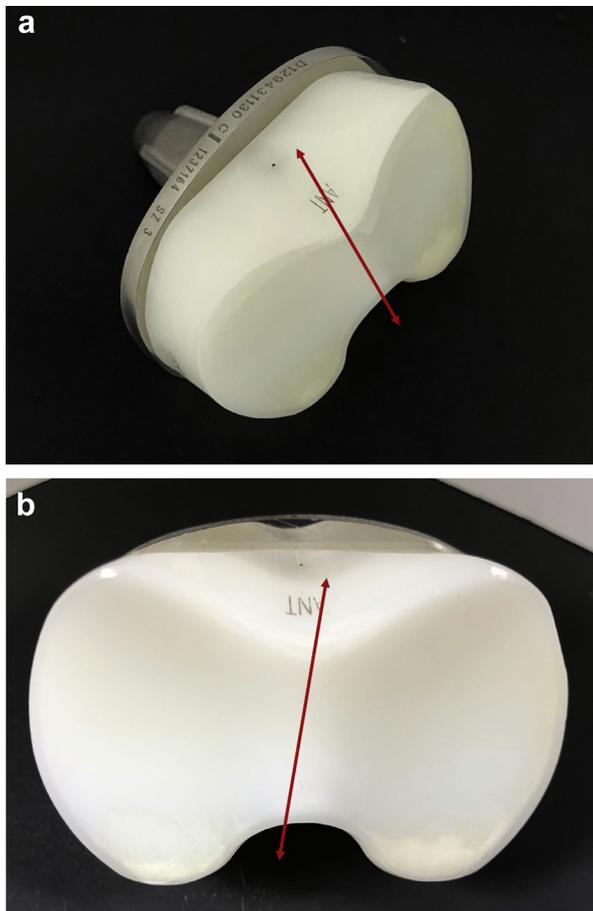
The mechanism of fracture of the cone appears to have been due to repeated rocking or cantilever stresses toward the direction of the red arrow (Fig. 11a and 11b), causing a primary fracture at the initiation site. We then observed initial rapid progression of the fracture across the cone surface followed by a slower fatigue fracture progression and finally separation of the cone due to a ductile fracture.

Figure 11. The arrows indicate the suspected direction of toggling of the insert within the tray seen in (a) and (b), ultimately leading to the fracture of the cone.
