Case report

Nontraumatic tibial polyethylene insert cone fracture in mobile-bearing posterior-stabilized total knee arthroplasty

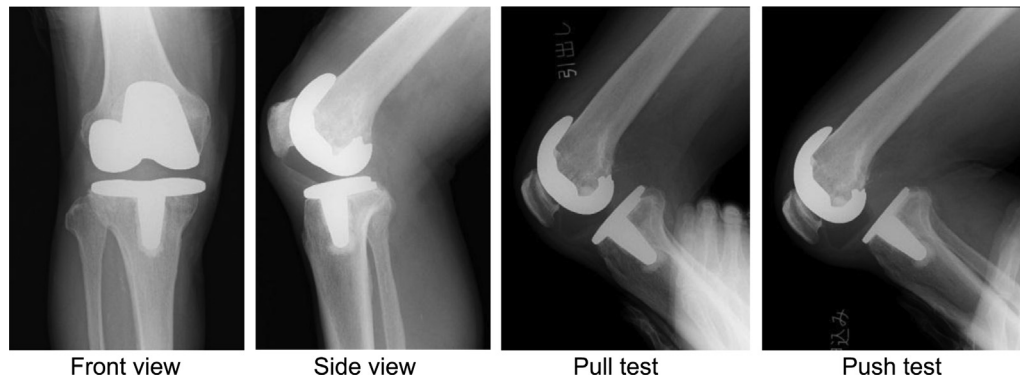
Figure 3. Radiographs of the dislocated tibial insert.

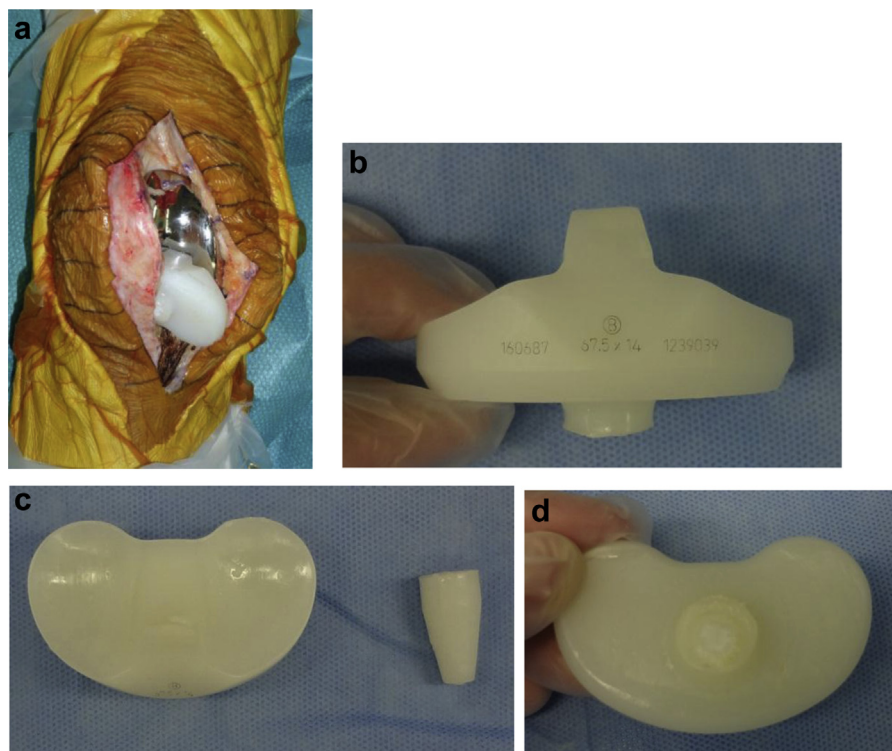
Figure 4. Intraoperative photographs. (a) The tibial insert was easily dislocated due to the fracture at the cone base of the tibial insert. (b) Front of the tibial insert. (c) Top of the fractured cone and tibial insert. (d) Bottom of the tibial insert.

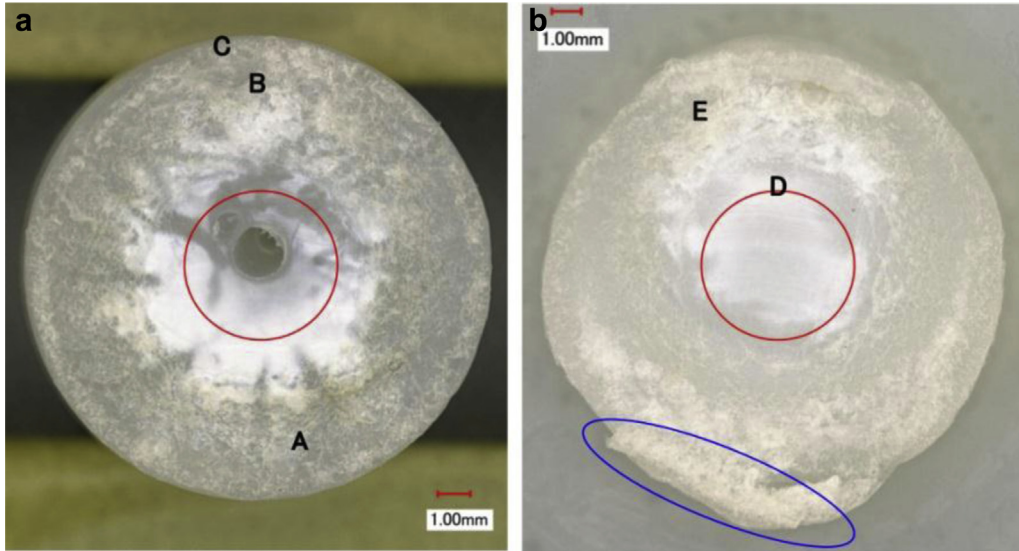
Figure 5a shows the fracture surface of the tibial polyethylene insert cone. A raised striation pattern was found on the upper part of the red circle, but it was blurred. Based on the figure, fatigue breaking was assumed to have originated and progressed from the posterior (lower part of Fig. 5a) toward the anterior of the cone

(upper part of Fig. 5a). However, the protrusion on the fracture surface of the tibial polyethylene insert (Fig. 5b, blue ellipse) did not correspond with the shape of the cone fracture surface.

Figure 5. Photomicrographed fracture surface of the tibial insert. (a) Photomicrographed fracture surface on the cone side. A raised striation marking is observed in the upper area encircled in red. The center opening is a hole drilled for removal at the time of the replacement surgery. (b) Fracture surface on the insert side. A protrusion is observed in the blue ellipse area; however, it did not correspond with the contour of the fracture surface in (a). Alphabets A through E in the photomicrograph express arbitrary positions on the fracture surface.

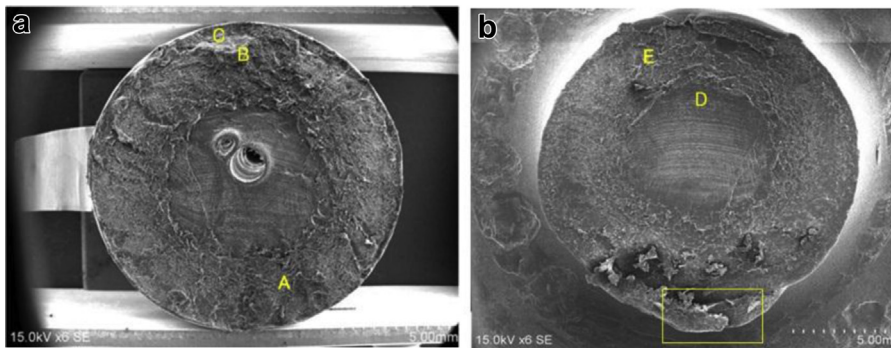
Figure 6 shows the SEM images of the fracture surface. Locations A-E roughly correspond with locations A-E in Figure 5 (photomicrographic image).

part of the image can be observed. Location E is potentially the final breaking point because a dimple image was observed in visual field E (Fig. 11), which indicates that fatigue breaking progressed from the upper to the lower part of the image. The initiating point of the fatigue fracture is suggested in Figure 6b (yellow square), and the starting point was crushed.

Figure 6. Overall SEM images. (a) Fracture surface on the cone side. (b) Fracture surface on the insert side. Locations A through E roughly correspond with those on the photomicrographic images in Fig. 5.

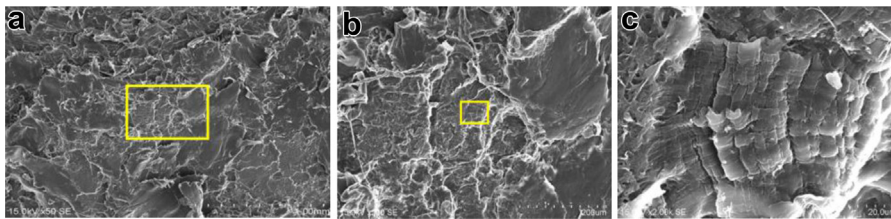
Figure 7 shows the magnified image of the cone fracture surface in visual field A. A difference in level was found at the part in the magnified image ($\times 50$), and a striation pattern was observed in Figure 7c ($\times 2000$), indicating progression of the fatigue breaking from the lower to the upper part.

Figure 7. Visual field A. (a) Visual field A in Fig. 6a ($\times 50$ magnification). (b) The area enclosed by the yellow square in (a) ($\times 200$ magnification). (c) The area enclosed by the yellow square in (b) ($\times 2000$ magnification).

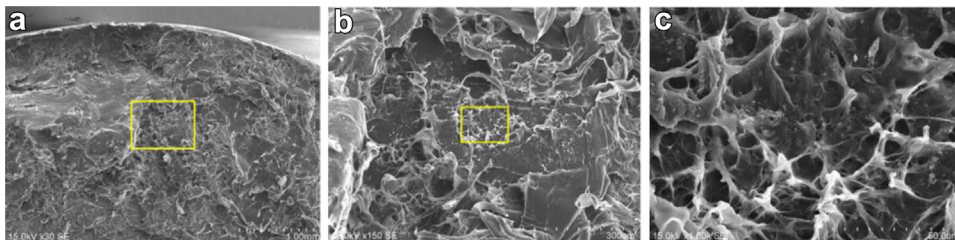
Magnified SEM images of visual field B are shown in Figure 8. A dimple image was observed, which indicates the final breaking point. Magnified SEM images of visual field C are shown in Figure 9. A raised striation crossing from the upper to the lower part of the image is observed. Visual field D (Fig. 10) is an image of the tibial polyethylene insert cone surface as shown in Figure 6. Although slightly blurred, a striation crossing from the upper to the lower

Figure 8. Visual field B. (a) Visual field B in Fig. 6a ($\times 30$ magnification). (b) The area enclosed by the yellow square in (a) ($\times 150$ magnification). (c) The area enclosed by the yellow square in (b) ($\times 1000$ magnification).

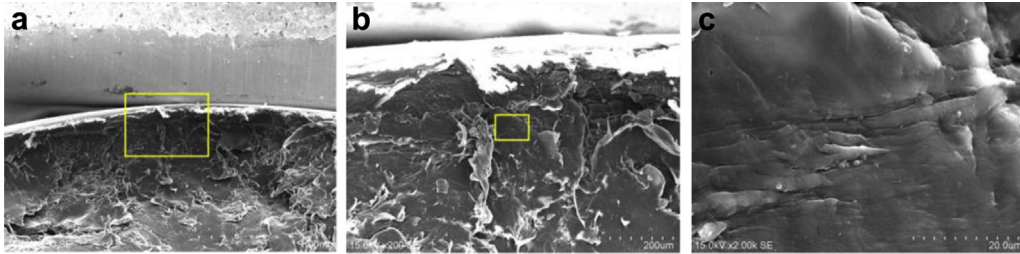
Figure 9. Visual field C. (a) Visual field C in Fig. 6a ($\times 50$ magnification). (b) The area enclosed by the yellow square in (a) ($\times 200$ magnification). (c) The area enclosed by the yellow square in (b) ($\times 2000$ magnification).

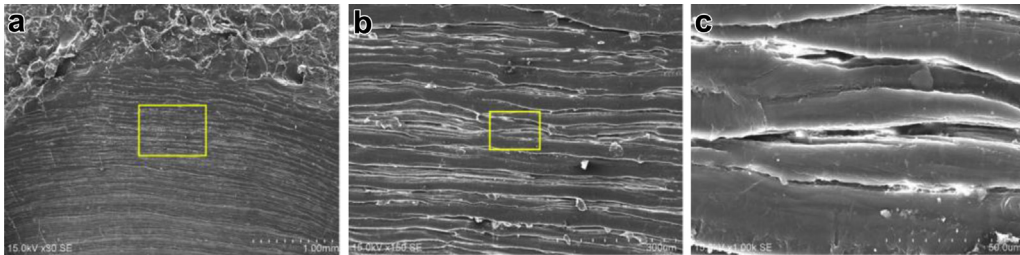
Figure 10. Visual field D. (a) Visual field D in Fig. 6a ($\times 30$ magnification). (b) The area enclosed by the yellow square in (a) ($\times 150$ magnification). (c) The area enclosed by the yellow square in (b) ($\times 1000$ magnification).

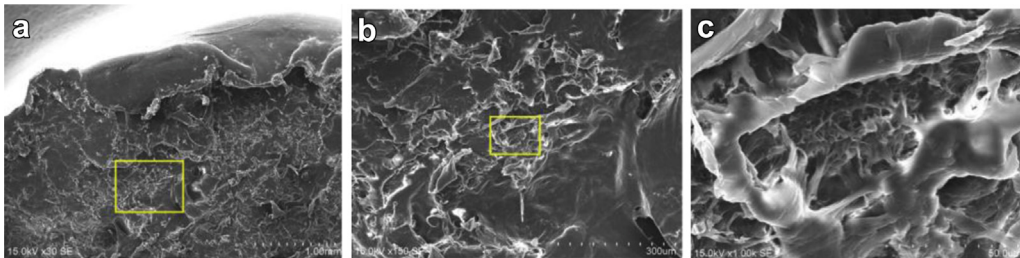
Figure 11. Visual field E. (a) Visual field E in Fig. 6a ($\times 30$ magnification). (b) The area enclosed by the yellow square in (a) ($\times 150$ magnification). (c) The area enclosed by the yellow square in (b) ($\times 1000$ magnification).

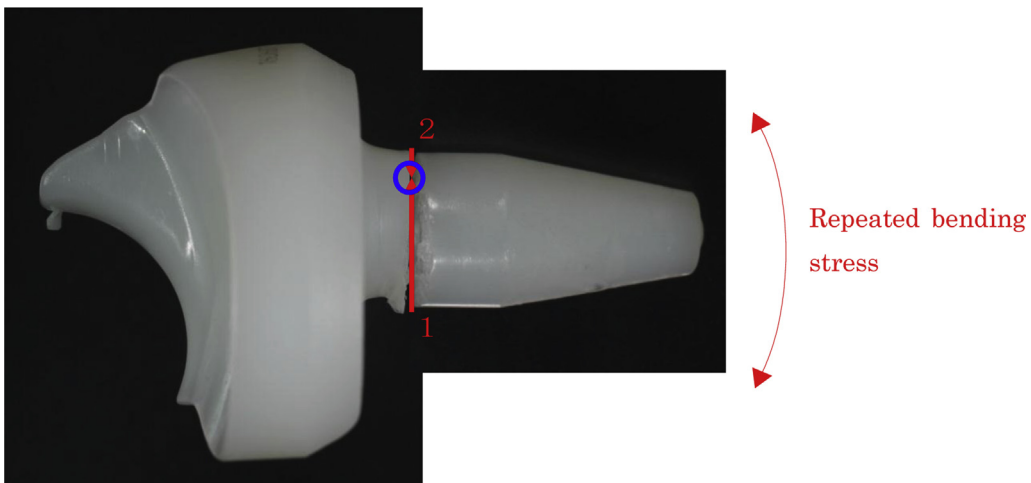
Striation is a striped pattern [7] on the fatigue fracture surface that is caused by the gradual progression of a crack that develops because of repeated changes in load. Based on the previously mentioned results, the fracture resulted from repeated bending stress toward the direction of the red curved arrow (Fig. 12), causing fatigue fracture at location 1, which progressed toward the direction of red curved arrow directions (from the lower to upper part in the image) and led to fatigue breaking in location 2. Then, fatigue breaking progressed from the lower to upper part of the image, and ductile fracture occurred at the point encircled in blue, resulting in fracture. The axis direction of the initiating point was the border of the linear and curvature parts of the cone.

Figure 12. Side view of the fractured tibial insert.

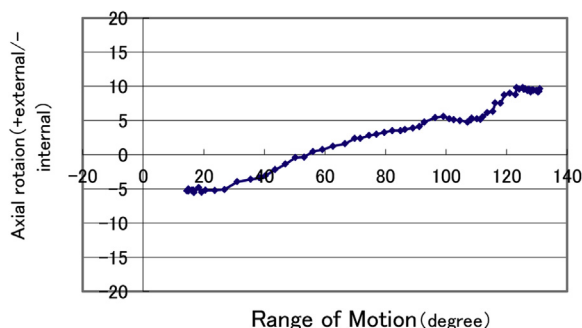
Figure 13. Axial rotation angle of the femoral component to tibial component at each flexion angle.

The axial rotation angle of the femoral component to the tibial component at each flexion angle showed a gradual lateral rotation, along with deeper knee flexion starting at medial rotation of 5° in knee joint extension of 10° and lateral rotation of 10° at knee joint extension of 130° (Fig. 13). Considering the characteristics of Vanguard RP, that is, the high conformity of the tibial insert with the femoral component, the rotation mechanism of the tibial polyethylene insert may have been maintained.
