# High-voltage impedance rise; mechanism and management in patients with transvenous implantable cardioverter-defibrillators: a case series

We describe a case series of patients for a gradual rise in daily, low-voltage sub-threshold measurement (LVSM) of shock (high-voltage, HV) impedance in a group of patients with Boston Scientific implantable cardioverter-defibrillators (ICDs) and investigate the cause of the abnormality.

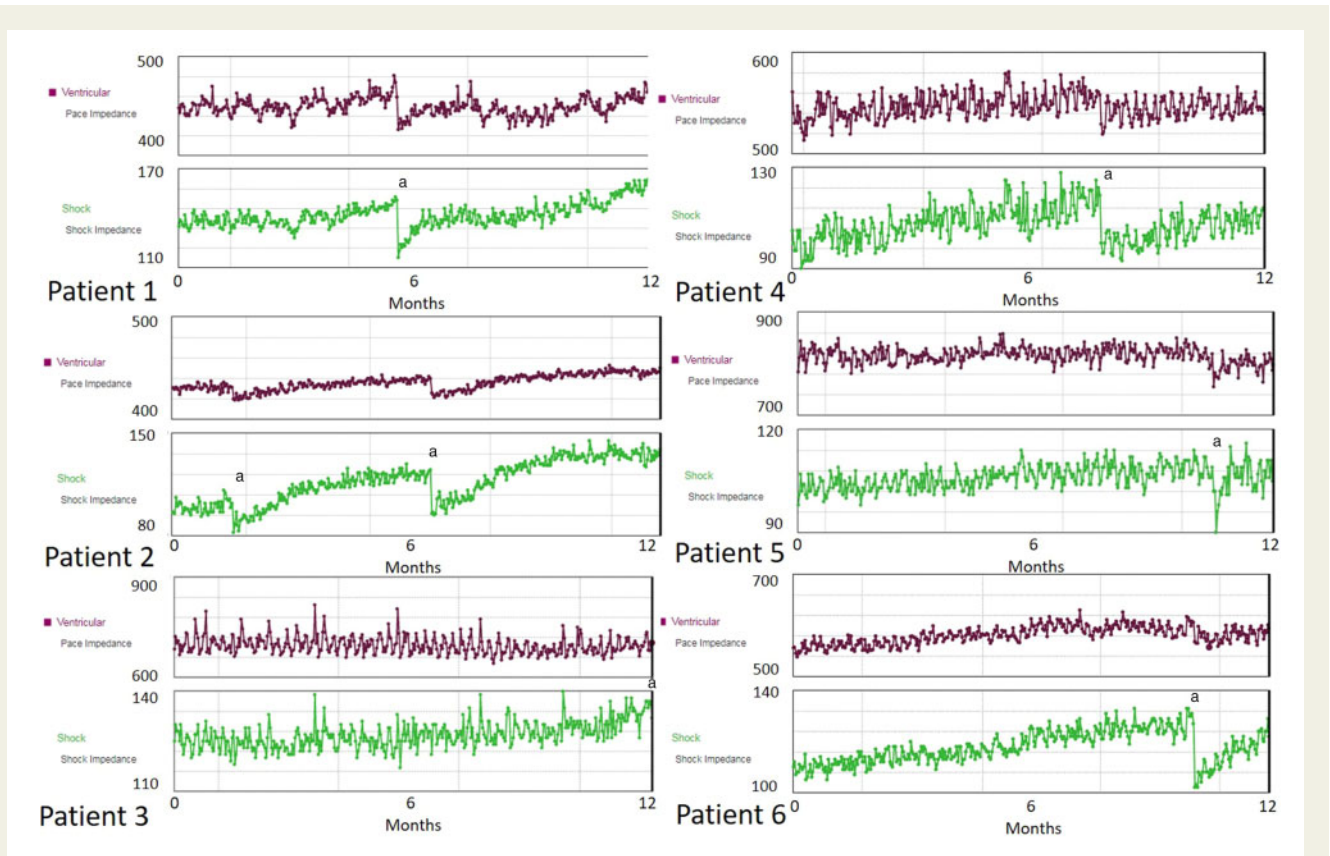
This case series describes six patients (Table 1) with low-voltage sub-threshold measurement (LVSM) values significantly higher than at initial implant (Figure 1). After reviewing each case in turn, the impedance rise did not correlate with any specific clinical event such as decompensated heart failure, pulmonary oedema, pneumothorax, or trauma, nor as a result of any change in medication. Furthermore, blood tests confirmed no electrolyte abnormalities in any of our patients. All leads had Gore polytetrafluoroethylene (ePTFE) coated coils. Chest radiographs showed no macroscopic appearances of a lead insulation breaches (Figure 2) and for the three patients that had procedures, there was no evidence of pocket calcification. Echocardiography was unable to demonstrate any evidence of exaggerated lead fibrosis for all cases. Patient 4 was the first patient presented in this series. Following an open discussion with the patient and their parents, a decision for attempted extraction and reimplantation was made.

There are distinct differences between a TSI and a LVSM. Device-based diagnostics now place greater demands on battery current and many manufacturers have reduced the energy used to obtain the LVSM. Since the Teligen generation of Boston Scientific ICDs, Boston Scientific used a smaller electrical impulse of  $80 \mu\text{A}@156 \mu\text{s}$  to measure the LVSM. This impulse was less than previous models which used  $15 \text{ mA}@60 \mu\text{s}$ .<sup>8</sup> Of note, Abbott and Biotronik devices also use small current impulses ( $750 \mu\text{A}@19 \text{ ms}$ ,  $1 \text{ mA}@30 \mu\text{s}$ , respectively). These smaller current calculated values can be affected by subtle changes to current flow, causing minor variation in impedance values day to day. These are caused by external and internal factors such as; positional, external electromagnetic interference, and electrolyte balance. Medtronic ICDs use a higher sub-threshold constant voltage stimulus ( $1 \text{ V}@90 \mu\text{s}$ ) coupled with mathematical scaling to arrive at the projected HV therapy pulse, making it less variable. In our patients, whilst the shock impedance trends show daily fluctuations (due to causes described above), the ongoing rising trend in impedance suggests an additional contributing factor (Figure 1).

**Figure 1** Shock impedance and bipolar right ventricular impedance ( $\Omega$ ) trends for each patient over the past year. <sup>a</sup>Highlights the when a high-voltage therapy was performed.

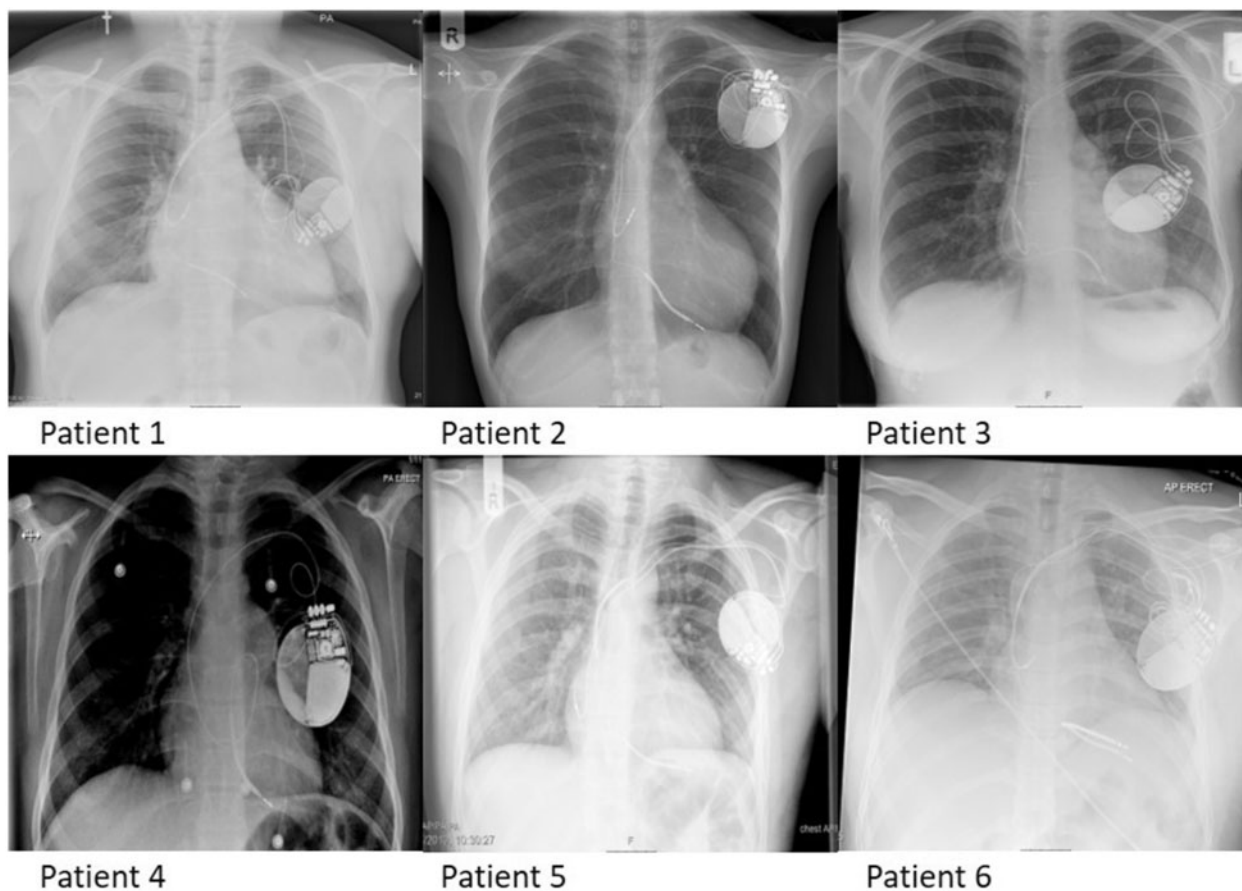
**Figure 2** Anteroposterior chest radiographs performed for each patient.
