# Coronary balloon catheter tip damage. A bench study of a clinical problem

## Abstract

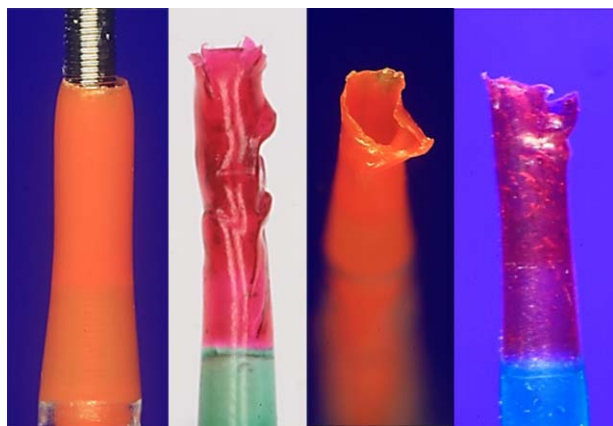
We have observed that one cause of obstructed passage of a balloon between stent struts to the side-branch is damage to the balloon catheter tip (Figure 1) [4]. A damaged, flared tip can catch on a stent or scaffold strut preventing passage to the side-branch and in addition may lead to displacement of stent struts and stent distortion [4–6].

**FIGURE 1** Balloon catheter tips retrieved from patients. The left most panel shows an undamaged tip. The rightward 3 panels show damaged balloon tips from 3 different manufacturers. While in these examples the flaring is marked, if of lesser degree it may not be detectable with the naked eye

**Conclusions:** Balloon tip damage is common with crossing between stent struts. This is one cause of failure of a balloon to access a side-branch and a new balloon should be used. If stent distortion is suspected, it should be corrected with kissing balloon post-dilatation.

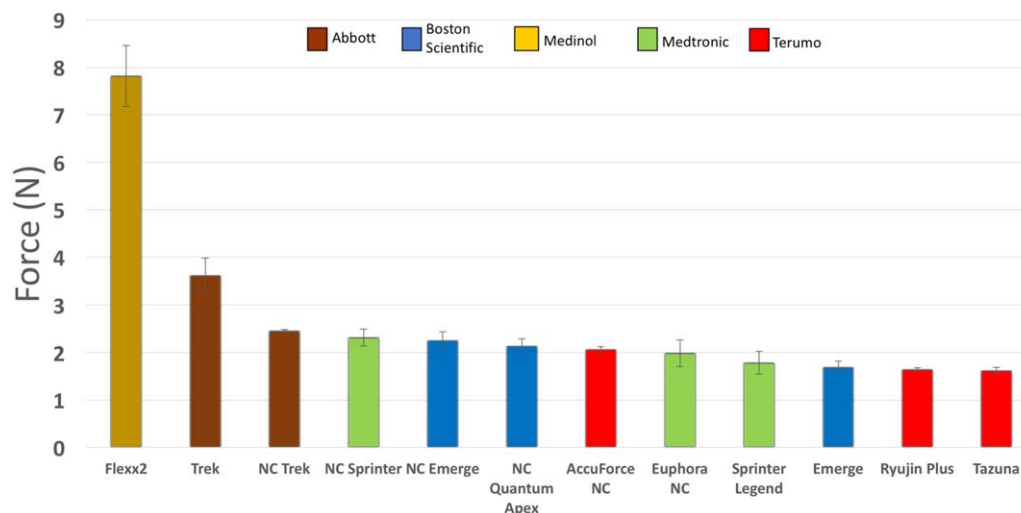
The force needed to compress a balloon tip 0.5 mm varies greatly between designs (Figure 4). The Flexx2 and the Trek designs were the most resistant to shortening. The Tazuma (Terumo) was the most easily compressed.

**FIGURE 4** The force required to shorten a balloon tip by 0.5 mm is shown on the vertical axis for the 12 balloon designs shown on the horizontal axis. The different colors identify the manufacturer

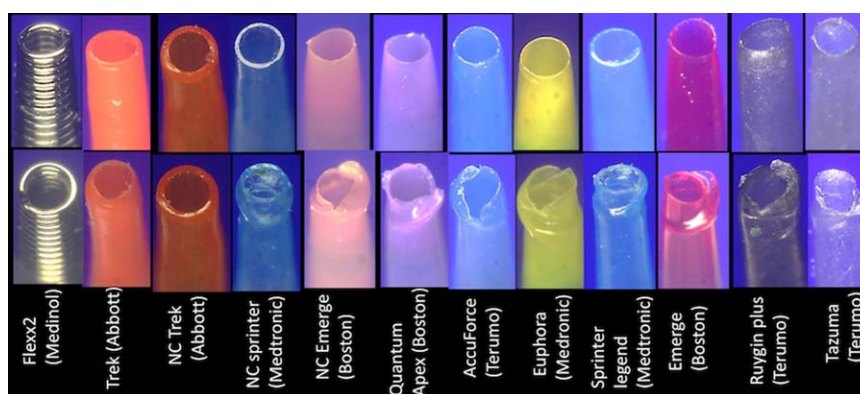
When compressed by 0.5 mm, some balloon tips are damaged whereas others recoiled returning to their original shape (Figure 5 and videos 1–3). The Flexx2 and Trek designs recoiled after compression and had minimal or no damage and all other tips were damaged.

**FIGURE 5** Balloon tips and damage with the compression test. In the upper panel are photographs of balloon tips before compression and the lower panel shows the tips after compression. The Flexx2 and Trek designs had no or minimal damage whereas all other designs tested were damaged

Some balloons are more resistant to entry tip damage than others. The Flexx2 tip design of the Galant balloon is reinforced with a wire coil and is very resistant to damage but has a larger entry profile than other balloon designs (Figures 4 and 5).

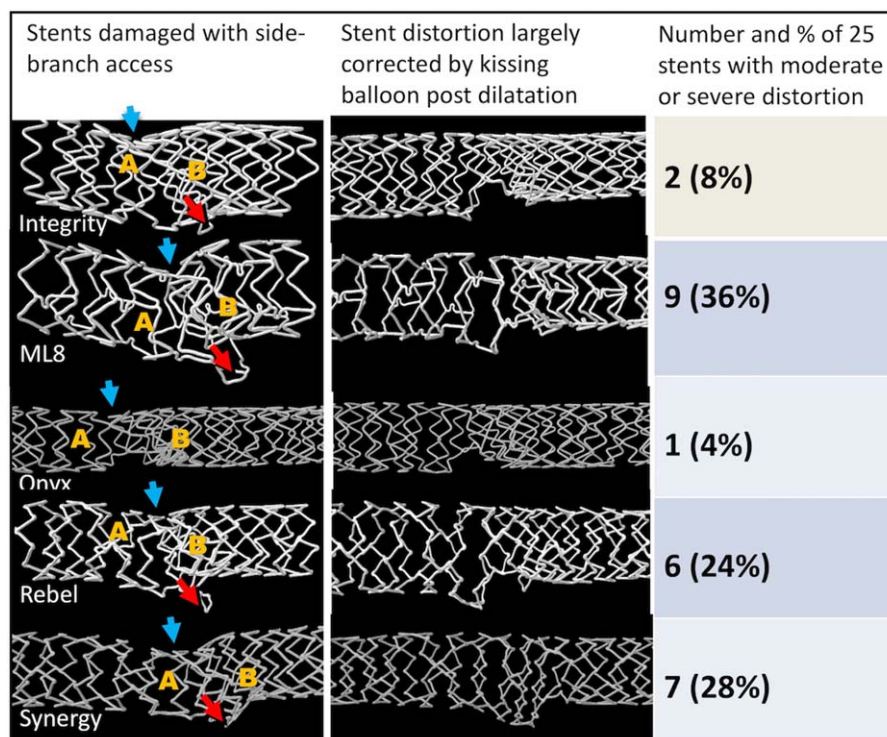
A damaged balloon tip can contact a stent strut pushing it toward the side-branch and distorting the stent. (Figure 8). The distortion can occur with any stent design but appears less common with sinusoidal

**FIGURE 8** MicroCT images of a stent distorted by damaged balloon catheter tips. Twenty-five examples of 5 different stent designs were assessed. The left column shows stents damaged with side-branch access. The middle column shows the same stents after the distortion is largely corrected by mini-kissing balloon post-dilatation (Mini-KBPD). The right-most column documents the number and percentage of the 25 stents of each design that had moderate or severe distortion defined as 0.4 mm malapposition and/or 0.4 mm protrusion into the side branch after 2.5 mm Trek balloon side-branch access. The red arrows indicate a strut pushed toward side-branch. Struts upstream from the side-branch are separated (A) and those downstream are pushed together (B). There is malapposition of struts opposite the side-branch (blue arrowhead). Mini-KBPD largely corrects the malapposition aspects of distortion while retaining side-branch protrusion and ostial size (middle column)

wire designs. It can be largely corrected by kissing balloon post-dilatation (Figure 8).

If stent damage is identified, it can be largely corrected by kissing balloon post-dilatation.

A damaged balloon catheter tip can cause stent distortion which can be largely repaired by kissing balloon post-dilatation.
