## A new type of silica-induced “moundless” pitting corrosion in copper observed in Japan

Masahiro Sakai

College of Design and Manufacturing Technology, Muroran Institute of Technology, 27-1 Mizumoto, Muroran, Hokkaido, Japan

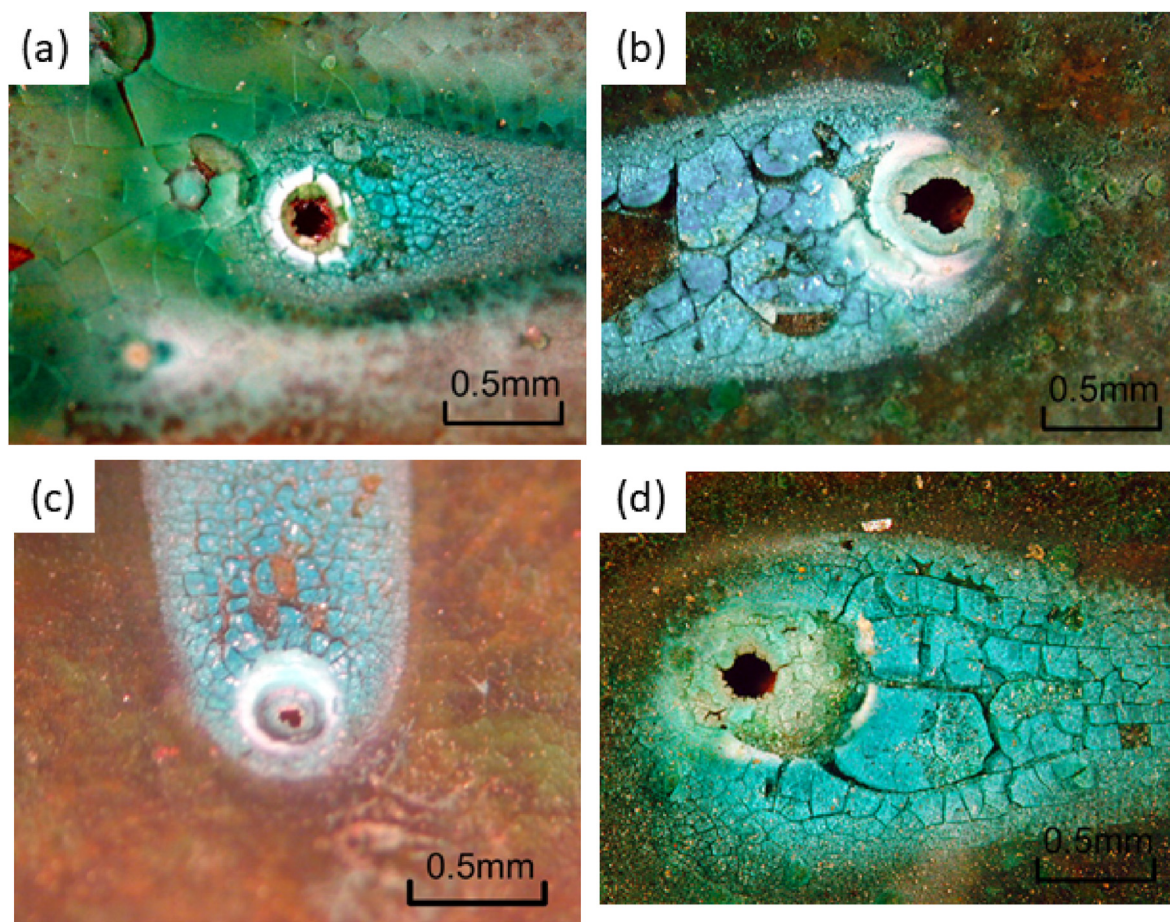
**Figure 3.** The new type of moundless pitting corrosion detected in domestic water copper feed tubes removed from houses a, b, c and d in the Noboribetsu area of the Hokkaido Prefecture.

Figure 3 shows the new type of pitting corrosion that occurred on the inner surfaces of the copper tubes employed in the water distribution

system of Noboribetsu City. These pictures are parts of pits caused 255 water leakage accidents in Noboribetsu City. This type of pit caused almost all of 255 water leakage accidents. The most distinctive feature of these pits is that the pit mouths are generally open and are not covered with a mound of verdigris; as shown in Figure 3, the ring of the verdigris deposit surrounds the pit mouth. The reflection of light from this verdigris around the pit mouth indicates that the deposited verdigris is vitrified. In addition, Figure 4 shows the new type of pitting corrosion in addition to type II pitting corrosion for comparison purposes. More specifically, the type II pit possesses a mound of verdigris, and the pit propagates under the mound, whereas the new pit type has no mound covering its pit mouth. This new type of pitting corrosion was therefore named “moundless” pitting corrosion because of its morphological features. Another characteristic feature of this moundless pit is its comparatively small pit diameter, which typically measures <1 mm; the pits of type I and type II pits generally possess diameters of a few millimetres.

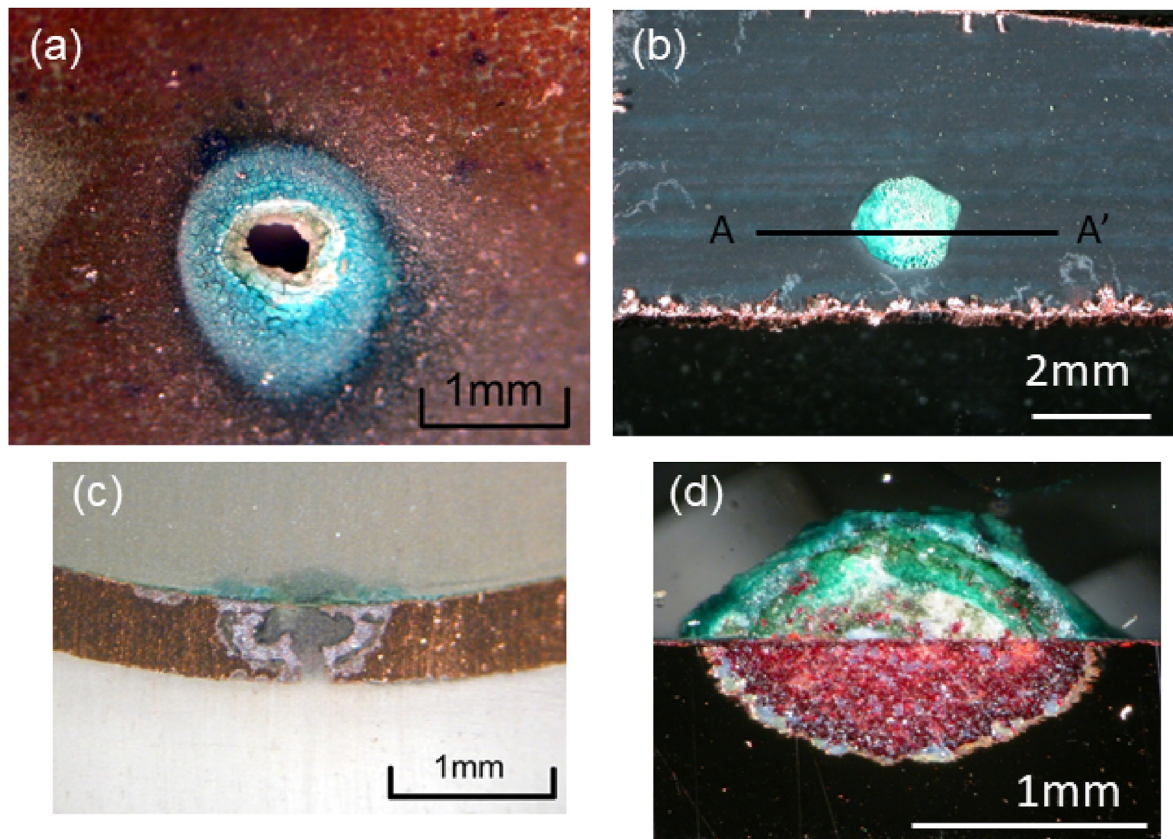
**Figure 4.** (a) An image of moundless pitting corrosion and (c) its cross-section. (b) An image of type II pitting corrosion and (d) its cross-section.

Furthermore, the preferential downward growth orientation can be seen clearly in the cross-sectional view shown in Figure 4(a).

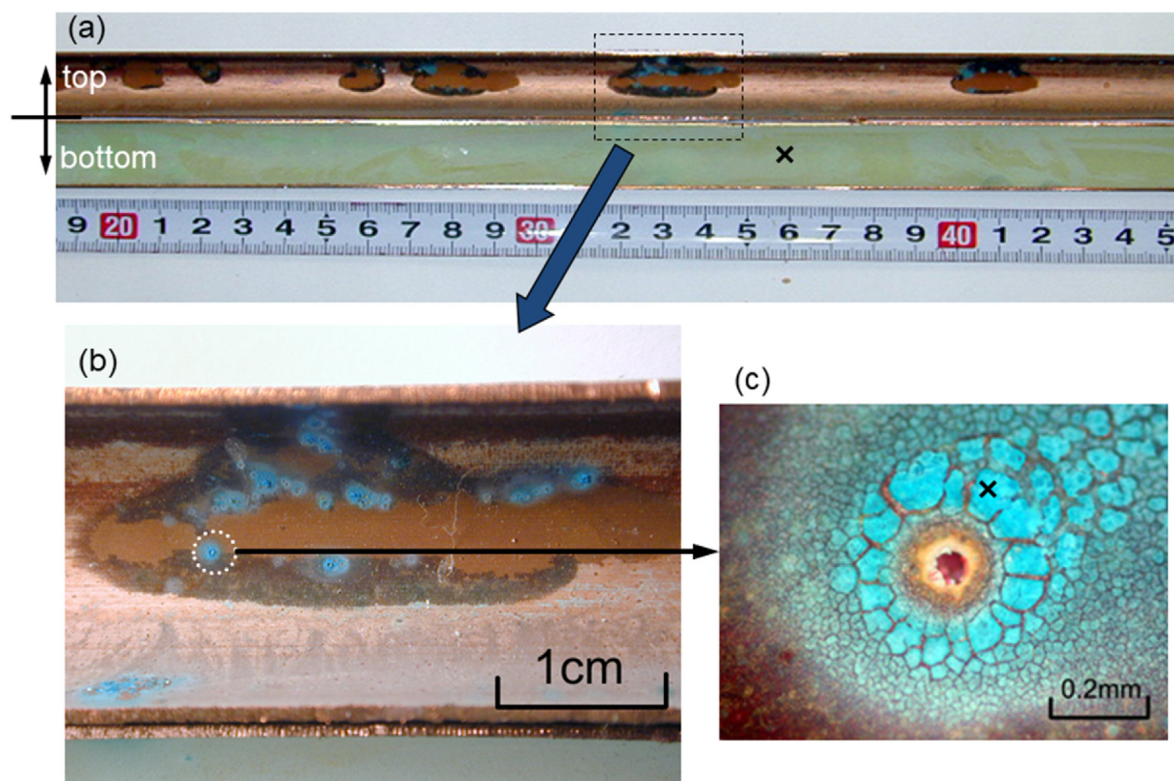
**Figure 9.** Inner surface of a copper tube after the 4-year field exposure test in the Noboribetsu area. The emergence of moundless pitting corrosion can be clearly observed: (a) General view; (b) Enlarged view of the selected area of Fig.9a; (c) Enlarged view of the selected area of Fig.9b. x-marks are analysis points for EDS.

Figure 9(a) shows the inner surface of a typical copper tube after the 4-year test, wherein the top (ceiling) and bottom (ground) sections of the copper surface are clearly distinguishable from one another. More specifically, the bottom section is homogeneously covered with a greenish-white scale, while islands showing discoloured brown spots can be seen on the top section of the tube. In addition, as shown in Figure 9(b), verdigris was detected along the boundaries of the brown spots, and many open-mouth pits were observed (see Figure 9(c)), which were surrounded by a glassy verdigris. Thus, using this field simulation test, the moundless pits detected in the water system were successfully reproduced, although the dimensions of the reproduced pits in this field test were smaller than those obtained in the field survey. A detailed inspection of the test piece showed that not all pits formed during the field test were open pits (Figure 10), wherein some of the closed pits possessed mouths covered with a film that could be broken using a needle. We therefore considered that in the initial stage of moundless pit development, the pit mouth is closed and covered with a thin film. During pit growth (or during sample drying), this film is broken by the impact of flowing water to give an open-mouth morphology.

We then performed EDS on both the tube sample containing moundless pits (i.e., the top component of the tube shown in Figure 9(a)) and the tube sample bearing a greenish white scale (i.e., the bottom component of the tube shown in Figure 9(a)). As presented in Figure 11, for the top (ceiling) region of the copper tube, Cu, Si, and S were detected by EDS analysis, whereas Fe, Cu, and Si were detected in the bottom (floor) region. The detected Fe represents the corrosion product of iron arising from the ductile cast iron pipe used in the tap water transportation line from the waterworks to each houses. This result indicates

that the greenish white scale formed by the reaction of Fe and Si in the water, and its subsequent deposition on the inner bottom surface of the copper tube. This scale of compound made from Fe and Si protected the copper surface, and so no moundless pits were formed on the bottom surface. Figure 12 shows typical EPMA maps for the elemental distribution profiles of the scale surrounding the moundless pit during the field test. More specifically, the condensation of Si was confirmed, and so we speculated that the scale film was formed from a silica component present in water. We suspected that the formation of this silica film was one of the key factors in initiating formation of the moundless pit.

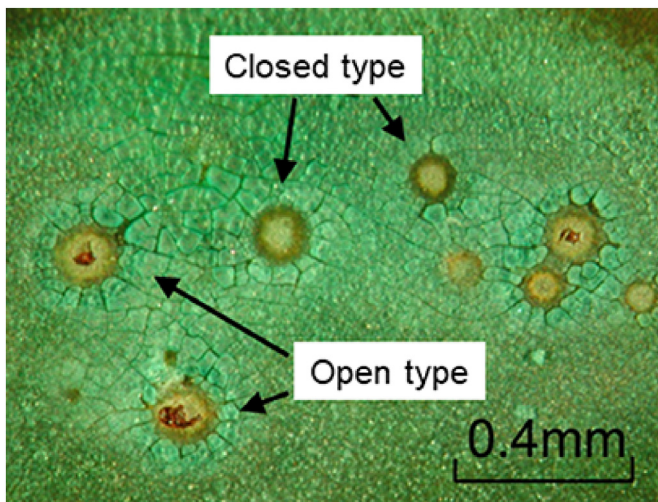
**Figure 10.** Initial stage of development of moundless pits wherein closed-mouth pits can be observed.

the moundless pits, I thought that some other process, distinct from the process of initiation and propagation of type I and type II pitting, was necessary to explain the moundless pit. However, as shown in Figure 10 and Figure 14(b), I discovered that closed pits were present together with the open pits. At least in the early stage of development of moundless pit, therefore, the pit top was not entirely open and was covered with thin surface film. This film may have acted as a shield between the solution in the pit and the surrounding environmental water, much as verdigris does in the case of type I and type II pits. Since the film thin and fragile, it was lost after a certain amount of propagation of the pitting or even after the pipe sampling after test, thus yielding the moundless morphology of the concerned pits. In light of this, we now believe that the thin film at the pit top was essential for the development of the moundless pits. Judging from the EPMA analysis (Figure 12 and Figure 15), this film was composed mainly of Si. I do not as yet know the detailed mechanism of formation of the thin film, but I am investigating it.

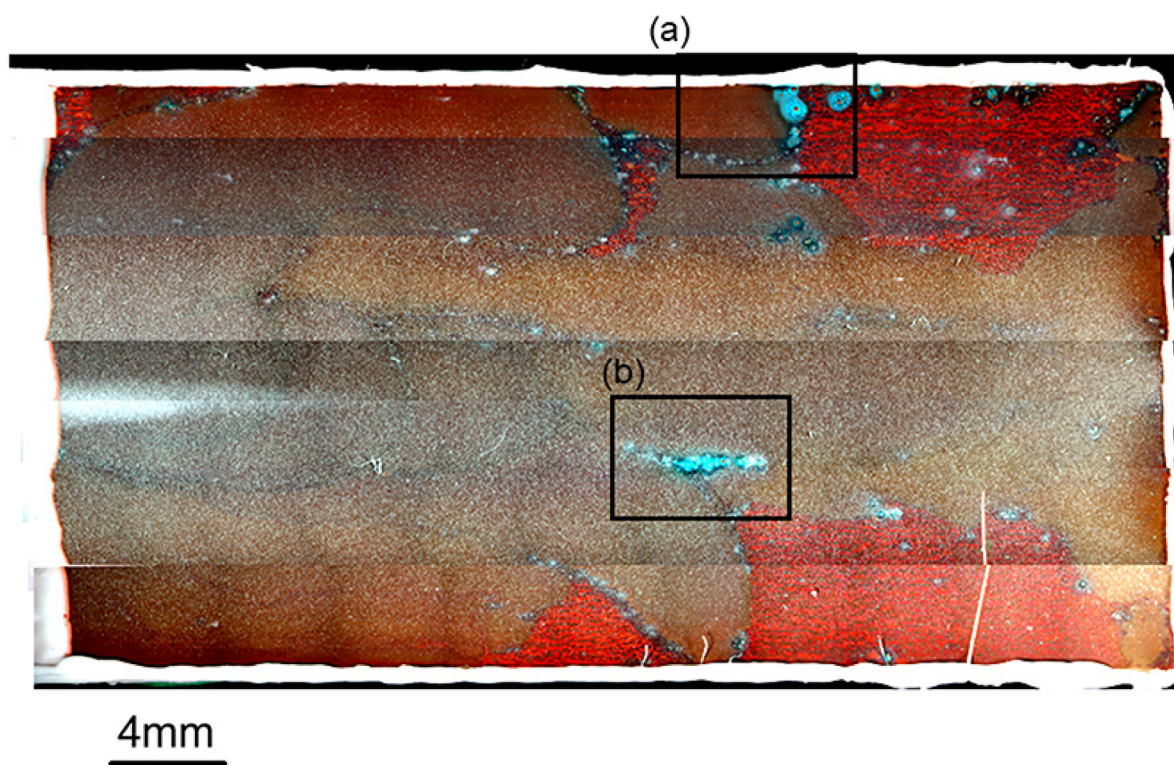
Figure 13. The inner surface of a copper tube specimen after 1 year of immersion in synthetic freshwater during the laboratory test. Areas (a) and (b) are enlarged in Figure 14.

Figure 13 shows the appearance of the entire surface of the copper tube test piece after 1 year. As can be seen from the figure, verdigris spots were discretely visible over the discoloured brown surface. In addition, Figure 14(a) and 14(b) show the optical micrographs of the areas indicated in Figure 13(a) and 13(b), whereas Figure 14(c) and 14(d) show magnified images of the verdigris corresponding to these areas. In some cases, the pits were open and a glassy verdigris was observed around the pit mouth; this reproduces the characteristic features of the moundless pits detected in the field. Pits with completely closed mouths were also detected (Figure 14(d)), as detected in the field (Figure 10). Furthermore, Figure 15 shows the EPMA mapping images of a moundless pit reproduced in the laboratory tests, wherein the presence of Si was clearly confirmed. This result is consistent with the field test results presented in Figure 12, thereby indicating that moundless pit formation was observed in the synthetic freshwater as well as in the field test using tap water distributed from a Chitose water treatment plant. It was therefore confirmed that the formation of moundless pits was initiated in

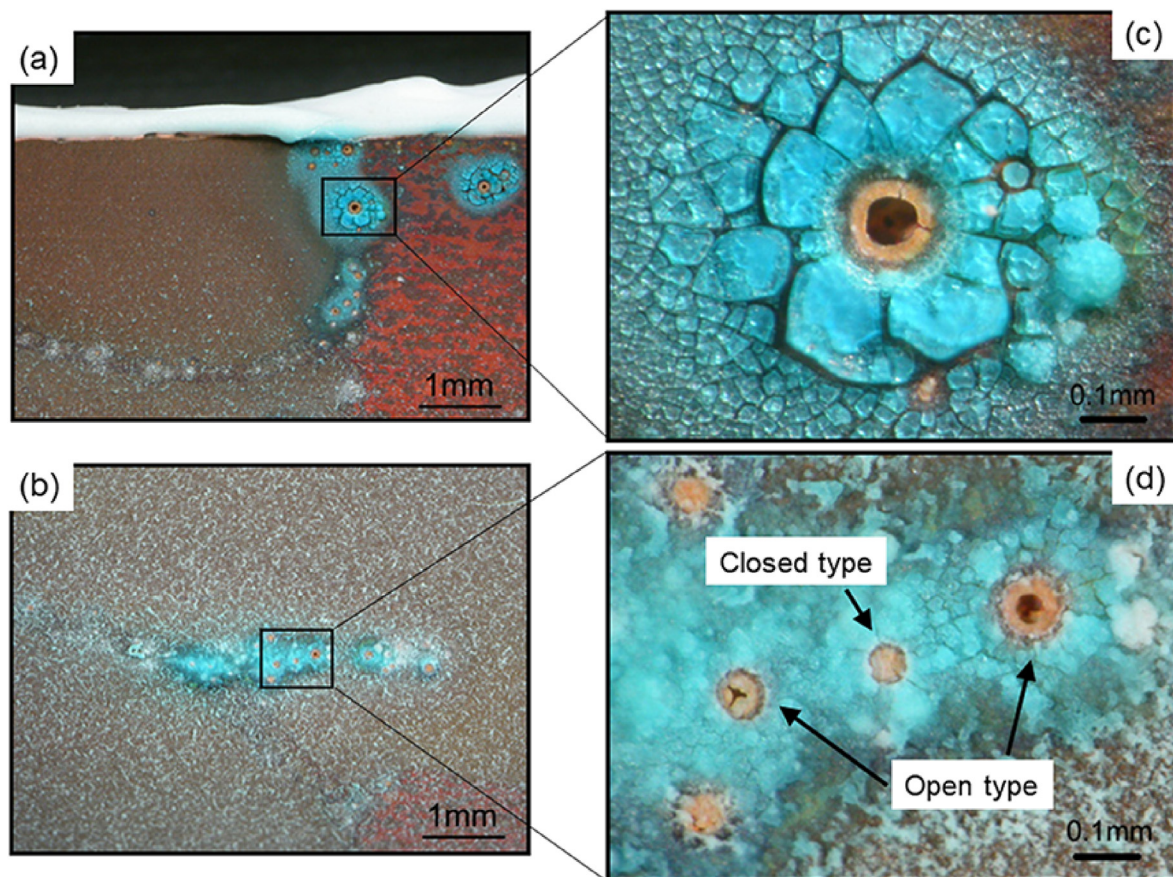
**Figure 14.** (a, b) Optical micrographs of the areas indicated in Figure 13(a) and 13(b) showing the reproduction of moundless pitting corrosion during a laboratory test using synthetic freshwater (c, d) Magnified images of the verdigris corresponding to these areas.

freshwater containing silica, sulfate ions, chloride ions, and bicarbonate ions. The depth of the pit shown in Figure 14(c) is the deepest of 0.216 mm, which corresponds to a corrosion rate of 0.216 mm/y, which is considered to be a relatively high rate.
