IMAGING VIGNETTE

Color Variations in Left Atrial Appendage Occluders

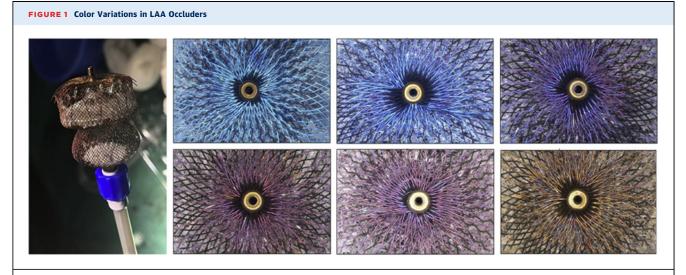
The four devices were returned to the manufacturer for investigation. No deficiencies were found related to materials, batches, or process that would implicate a potential impact on the performance of the devices. The devices were inspected on both the macroscopic and the microscopic level. All four devices were loaded into their loaders and were flushed with water. The water ran clear in all instances, and no material or color was observed in the water. On the microscopic level, the devices were inspected by stereoscopy, scanning electron microscopy, and energy-dispersive spectrometry. No evidence of corrosion was found on any device.

is approximately 300 to 2,000 times greater than the oxide layer, and the oxide layer does not affect the mechanical properties of the wire. Different oxidation states in combination with variations in the oxide layer thickness result in different colors, from a blue to a brownish hue, caused by a light interaction with the oxide layer (Figure 1).

(Left) Left atrial appendage (LAA) occluder from the LAA occlusion (LAAO) procedure showing brownish colors. (Right) Original photos of different LAAO devices from the manufacturing line at the Abbott Company showing color variations.
