Shock-induced right ventricular pacing failure caused by a short circuit: Uncommon but life-threatening complication of the Riata lead

KEYWORDS Electrical failure; ICD; Pacing failure; Shock; Short circuit; Riata lead

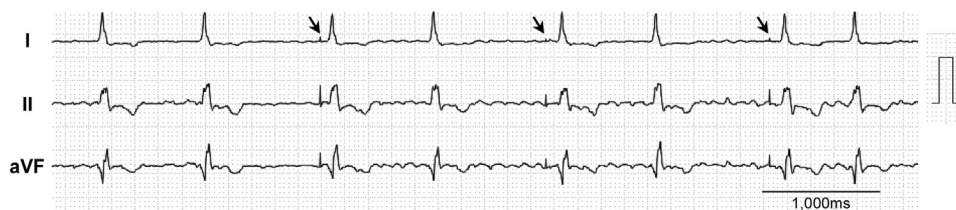
Figure 1 Surface electrocardiogram showing right ventricular pacing failure. The right ventricular pacing (arrows) at the programmed lower rate of 60 beats/min due to appropriate mode switching during atrial fibrillation did not capture the myocardium.

Jude Medical) implanted in 2005 visited the emergency department after experiencing 4 successive sets of shocks (1, 6, 6, and 6 shocks, respectively) within an hour in 2013. The surface electrocardiogram showed atrial fibrillation (AF) with RV pacing failure (Figure 1). Externalized conductors (ECs) were not apparent using multidirectional fluoroscopy. Measurement values related to the lead since the implantation had been within the normal ranges and stable up to and including the last evaluation conducted 5 weeks before the event, with the normal ranges as follows: an RV pacing impedance of 400–450 Ω , an RV pacing threshold of 0.25–0.5 V/0.5 ms, an RV sensing threshold of 4.0–6.0 mV, and an HV lead impedance of 52–57 Ω . Device interrogation revealed that all 19 shocks of 36 J were delivered inappropriately owing to AF. The HV lead impedance decreased to 24 Ω for the first shock and was 48, 48, and 45 Ω for the subsequent sets of shocks, respectively. The RV sensing threshold decreased to 2.8 mV. The RV pacing threshold markedly increased to 6.0 V/0.5 ms with an increased impedance of 1500 Ω (Figure 2A). The stored intracardiac electrograms of the first shock episode were unavailable because of the accumulation of data from the subsequent episodes. The second shock episode is shown in Figure 2B. The shock was delivered inappropriately owing to the rapid ventricular response during AF. Noise became apparent on the RV lead after shock delivery. The noises were transiently seen afterward on the intracardiac electrograms of the subsequent episodes.

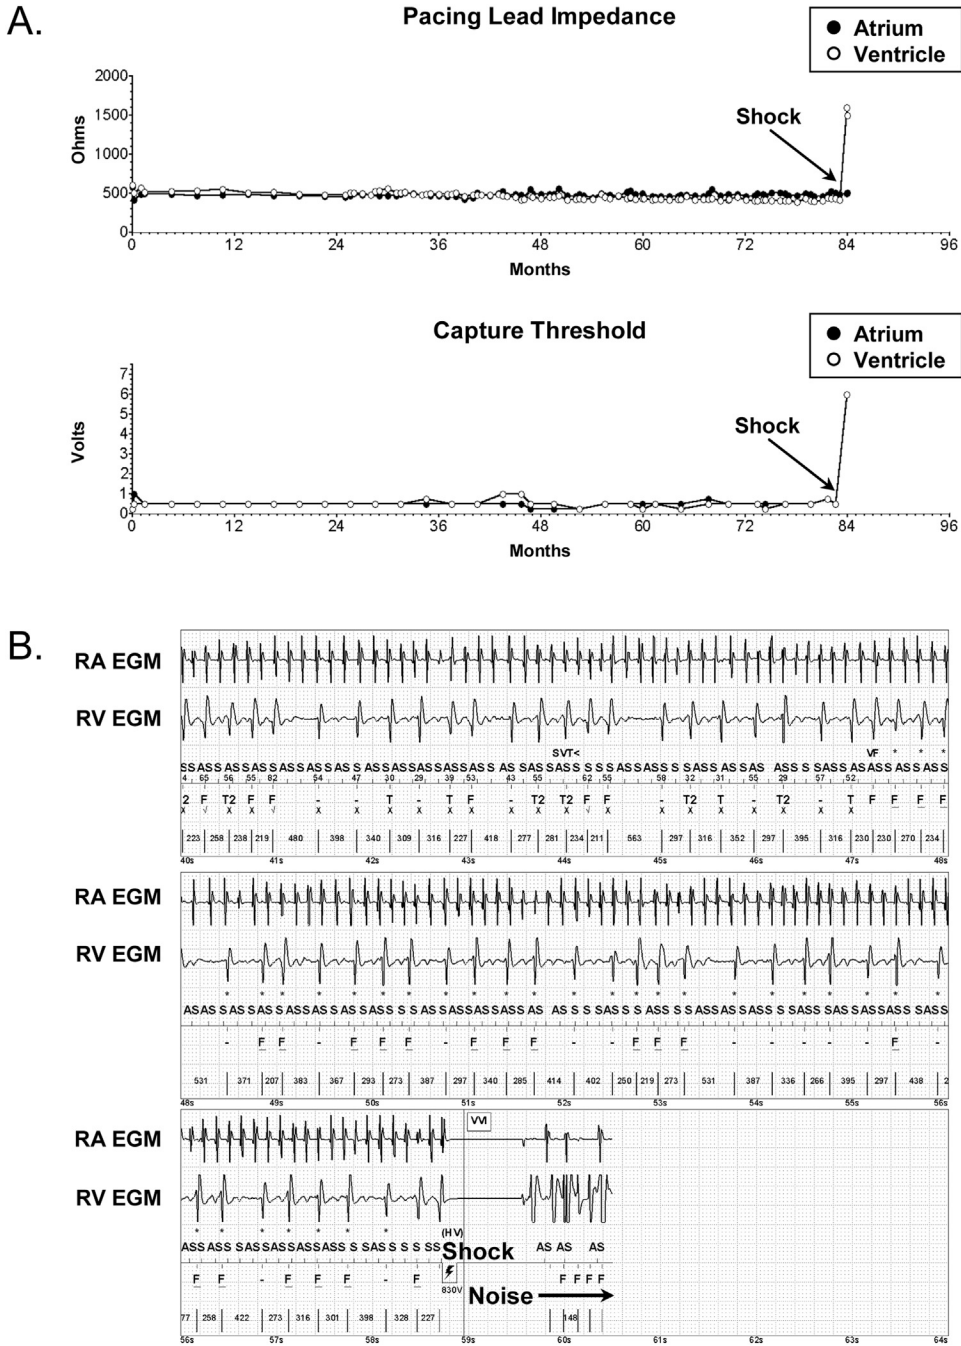
The patient underwent the implantation of a new defibrillator lead. The affected lead was intact as far as could be visually inspected in the pocket. The RV ring and tip electrode conductors were evaluated individually. The unipolar measurements of the RV ring electrodes were within the normal range, with a pacing impedance of 299 Ω and a pacing threshold of 1.9 V/0.5 ms, whereas those of the RV tip electrodes were abnormal, with a pacing impedance of 1953 Ω and a pacing threshold of 6.5 V/0.5 ms. All connectors of the damaged lead were capped, and the lead was not extracted. A new ICD lead was implanted, and a generator was exchanged. The explanted ICD was bench tested by the manufacturer, and no abnormal findings were obtained.

Figure 2 A: Trend of pacing lead impedance and capture threshold. The right ventricular pacing lead impedance and pacing threshold had been stable since device implantation, but markedly increased after shock delivery. B: Stored intracardiac electrograms before and just after the second shock delivery. The shock was delivered inappropriately owing to the rapid ventricular response during atrial fibrillation. No noise or nonphysiologic signals were apparent before shock delivery. Noise appeared shortly after shock delivery on the right ventricular electrogram. RA EGM = right atrial electrogram; RV EGM = right ventricular electrogram.

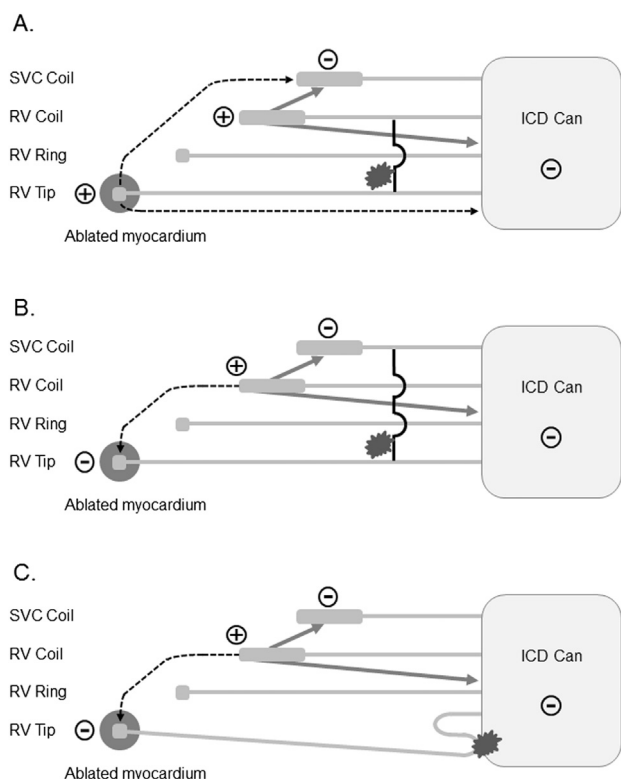
It is quite evident that an electrical short circuit occurred during the first shock. However, a short circuit between the HV conductors was unlikely in this case, because the bench test found no abnormality in the internal circuitry of the explanted pulse generator. Since the ATRAS DR ICD was not equipped with an overcurrent detection system, an electrical short circuit between the HV systems should have damaged the internal circuitry of the pulse generator. RV pacing failure seen shortly after shock delivery was caused by the failure of the RV tip conductor that was centrally located in the lead. Thus, it was most likely that a short circuit occurred between the RV tip conductor and one of the following HV systems: the RV coil conductor, the superior vena cava (SVC) coil conductor, or the ICD can (Figure 3). The 3 hypotheses regarding how RV pacing failure developed owing to a short circuit are described below. *Hypothesis 1* is that an electrical short circuit occurred between the RV tip

conductor and the RV coil conductor (Figure 3A). The RV tip electrode functioned as an anode during shock delivery. The electrical current ran from the RV tip electrode to the SVC coil as well as to the ICD can, making a circuit parallel to those between the RV coil and the SVC coil/ICD can. As a result, the shock impedance decreased to 24 Ω . The myocardium surrounding the RV tip electrode was ablated by the shock current, which increased the pacing impedance and pacing threshold. Furthermore, because of the impedance increase in the myocardium surrounding the RV tip electrode caused by the first shock, the shock impedances of the subsequent shocks were increased to the near-normal range. *Hypothesis 2* is that an electrical short circuit occurred between the RV tip conductor and the SVC coil conductor (Figure 3B). In this setting, the RV tip electrode functioned as a cathode. The current ran from the RV coil to the RV tip electrode. The circuit was parallel to that between the RV coil and the SVC coil and to that between the RV coil and the ICD can. The subsequent result was the same as in Hypothesis 1. *Hypothesis 3* is that an electrical short circuit occurred between the RV tip conductor and the ICD can (Figure 3C). The RV tip electrode functioned as a cathode, with the same result as in Hypothesis 2. The Riata lead consists of a centrally located RV tip conductor coil and 3 surrounding pairs of conductor cables: the RV HV defibrillation conductor cables, the SVC HV defibrillation conductor cables, and the ring electrode conductor cables. The central RV tip conductor coil is encased in a tube of polytetrafluoroethylene (PTFE), and each of the 3 pairs of conductor cables is extruded with ETFE. When the lead structure is considered, Hypothesis 3 becomes less likely. Theoretically, it seems impossible to selectively damage the central RV tip conductor without the other surrounding conductors being affected by can abrasion. In addition, the lead damage was not obvious in the pocket. Thus, in this case, breaks in the PTFE insulation and the ETFE insulation of either the RV or the SVC coil conductor were most likely responsible for the short circuiting.

Figure 3 Presumed mechanisms of the electrical short circuit. **A:** Hypothesis 1: An electrical short circuit between the RV tip conductor and the RV coil conductor. **B:** Hypothesis 2: An electrical short circuit between the RV tip conductor and the SVC coil conductor. **C:** Hypothesis 3: An electrical short circuit between the RV tip conductor and the ICD can. Dotted arrows indicate the direction of the short current. The myocardium surrounding the RV tip electrode was ablated by the short current, resulting in an increase in the RV pacing lead impedance and capture threshold. Because the impedance increase occurred in the myocardium surrounding the RV tip electrode owing to the first shock, the shock impedances of the subsequent shocks were increased to the near-normal range. RV = right ventricular; ICD = implantable cardioverter-defibrillator; SVC = superior vena cava.
