Sense-B-noise: an enigmatic cause for inappropriate shocks in subcutaneous implantable cardioverter defibrillators

Aims

Subcutaneous implantable cardioverter defibrillators (S-ICDs) are well established. However, inappropriate shocks (IAS) remain a source of concern since S-ICDs offer very limited troubleshooting options. In our multicentre case series, we describe several patients who experienced IAS due to a previously unknown S-ICD system issue.

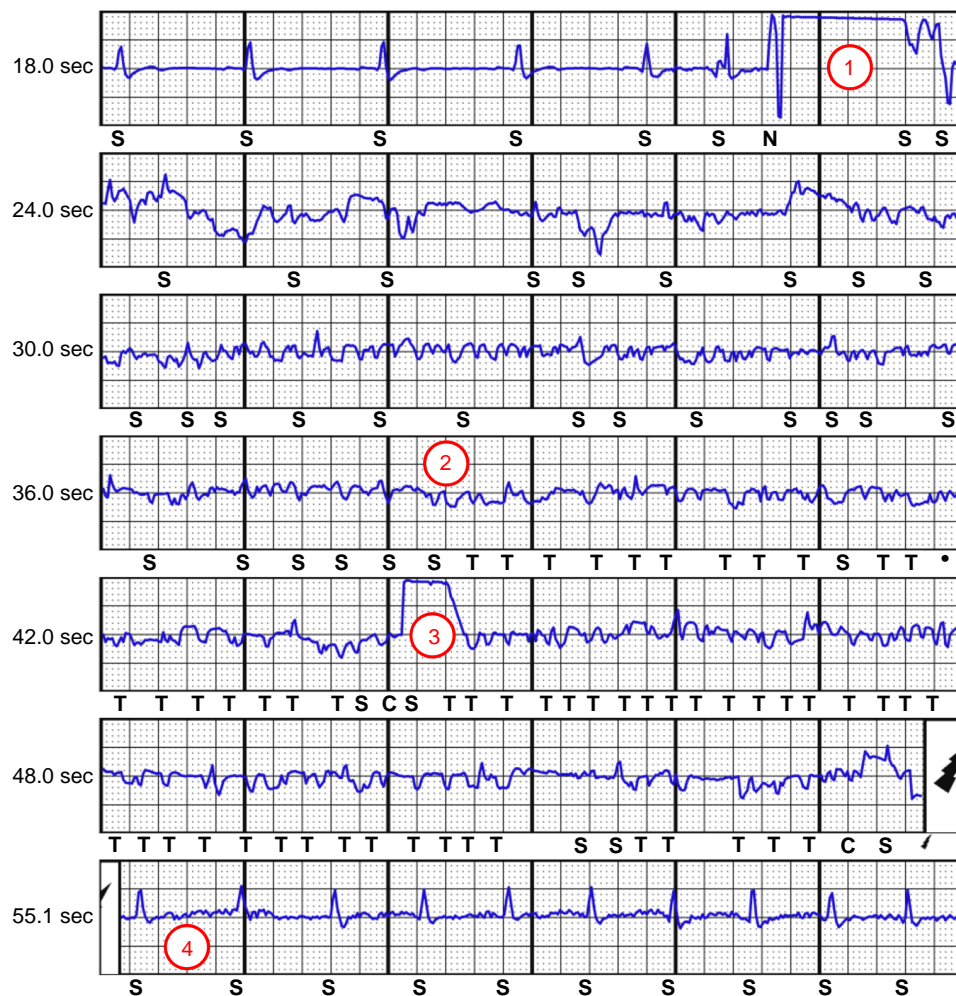
A 29-year-old male had received an Emblem A219 S-ICD with a 3501 lead (Boston Scientific, Marlborough, MA, USA) in July 2019 due to idiopathic ventricular fibrillation (VF). Two months after implantation, he received two shocks due to VF. After 16 months, while working on the computer, the patient received an IAS (Figure 1; SMART pass on, primary sensing vector, gain 2x, shock impedance 64Ω). Device manipulation and provocation manoeuvres showed no suspicious findings. The patient underwent system revision and the complete S-ICD was sent to the manufacturer for analysis. The analysis revealed that no lead defect was present. However, changes in the generator's impedance pathway of the primary sensing vector were identified, which may have caused the noise oversensing according to the manufacturer.

Figure 1 Inappropriate shock due to oversensing (Case #1). The episode begins with a sudden artefact driving the signal into saturation (1). Subsequently, the cardiac signal becomes largely unrecognizable with low-amplitude signals (2), and the S-ICD starts to charge (3, charging artefact). The shock delivery is ensued by normal QRS signal amplitudes (4).

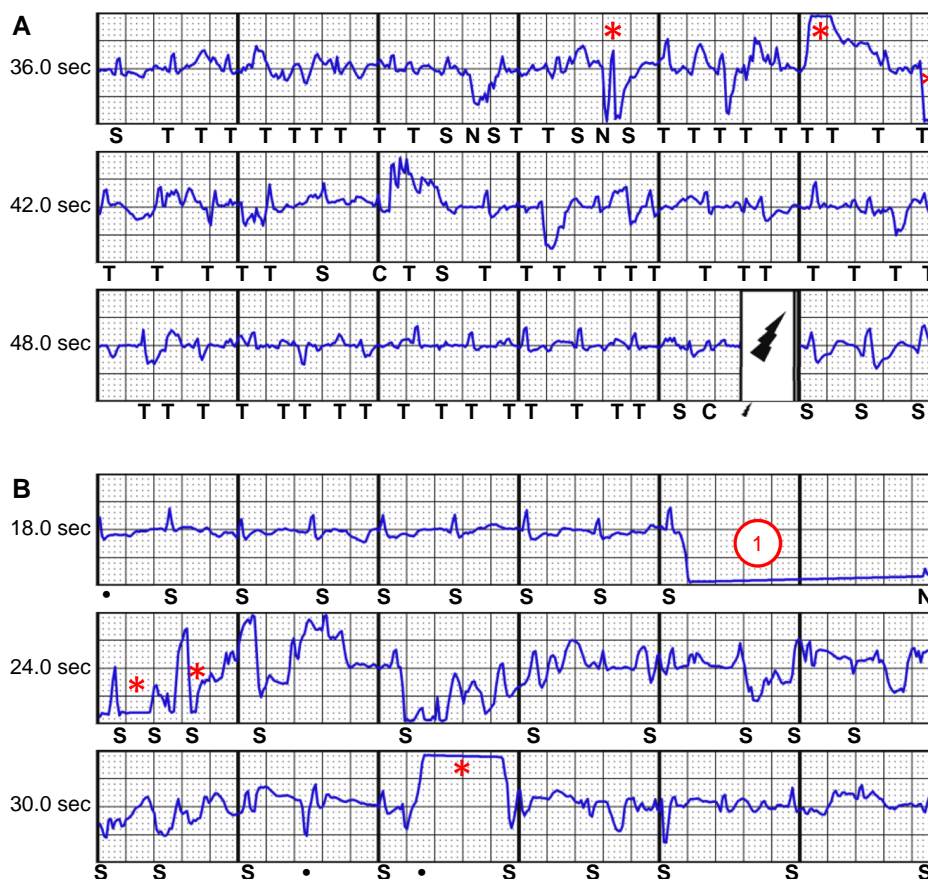
A 25-year-old woman had received an Emblem A219 S-ICD with a 3501 lead in February 2020 due to malignant mitral valve prolapse (primary prevention). Six months later, she experienced an IAS (Figure 2A). Another untreated episode had been registered two weeks prior (Figure 2B). During shock delivery (SMART pass on, primary sensing vector, gain 1x, shock impedance 59Ω), she was cleaning the floor.

Figure 2 Patient Case #2. Panel (A) inappropriate shock due to artefact oversensing. Signal saturation episodes are visible (asterisks), the low-amplitude QRS becomes better visible after the IAS. Panel (B) similar to Figure 1, the episode is triggered by a sudden artefact (1). The ensuing artefact-rich signal shows episodes of signal saturation and oversensing.

Extensive device manipulation and provocation manoeuvres at rest and during exercise could not reproduce oversensing. The X-ray showed correct connection of the lead inside the header without signs of lead fracture or kinks. Lead revision was considered but—based on the manufacturer's suggestion—we only reprogrammed the device to secondary sensing vector and installed remote monitoring. The patient was successfully rescued from VF by an appropriate shock delivered 15 months after device reprogramming. During those 15 months and until today, no oversensing was observed.

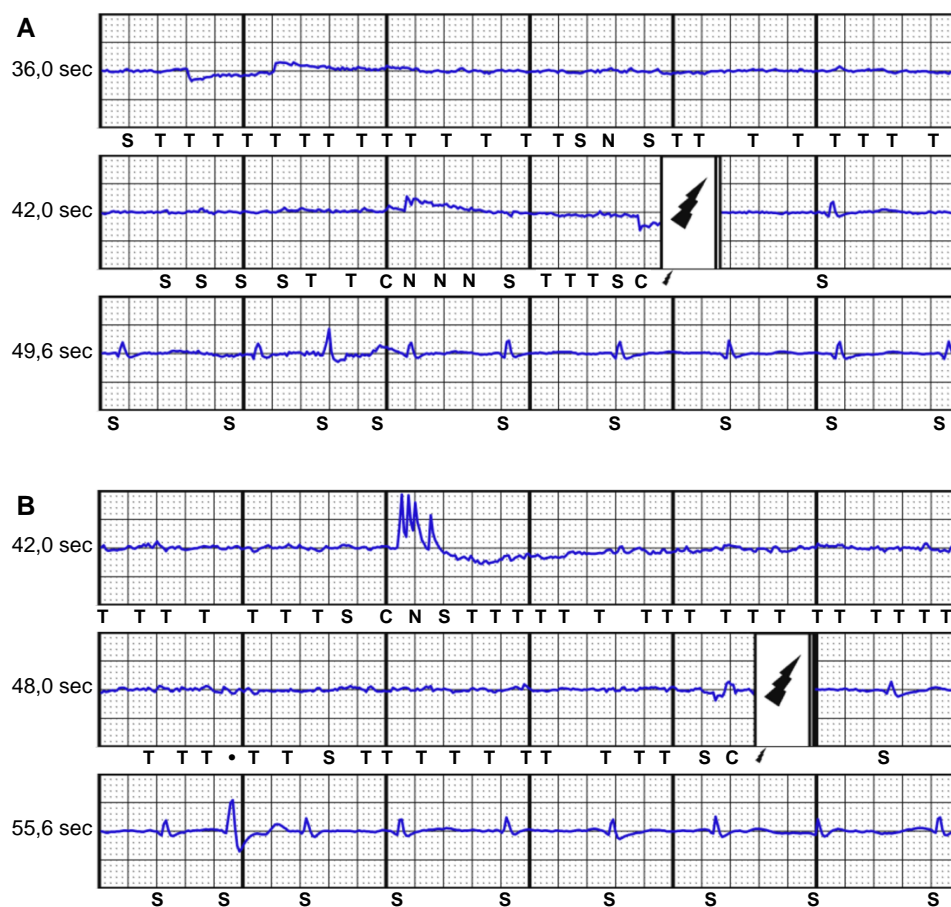
A 42-year-old male had received an Emblem A219 S-ICD with a 3401 lead in September 2016 after survival of sudden cardiac death (SCD, Chagas heart disease). Sixteen months after implantation, he received an IAS due to signal dropout (Figure 4A, SMART pass off, primary sensing vector, gain 1x, shock impedance 72Ω). Similar non-sustained episodes with aborted shocks had been stored a minute before and on the preceding evening. Secondary and alternate sensing vectors showed low-amplitude signals, so the primary sensing vector was maintained, with re-activation of SMART pass. Two days later, the patient presented with a new IAS, again due to signal dropout (Figure 4B), again with automatic inactivation of SMART pass due to low signal amplitudes. Since there was no satisfying explanation, the patient underwent system explantation. Perioperatively, the suture sleeve was properly fixated and did not cover the proximal electrode, the lead pin was correctly inserted and showed no signs of failure. Technical analysis of the device by the manufacturer was unable to determine the root cause since the device function was unremarkable.

Figure 4 Patient Case #4. Panel (A) heavily diminished ECG signal amplitudes causing oversensing and shock delivery. Panel (B) similar episode 2 days later. Both episodes (panel B and C) showing QRS amplitude restoration after shock delivery.
