Article

Corrosion Processes on Weathering Steel Bridges Influenced by Deposition of De-Icing Salts

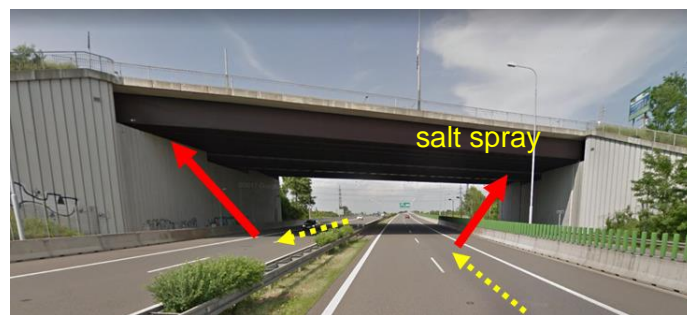
For some bridge constructions, inspections have identified surfaces that are not exposed to direct leakage, yet they do not develop a sufficiently protective layer of corrosion products [10]. In all observed cases, the upper surface of the bottom flanges of the main bridge girders was damaged. This type of corrosion damage was identified only at the bridges or their parts that are above road with intensive traffic. For other types of obstacles (vegetation, rivers and lakes, railway lines) there is no corrosion damage on the bottom flanges. It has been found that the development of unprotected corrosion layers is associated with the increased deposition of aerosol and airborne impurities on these surfaces. The development of no protective corrosion products on the bottom flanges is mainly caused by the increased deposition of chlorides that are bound to dust particles and aerosols. Chloride sources are chemical de-icing agents used in winter road maintenance. The amount of deposited chlorides is significantly affected by the structural solution of the bridge (see Figure 1).

Figure 1. Tunnel-like conditions under the bridge (road bridge over highway D1 in the city of Ostrava, Czech Republic).

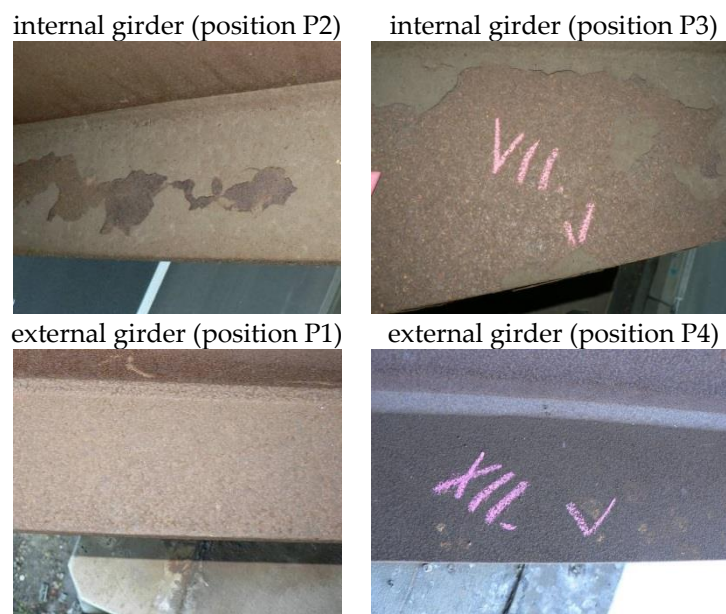
A sufficiently protective layer of corrosion products, typical of sheltered exposures, has developed on bridge B1. An exception is on the upper surface of the bottom flanges of the inner girders (see Figure 5), where non-adherent layers of corrosion products have formed, with a large proportion of deposited impurities on the surface. Non-adherent corrosion products have formed on both the northern and southern sides of the inner main girders, i.e., both in the direction and opposite direction of traffic under the bridge construction. Compared to the bottom flanges of internal girders, a compact and sufficiently adherent layer of corrosion products has developed on the outer flanges of exterior main girders (see Figure 5).

Figure 5. Development of corrosion products on the bottom flanges of the main girders on bridge B1: above—detrimental development on inner surfaces; below—acceptable development on outer surfaces.

The apparent disproportion between the amount of chlorides found in the corrosion products (m_{Cl}) and the deposition rates of chlorides (S_{d}) can be explained by the fact that although the external surfaces of the bridge are more exposed to chlorides and impurities, the external surfaces are also regularly cleaned by wind and rainfall. The amount of chlorine found in the corrosion products of the external surfaces of bridge B1 was therefore less than the internal surfaces. This phenomenon negatively manifests in long-term development, where non-adherent layers of corrosion products with a large proportion of settled impurities form on the upper surfaces of the bottom flanges of the inner main girders (see inner surfaces shown in Figure 5).

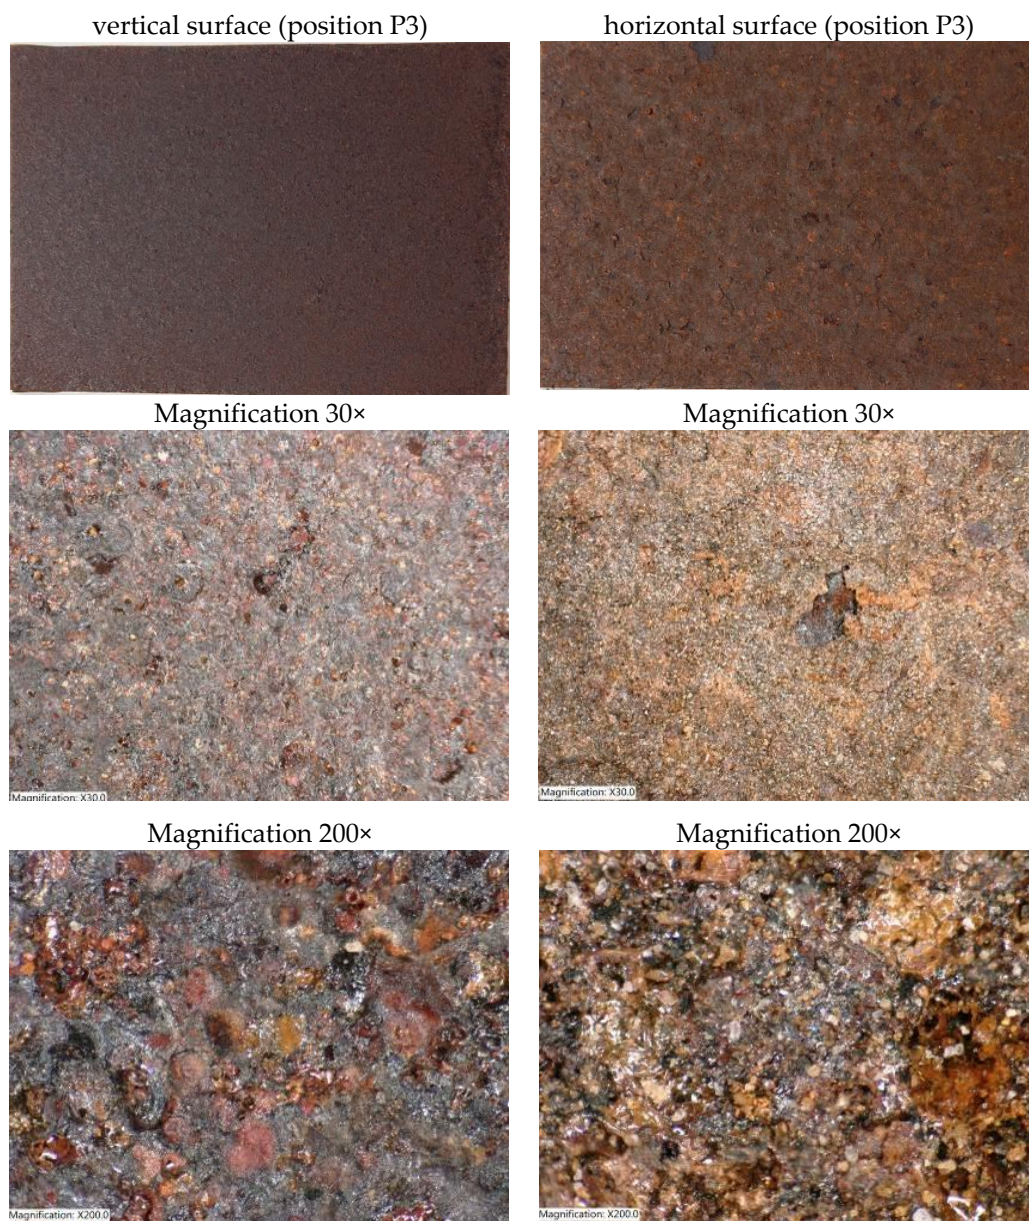
Figure 6 shows the surface of exposed steel samples in the vertical and horizontal orientation for position P3. On the horizontally-oriented sample, a larger and less compact layer of corrosion products has developed compared to the vertically-oriented sample. The corresponding corrosion layers also have a different coloration. In the horizontally-oriented sample, a higher proportion of settled pollution is evident.

Figure 6. Bridge B1, position P3—layer of corrosion products on the surfaces of exposed samples after one year of exposure.

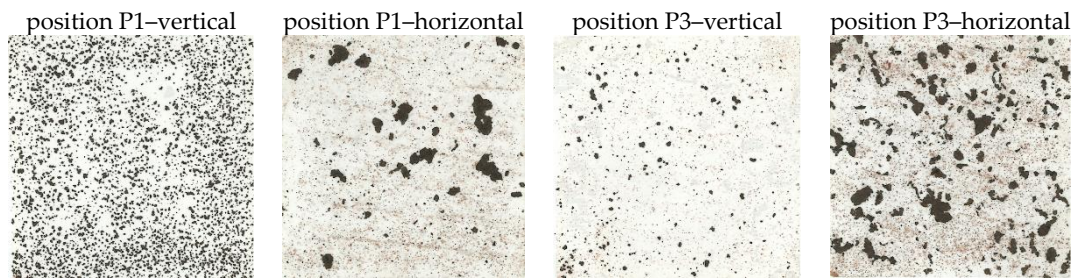
Adhesion of corrosion products was assessed using the Scotch-tape test method. Imprints were collected after a one-year exposure of the corrosion samples (see Figure 7). Small, evenly distributed corrosion particles less than 1 mm in size were collected from both vertically-oriented surfaces. On both horizontally-oriented surfaces, larger particles with a size of approximately 5 mm were collected. Higher proportions of large corrosion particles were identified on the inner main girder (horizontal surface at position P3).

Figure 7. Scotch-tape test for positions P1 and P3 for vertical and horizontal placement of the surface of the steel coupon and one-year exposure.

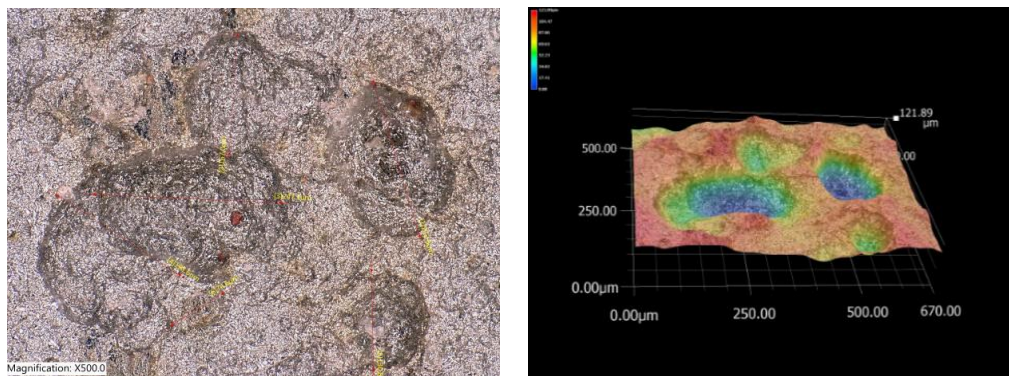
The frequency and size of the individual corrosion pits were evaluated using a Keyence VHX500 3D microscope. Figure 8 shows a selected example of the surface of a corrosion sample located on the bottom flange of the inner main girder (sample from position P3).

Figure 8. Structure of the steel surface under the corrosion layer.

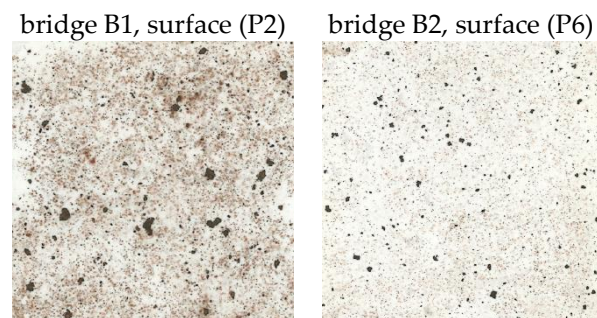
The different development of corrosion products on the horizontal surfaces of both evaluated bridges can also be documented based on a visual evaluation. On the bridge B1 samples, bulkier and less adherent corrosion products developed with a higher proportion of settled impurities. Visual evaluation was supplemented by an evaluation of adherent and non-adherent rust layers using the Scotch-tape test. Imprints of horizontal surfaces from the bridge B1 show an uneven distribution of trapped particles of various sizes, whereas the size of the largest particles collected on the imprint were approximately 5 mm. For bridge B2, the collected particles were evenly distributed and the particle size was up to 2 mm. Imprints from the compared surfaces at positions P2 and P6 are shown in Figure 13.

Figure 13. Scotch-tape tests on selected horizontal surfaces.
