An analysis of the regulatory program of quality audits in radiotherapy in Brazil from 1995 to 2007

Instituto de Radioproteção e Dosimetria – IRD/CNEN/MCT, Rio de Janeiro, Brazil
epaiva@ird.gov.br

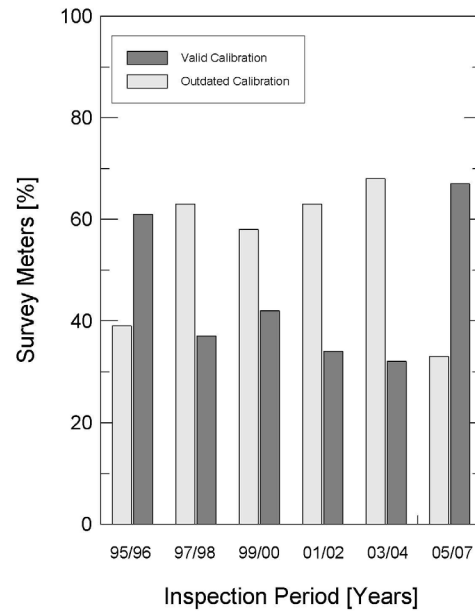
Another item taken into account was the validity of the calibration factor of survey monitors and clinical dosimeters employed by the radiation safety officers and the medical physics staff working in the radiotherapy facility. Figures 1 and 2 present the existing situation of valid calibration equipments and outdated calibration equipments, for each inspection period considered, respectively, for survey monitors and clinical dosimeters.

Fig. 1. Percentage of survey monitors with valid calibration factors and with outdated calibration factors, according to the inspection period considered.

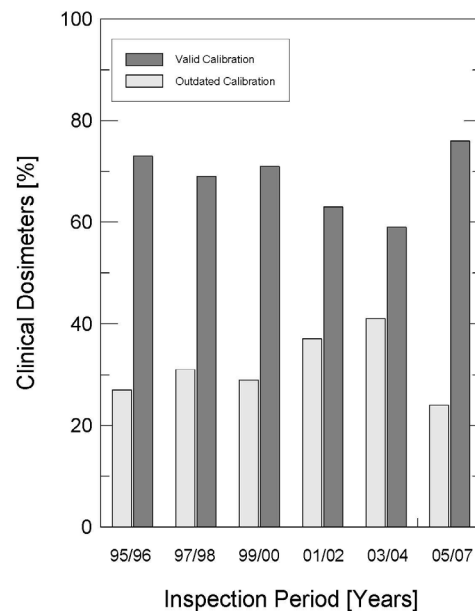
Fig. 2. Percentage of clinical dosimeters with valid calibration factors and with outdated calibration factors, according to the inspection period considered.

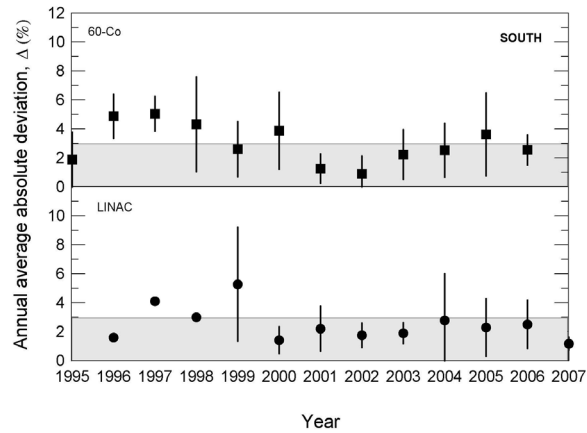
The results presented in Figs. 3 to 7 show, in general, a decrease of δ and Δ values with an increase in the numbers of audit inspections to which the radiotherapy facility was subjected. This behavior can indicate a positive response of radiotherapy facilities to IRD/CNEN inspections in the sense that they are giving more attention to dosimetry and quality control procedures. In Fig. 5, which presents the data for the Brazilian north region, the same symbols were used for LINACs and Co-60 irradiators, due to the low statistics.

Fig. 3. Annual average absolute percent dosimetric deviation values, Δ , for Brazilian south region. Error bars are one standard deviation of the mean absolute value.

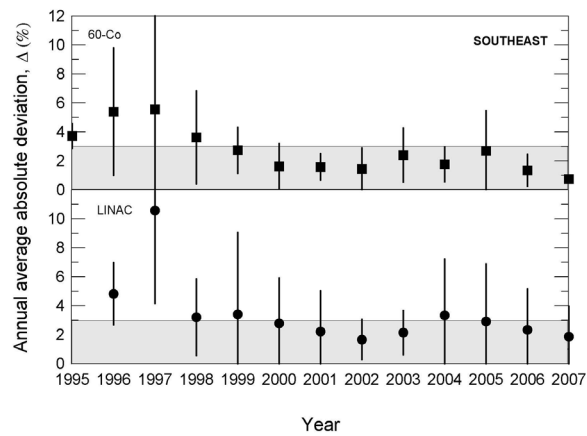
Fig. 4. Annual average absolute percent dosimetric deviation values, Δ , for Brazilian southeast region. Error bars are one standard deviation of the mean absolute value.

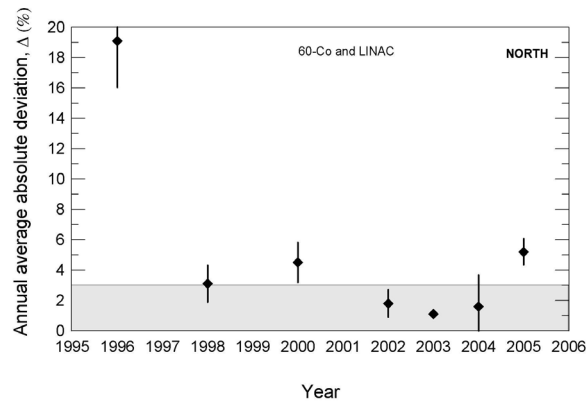
Fig. 5. Annual average absolute percent dosimetric deviation values, Δ , for Brazilian north region. Error bars are one standard deviation of the mean absolute value.

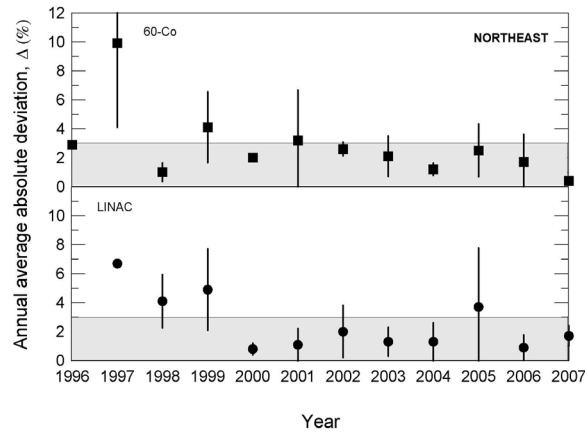
Fig. 6. Annual average absolute percent dosimetric deviation values, Δ , for Brazilian northeast region. Error bars are one standard deviation of the mean absolute value.

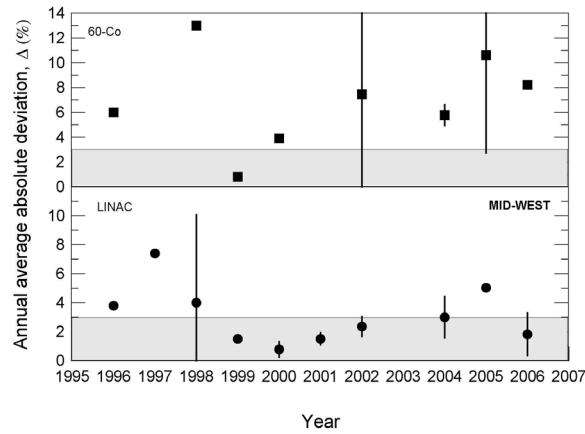
Fig. 7. Annual average absolute percent dosimetric deviation values, Δ , for Brazilian mid-west region. Error bars are one standard deviation of the mean absolute value.

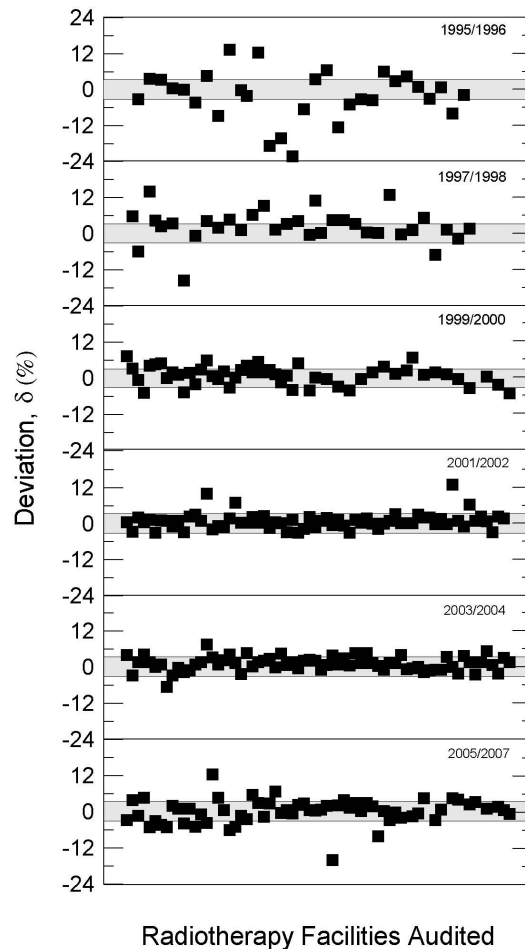
Figures 8 and 9 show that, for cobalt-60 irradiators (squares) and linear accelerators (circles), respectively, the percent dosimetric deviation, δ , between the requested absorbed dose, D_R , and the mean measured dose, D_M , for the whole country from 1995 up to 2007. It can be noted that most of the deviations are in the range $\pm 3\%$, although some results were, in modulus, higher than 3%. For instance, in 1999 a negative deviation of -23.4% for a 6 MV linear accelerator was measured. A positive deviation of 19.7% for a 15 MV linear accelerator was measured in 2005. A δ value equal to -15% was measured for a 6 MV linear accelerator in 2006. In 1996 δ values varying from -22.3% to -12.5% for different telecobalt units were found and, in 2005, a δ of -16.2% was determined for a unit of cobalt-60. In Table 2, the worst δ values (absolute values greater than 10%) and the main possible sources of errors are summarized.

Fig. 8. Percent dosimetric deviation, δ , between the requested absorbed dose, D_R , and the mean measured dose, D_M , for cobalt-60 irradiators, for all Brazilian regions, from 1995 to 2007.

Figures 8 and 9 show the absorbed dose percentage deviations evaluated from 1995 to 2007 for telecobalt irradiators and clinic linear accelerators. Several noncompliances, deviations out of the range $\pm 3\%$, can be observed – mainly for units of ⁶⁰Co. Many of these facilities were obsolete and were subsequently replaced or modernized.

The largest deviations shown in Figs. 8 and 9 and their possible causes are listed in Table 2. The worst result found was -23.4% (Fig. 9) for a 6 MV Linac in 1999. A investigation team of inspectors from the IRD/CNEN discovered that the professional responsible for the beam dosimetry had applied wrong factors in the calculation of monitor units. A deviation of -22.3% (Fig. 8) was found in 1996 for a ⁶⁰Co unit as a result of misuse of the dosimetry protocol. In 2005 a deviation of 19.7% (Fig. 9) was observed for a 15 MV Linac, possibly due to the absence of clinical dosimeter quality control procedures. The facility did not have, or did not use, any source test. In 1998 a linear accelerator dosimetry audit produced a deviation of -16% (Fig. 9). The facility had no clinical dosimeter calibrated. Many medical physicists and radiation protection officers claim that it is very difficult to schedule the equipment calibration, clinical dosimeter or survey monitor, in a Brazilian-certified calibration laboratory.

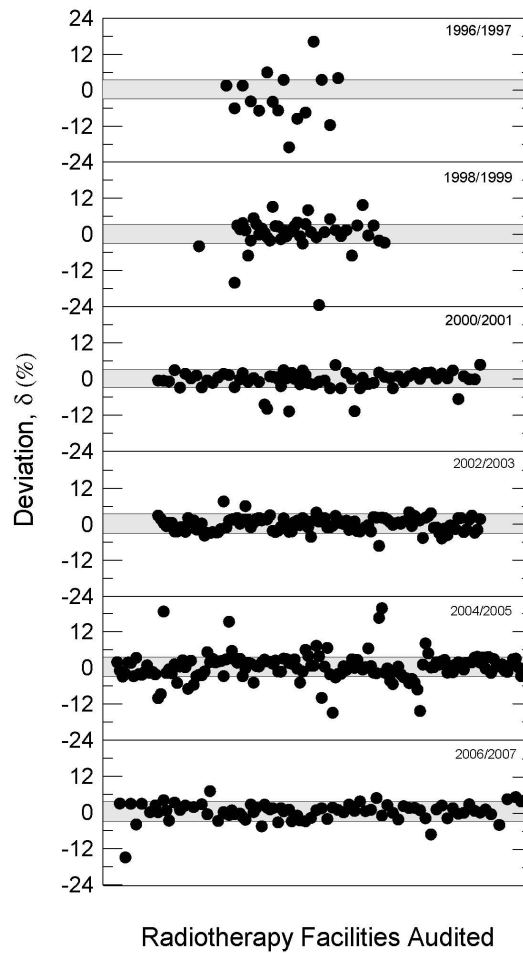
Fig. 9. Percent dosimetric deviation, δ , between the requested absorbed dose, D_R , and the mean measured dose, D_M , for linear accelerators, for all Brazilian regions, from 1996 to 2007.

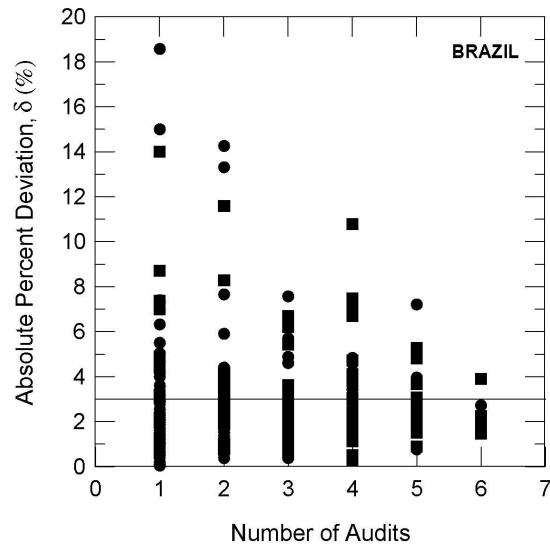
Figure 10 depicts the last absolute value of δ measured for each therapeutic irradiator with the number of audits already completed by these irradiators. It is easily observed that δ values decrease with the increase of the number of audits, indicating the important role that the IRD/CNEN biennial program of audits plays to enhance the effectiveness of cancer treatment.

Fig. 10. Relationship between the last absolute value of δ measured for each therapeutic irradiator and the number of audits already completed by these irradiators. Linear accelerators are represented by circles and Co-60 irradiators by squares.
