Case Report

Bilateral Mechanically-Assisted Crevice Corrosion Resulting in Femoral Stem-Head Dissociation in Metal-on-Polyethylene Total Hip Arthroplasty

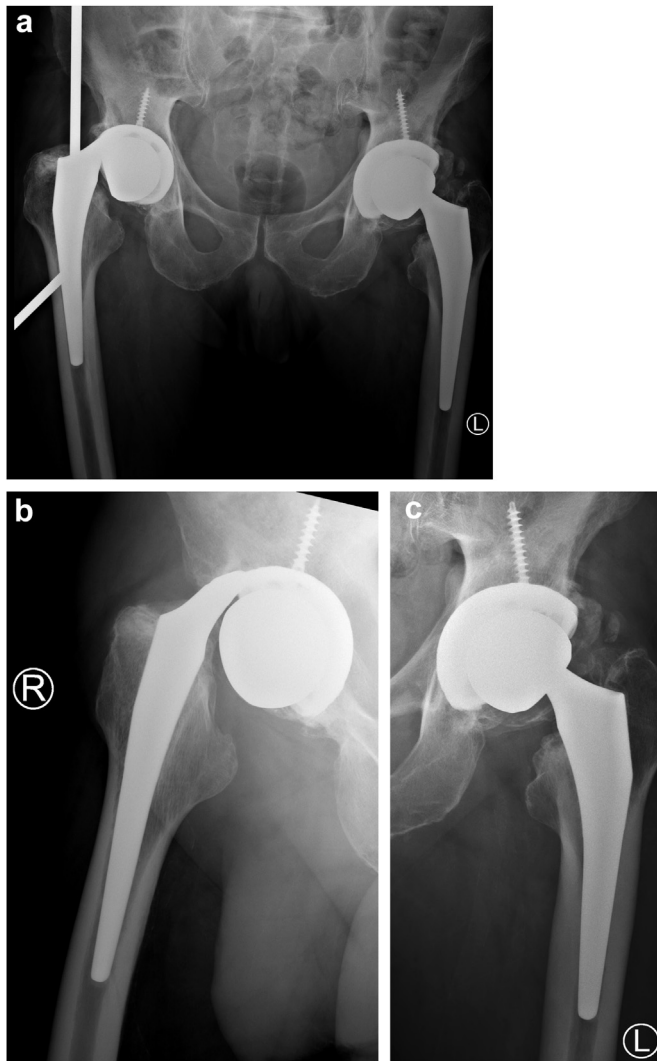
Figure 1. (a, b) Antero-posterior XR performed on presentation showed complete head-neck taper dissociation with malalignment and shortening. No obvious signs of peri-prosthetic osteolysis, suggestive of infection or component loosening. Advanced imaging was unnecessary because of the obvious need for revision. (c) The contralateral left THA showed peripheralization of the femoral stem in relation to the femoral head. This may demonstrate asymmetrical trunnion wear and impending dissociation.

This case describes an 83-year-old Caucasian man who presented to the emergency department with pain, decreased range of motion, and inability to bear weight on his right hip that occurred after crossing his legs. His initial radiographs demonstrated complete dissociation of the right modular femoral component suggesting GTF. Peripheralisation of his contralateral, left femoral stem with an increased axial tilt in relation to the femoral head was also

noted. (Fig. 1a-c) This was however asymptomatic. Our patient had a BMI of 22.4, was 175 cm in height, and his past medical history included hypertension, triple coronary bypass grafting, and a mitral valve repair for which he took warfarin. He was 9 years and 9 months after his index right total hip and exactly 10 years after his left hip replacement, both of which were for severe osteoarthritis.

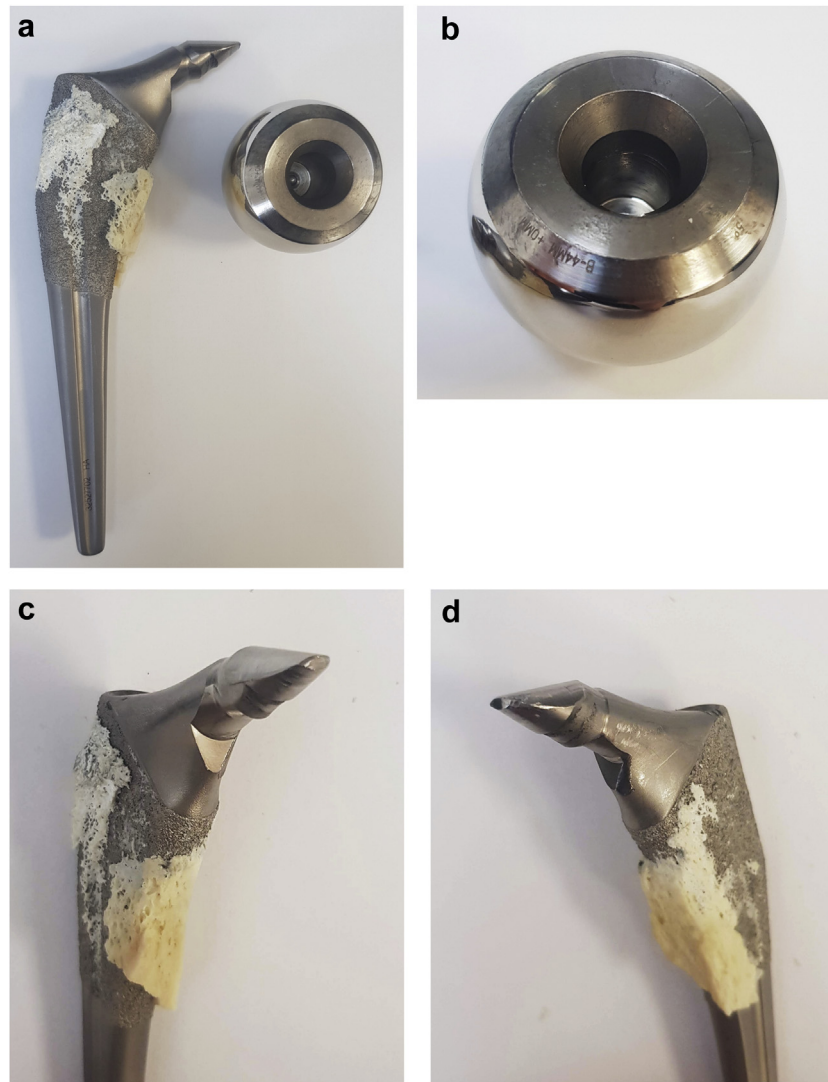
Intraoperative findings during the right hip revision surgery showed darkened synovial fluid and necrotic-looking, fibrous tissue suggesting metallosis of the intracapsular space, and femoral medullary canal. There was no obvious pseudotumour or heterotopic ossification along the greater trochanter, and the abductors were fully intact. The posteromedial calcar was preserved. The femoral stem was removed without the need for an extended trochanteric osteotomy and exhibited severe trunnion corrosion without signs of fatigue or fracture. There was also significant medial wear of the femoral neck. The Co-Cr head was intact with minor abrasions at the taper junction but no loss of material internally or externally (Fig. 2a-d).

Figure 2. (a) The recovered accolade TMZF explant showed severe corrosion of the modular junction and corrosion of the medial portion of the femoral neck. (b) There was no increased wear visible inside or outside the size 44/0 cobalt-chrome head. (c, d) Rotational views of the recovered explant demonstrate the extent of corrosion present without fracturing of the stem.

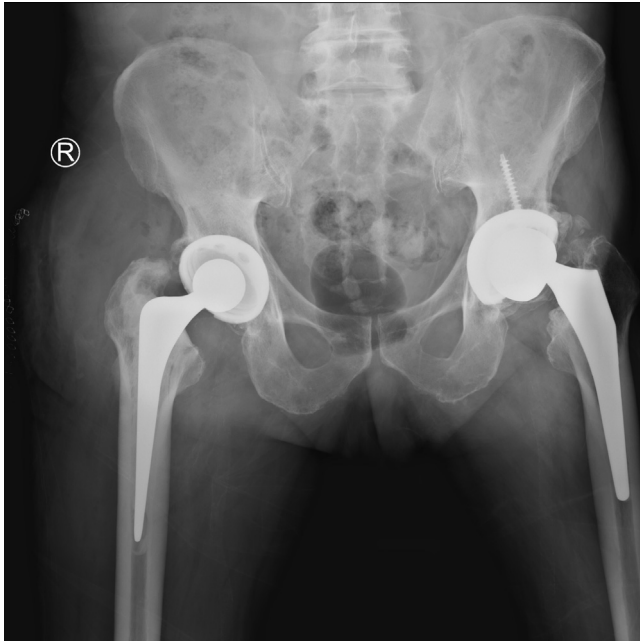
Figure 3. Post operative XR showed successful single-stage revision with a cemented exeter stem. The femoral stem of the contralateral left hip remains off-centre in relation to the femoral head.

An Exeter number 1 stem with 44 offset, length 150 mm, was cemented in situ. A Stryker V40 stainless steel femoral head, size 32/0, was impacted to the stem. The trident acetabular cup was deemed stable after explantation of the polyethylene insert, which was exchanged. Intraoperative tissue and synovial fluid specimens both returned sterile (Fig. 3). At 6-month follow-up, our patient had returned to his baseline, unaided level of mobility. He was satisfied with the outcomes of the right hip revision surgery but has declined surgery for the contralateral side. His Oxford Hip Score was 37/48.
