## Case Report

## Bilateral Failure of Oxidized Zirconium Implants in Total Knee Arthroplasty

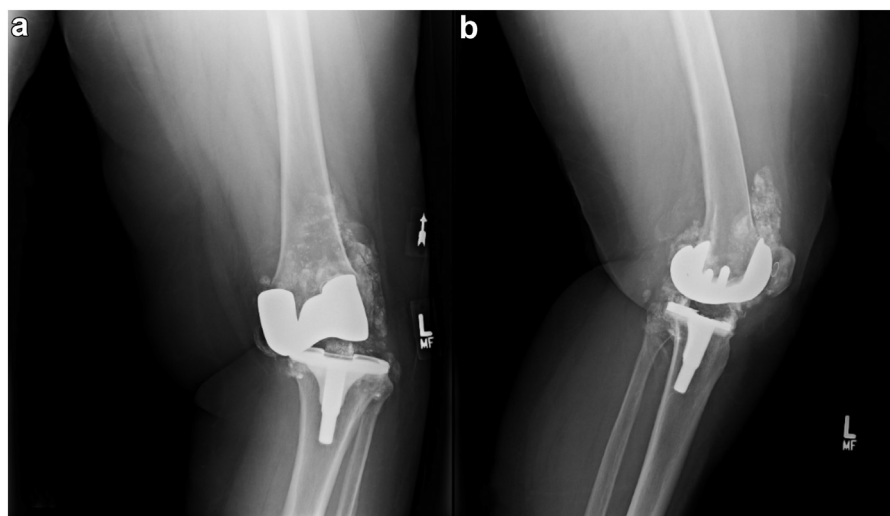
**Figure 1.** (a) Anteroposterior and (b) lateral x-rays of a skeletally mature left knee demonstrate metallosis and heterotopic ossification in the superior patellar pouch and the lateral gutter. The anteroposterior view shows complete medial compartment collapse, medial subluxation, and subsequent varus alignment. The femoral and tibial components were properly sized with no signs of loosening or fractures.

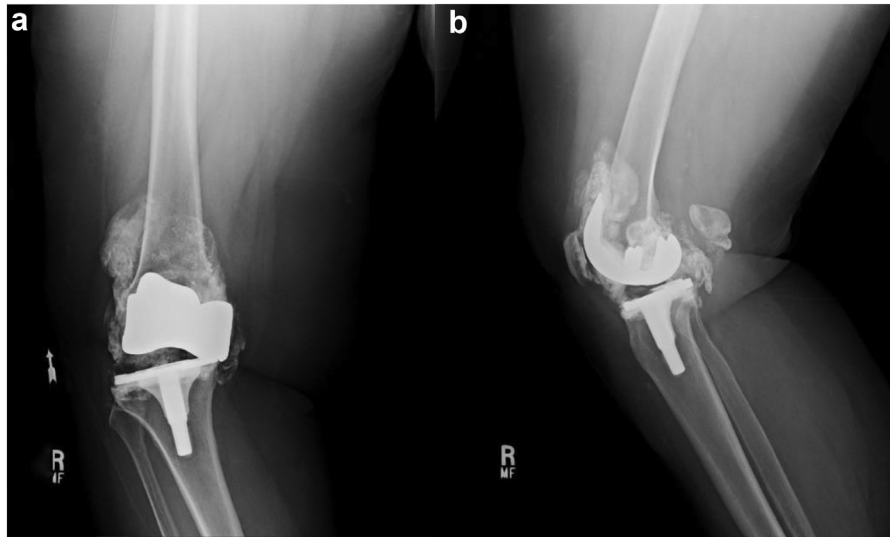
**Figure 2.** (a) Anteroposterior and (b) lateral x-rays of a skeletal mature right knee demonstrate metallosis and heterotopic ossification in the superior patellar pouch, lateral gutter, and popliteal recess. Complete medial compartment collapse, medial subluxation, and varus alignment are present. The tibial and femoral prostheses are well-sized without any apparent signs of loosening. No fractures are noted.

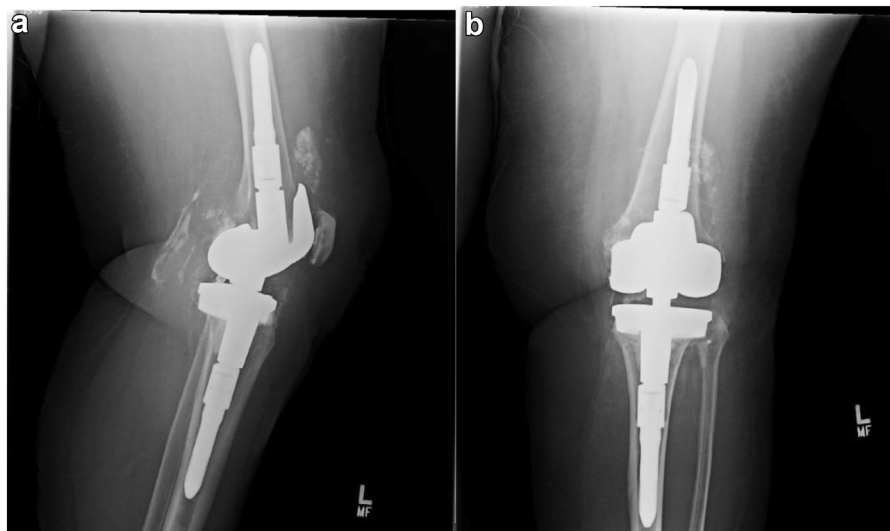
**Figure 3.** (a) Anteroposterior and (b) lateral x-rays of a skeletal mature left knee demonstrate the Smith + Nephew hinged knee prosthesis. Images were obtained at the patient's 5-day postoperative visit and showed a notable reduction in metallosis and heterotopic ossification when compared with previous images. Good bone stock and alignment of femoral and tibial hinged components are noted without signs of loosening.

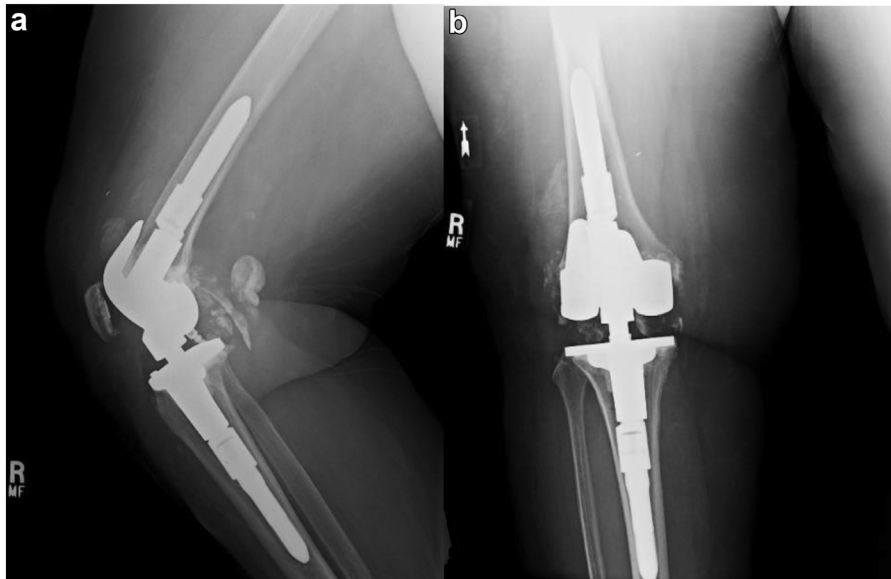
**Figure 4.** (a) Anteroposterior and (b) lateral x-rays of a skeletal mature right knee demonstrate the Smith + Nephew hinged knee prosthesis and a 15-mm polyethylene insert. The images were obtained at the patient's 5-day postoperative visit. Good bone stock and alignment of the femoral and tibial components are noted without signs of loosening.

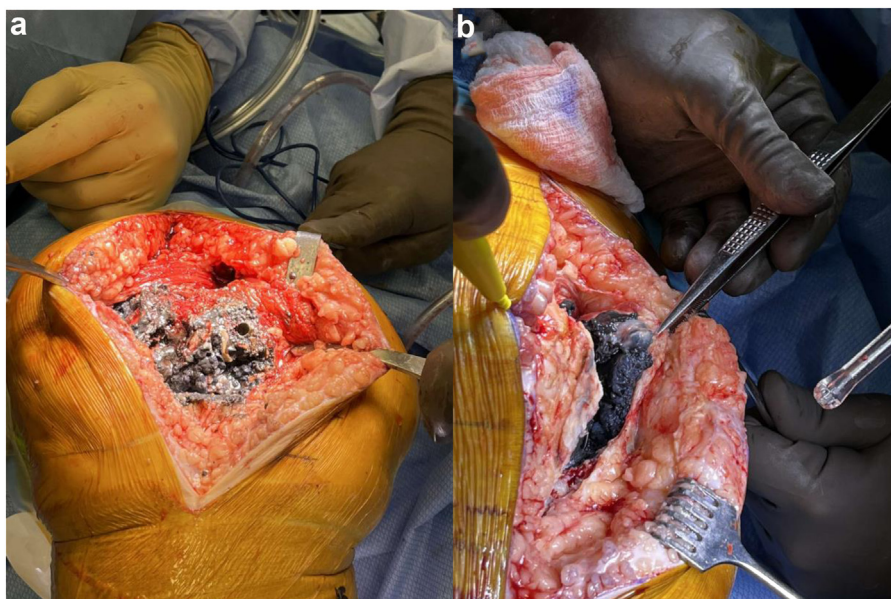
During the right knee arthroscopy, a remarkable amount of metallosis was noted. It extended into the periprosthetic tissues and was excised with care (Fig. 5). No evidence of purulence was noted, and there was no foul odor associated with the black synovial tissue. After the oxinium component was excised (Fig. 6a), a large amount of bone loss was observed in the lateral femoral condyle. The patellar dome appeared intact with no signs of loosening and was subsequently left in place. The index tibial baseplate and polyethylene components were dislodged and removed without complications. Both implants showed severe wear medially (Fig. 6b and c). Smith and Nephew locking hinged components were chosen and fitted for the revision. A size 2 tibial baseplate and a 15-mm polyethylene spacer were utilized for implantation. Before closure, heterotopic ossification was noted in the popliteal recess; however, the risk of damaging the popliteal neurovascular structures was considered too great. Therefore, this was not excised. Final hinged prosthesis placement and closure were unremarkable.

**Figure 5.** Intraoperative images of the right knee demonstrate (a) marked osteolysis and (b) metallosis in the periprosthetic synovial tissue.

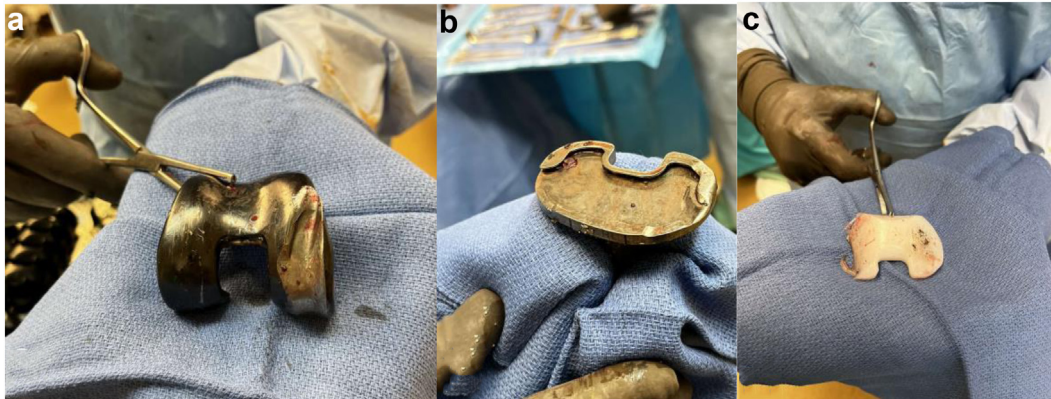
**Figure 6.** Intraoperative images of the removed oxinium implant. (a) Right oxinium femoral prosthesis after being removed during the revision procedure. The prosthetic medial femoral condyle demonstrated erosion of the oxidized zirconium layer that exposed the zirconium alloy substrate. (b) Right tibial baseplate after being removed during the revision procedure. Erosion of the medial tibial plateau indicated metal-on-metal articulation. (c) Right tibial polyethylene component of the prosthesis after being removed during the revision procedure. One-third of the medial aspect showed decimation.

The 5- $\mu$ m oxidized zirconium layer of the oxinium femoral prosthesis component offers exceptional scratch resistance and durability. Unfortunately, it simultaneously has a unique degradation pattern once compromised. The primary mechanism of compromise in this case report is polyethylene wear, which secondarily caused metallosis from metal-on-metal contact between the femoral and tibial components. It is believed that the patient's significant varus knee deformity likely accelerated the wear on her polyethylene insert, causing significant metallosis and further damaging the soft tissue structures surrounding her knee. It is probable that this reaction led to increased pain and joint instability, as the patient explained during her preoperative visit. Unlike previous cases of catastrophic failure with the oxinium prosthesis, the patient of the current case did not report a steep decline of function. Instead, she reported multiple falls over 5 years without a record of radiographs that corresponded with a steady increase in pain. The patient did not report an acute change in function or pain to either knee after each fall, but instead recounted a gradual worsening of symptoms after each subsequent event. Despite these differences in outcomes, we recommend that providers educate patients about the potential complications of the oxidized zirconium femoral knee prosthesis. Patients should also be urged to practice diligence during their rehabilitation and report
