# Durability and Degradation of PVC-P Roofing Membrane—Example of Dynamic Fatigue Testing

Andrej Ivanič and Samo Lubej \*

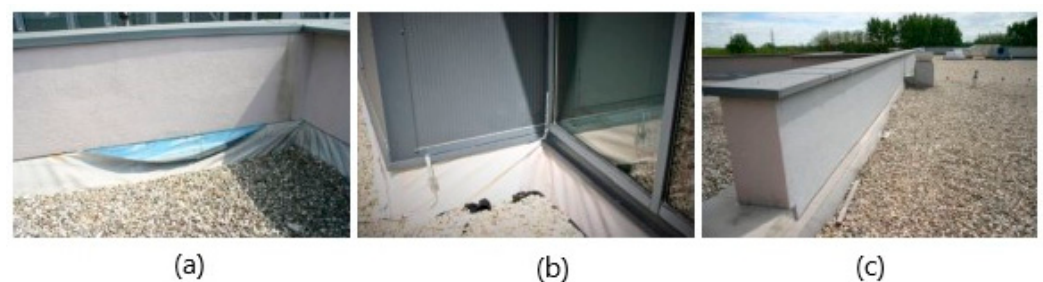
The visual inspection revealed several construction defects resulting from non-compliance with the rules of the roofing and carpentry trade and obvious signs of degradation of the

waterproofing, which is a single-layer synthetic membrane made of PVC-P. The findings of the visual inspection are that the waterproofing is crumpled and stretched. The shrinkage of the waterproofing and the improper execution of the finishing on the roof attic led to damage and consequently to waterlogging. Many leaks are also caused by inadequately executed carpentry finishes.

**Figure 1.** Photos of typical injuries: (a) damage to the detail of the waterproofing finish—tearing out of the finish below the façade attic; (b) the waterproofing wrinkling phenomenon; (c) the waterproofing membrane stretched and no longer vertically terminated at the attic.

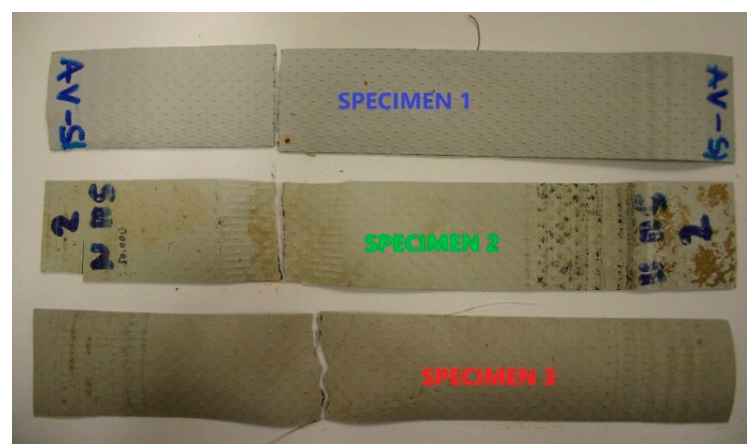
respectively. The values of the specific strains  $\varepsilon_B$  and  $\varepsilon_C$  for the dynamic test of Specimen 2 and 3 are comparable to the average values of the specific strains at maximum force ( $\varepsilon_{Fmax}$ ) and at rupture ( $\varepsilon_{Break}$ ) measured in the static test. Again, the comparison of the specific strains of the Specimens subjected to higher temperature loading shows that the deformation capacity is reduced [20]. The comparison of the breaking forces shows that the breaking force in the dynamic test is reduced rigorously for Specimen 1 compared with the static tensile test. The breaking force for Specimen 1 in the dynamic test is 37.96% lower than the average value of the breaking force in the static test. This value is reduced by 11.08% for Specimen 2 and by 22.51% for Specimen 3. The behaviour of the PVC-P roof membrane Specimens in dynamic tension is not comparable to the results of the static tensile test. For all three Specimens it was observed that the Specimen breaks brittlely after the dynamic tensile test, only Specimen 2 shows a neck-narrowing phenomenon in the fracture area. There is a colour change on Specimens 1 and 2 exposed to UV radiation—see Figure 6.

**Figure 6.** Specimens after dynamic tensile test.

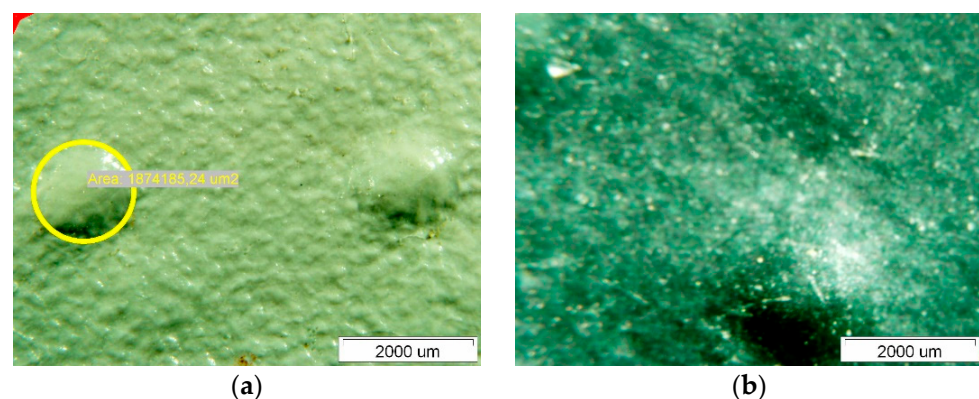
Figure 7 shows the surface of Specimen 1. On both the upper and lower surfaces, we observed degradations which are fistula-like formations. These degradations always occur at the crossing points of the curing phase—the fibres of the polyester mesh. The characteristic area of the degraded site on the upper side exposed to insolation is about  $1,800,000 \mu\text{m}^2$ . The thickness of the Specimen was measured at two characteristic locations along the fibre mesh and in the cross-section of the composite with the polyester mesh fibres—see Figure 8.

**Figure 7.** Surface of Specimen 1: (a) upper side, (b) lower side.

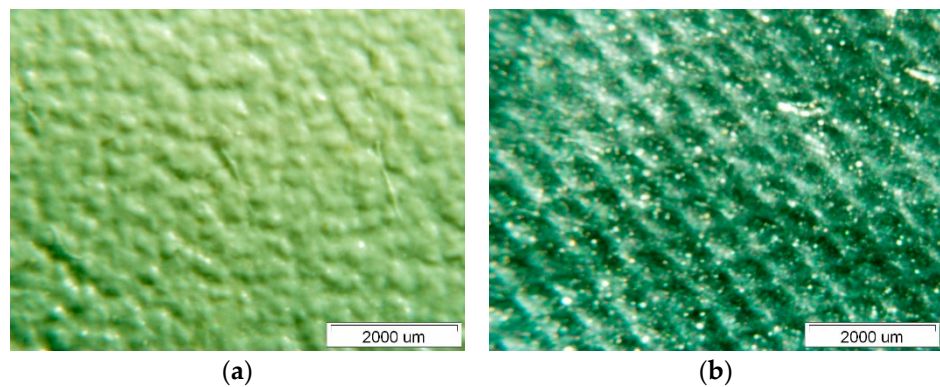
Figure 9 shows the surface of Specimen 2; interestingly, the surface of this Specimen is more diffuse on the upper side than that of Specimen 1. The surface of this Specimen also shows no noticeable degradation similar to the fistula-like formations already mentioned for Specimen 1. The thickness measurement of Specimen 2 is given in Figure 10. It can be seen that the thinning of the thickness of this Specimen is much less than that of Specimen 1, and the variation in thickness at the different measurement points is not noticeable.

**Figure 9.** Surface of Specimen 2: (a) upper side, (b) lower side.

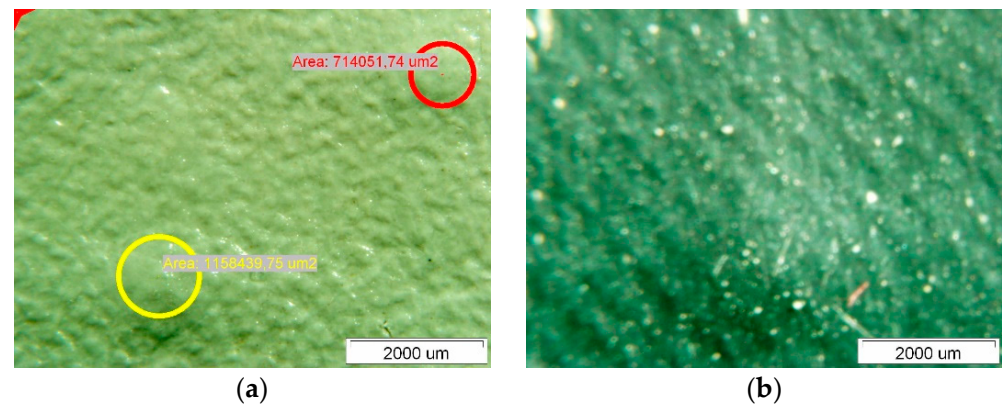
Figure 11 shows the degraded surface of Specimen 3. This surface also shows degradation similar to that of Specimen 1. The spherical degraded areas appearing at the intersections of the polyester mesh filaments are very visible on the upper side, see Figure 11a, while they are barely visible on the lower side, see Figure 11b. The areas of spherical degradation on the upper side of the membrane are different and vary between  $700,000 \mu\text{m}^2$  and  $1,200,000 \mu\text{m}^2$ , they are significantly smaller than those observed for Specimen 1. Additionally, when measuring the thickness of this Specimen, we measured the thinning of the Specimen—the measurements are shown in Figure 12.

Figure 11. Surface of Specimen 3: (a) upper side, (b) lower side.

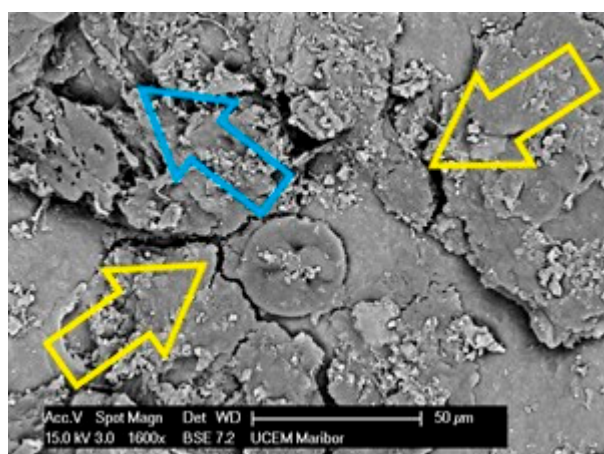
Specimen 1 has a highly degraded surface on the upper surface with many cracks, some areas (yellow arrows) behind the labile with poorly bonded surfaces, and in some places the polyester mesh is no longer covered by the PVC-P (blue arrow) layer. An example of such an area of microstructure is shown in Figure 13.

**Figure 13.** Microstructure of the surface of Specimen 1 at 1600× magnification.

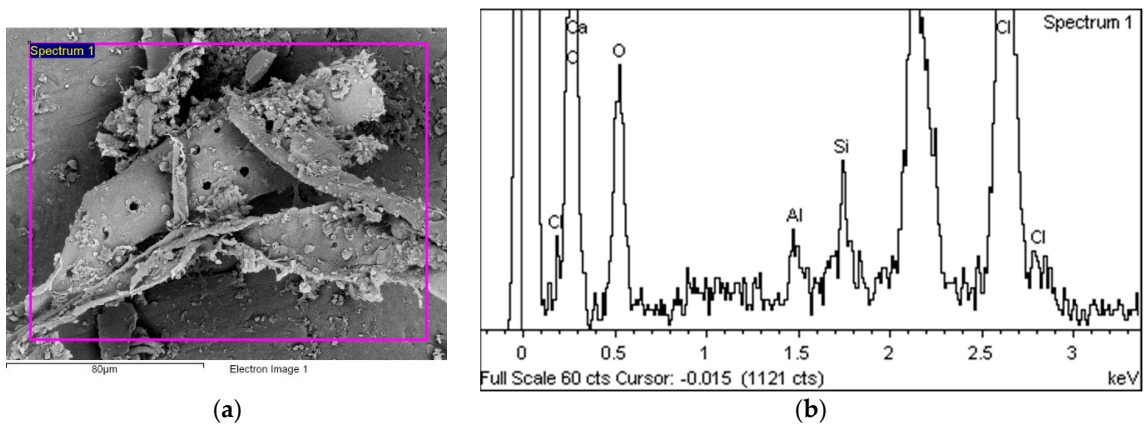
Figure 15a shows an area with a pronounced degradation of the PVC top layer, to the extent that the polyester mesh is no longer completely covered by PVC. The left-hand side (b) shows a typical EDS spectrum of this area. Figure 16 shows the 5 areas where the EDS analysis was carried out. Table 4 summarises the EDS analysis results for Specimen 1.

Figure 15. EDS analysis area (a) and EDS spectrum (b).

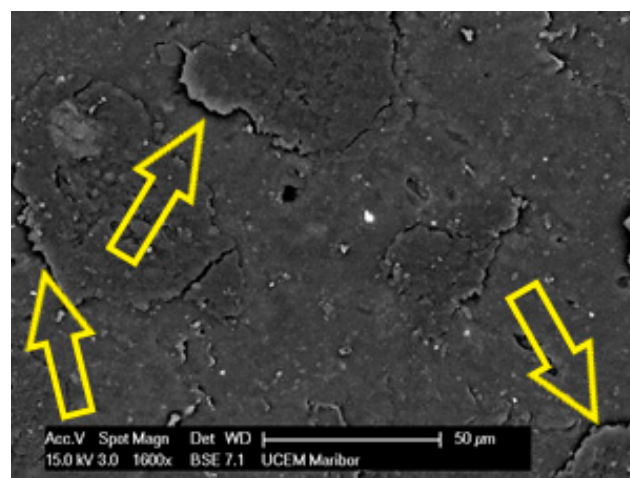
Figure 17 shows the typical microstructure of the upper surface of Specimen 2. Degradation is also evident on this surface, with microcracks (yellow arrows) predominating, but less extensive than Specimen 1.

**Figure 17.** Microstructure of the surface of Specimen 2 at 1600× magnification.

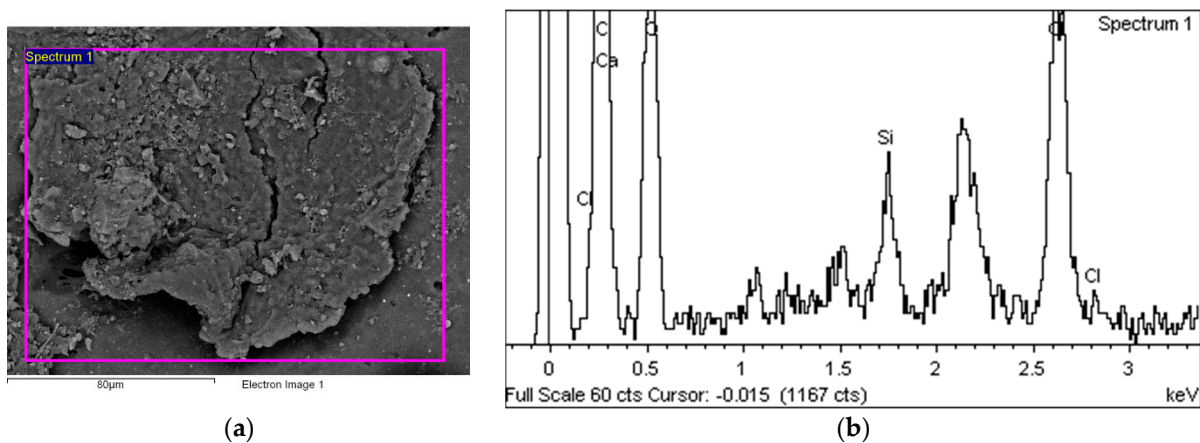
Figure 19a shows a part of the area with a slightly more pronounced degradation in the form of a flake which is almost separated from the base material—the PVC-P matrix. The EDS spectrum for this area is shown on the left (b).

Figure 19. EDS analysis area (a) and EDS spectrum (b).

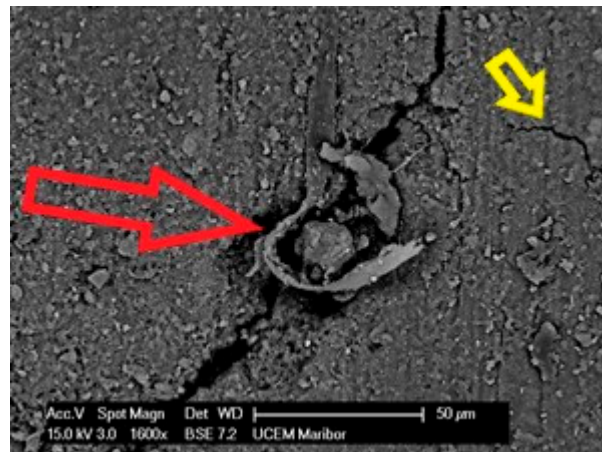
The characteristic microstructure of the upper surface of Specimen 3 is given in Figure 21. This surface is also highly degraded behind many microcracks (yellow arrow) and gaps appearing at the crossing points of the polyester mesh (red arrow). Figures 22 and 23 show such a structure with the area of the EDS spectrum marked (a) and the EDS spectral analysis plot (b). Figure 24 shows the area of the five surfaces on which EDS analysis was performed and Table 6 gives a summary of the spectral analysis results for Specimen 3.

Figure 21. Top surface of Specimen 3 at 1600× magnification.

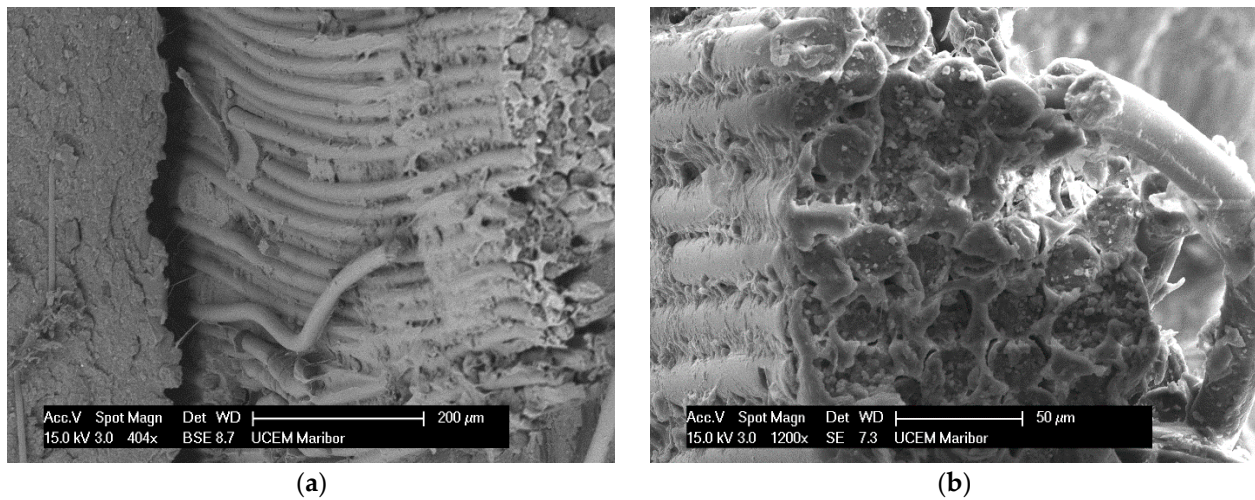
**Figure 31.** The micrograph shows a tough fracture of a composite membrane. The fibres of the cured phase are bonded to the PVC-P matrix (b) and there is a clear slip at the point where the fibres are pulled out of the matrix (a).

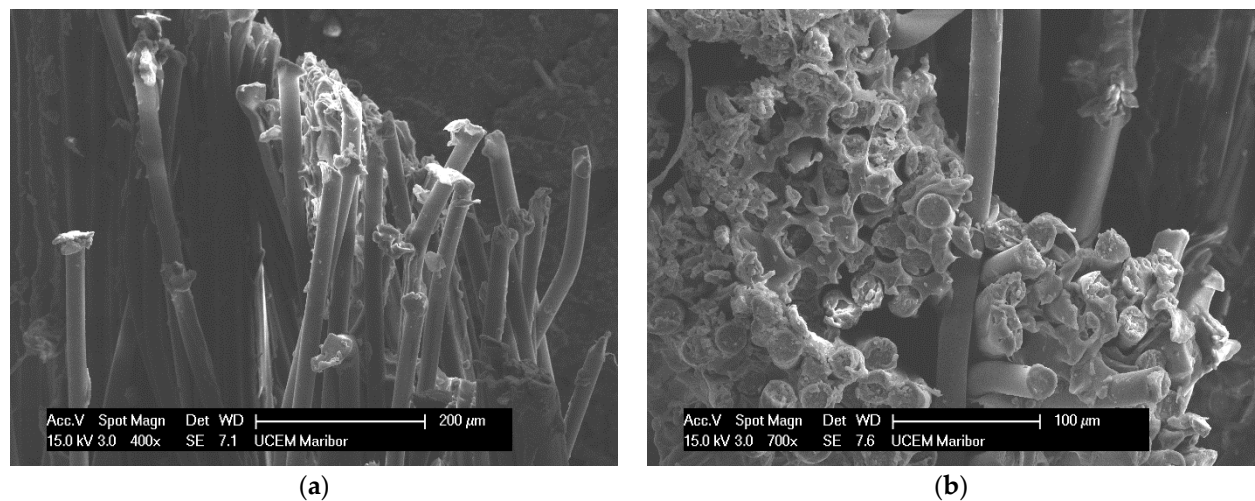
Figure 32 shows the microstructure of the brittle fracture of the composite due to the effect of cyclic tensile loading in Specimen 3. The brittle fracture is due to the degraded polymer matrix, which no longer interacted with the reinforcement—the polyester mesh—during the failure (rupture) phase of the Specimen. The measured value of the specific strain at failure of this Specimen is 29.90% and the breaking force is 1100.19 N.

**Figure 32.** The microphotographs show a brittle fracture of the Specimen 3 without the formation of a neck in tensile test. The fibres have been pulled out of the PVC-P matrix and are no longer connected to each other (a,b).
