New Insights into Osteointegration and Delamination from a Multidisciplinary Investigation of a Failed Hydroxyapatite-Coated Hip Joint Replacement

Abstract: Hydroxyapatite (HA) coatings have become very popular in uncemented total hip arthroplasty (THA). Analysis of retrievals and tissue samples from an HA-coated femoral stem, which failed within 14 months after THA, provides exceptional insights into the failure mechanism, as well as the process of osteointegration of such an implant. **Methods:** Retrievals were photo-documented. Samples were examined by micro-computed tomography, X-ray diffraction (XRD) and embedded in polymethylmethacrylate for histology. **Results:** The coating had partially delaminated. The sandblasted surface of the stem was partially polished by the delaminated HA coating, indicating failure before revision. In the tissue samples, the HA coating was well integrated by newly formed bone trabeculae. No adverse biological reaction was observed. XRD analysis showed that residues of the HA coating were still present and could clearly be differentiated from the surrounding bone. Preferential orientation of the HA crystallites could be identified within the newl

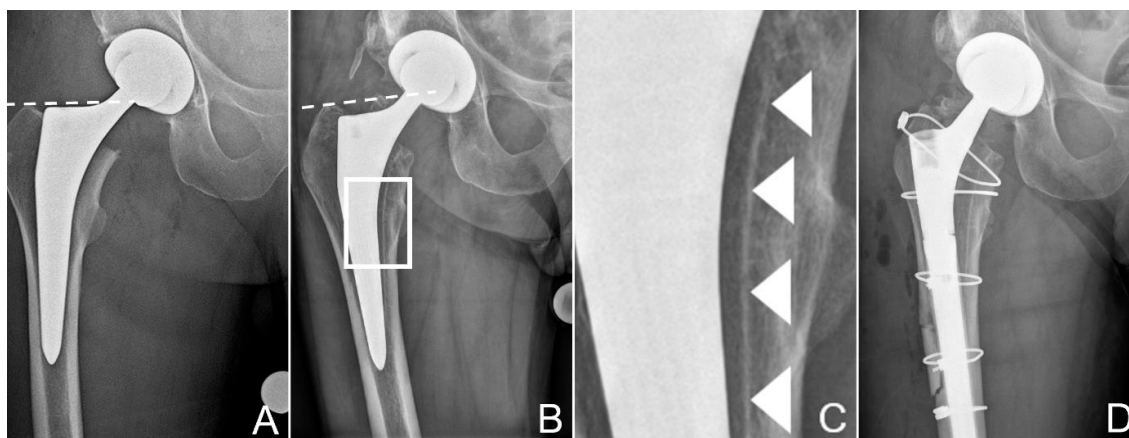
Figure 1. Zone of interest of the anteroposterior radiographies of the pelvis after total hip replacement (A) and after the patient had suffered the periprosthetic fracture of the proximal femur (B). Dashed lines at the tip of the greater trochanter help identify posttraumatic sintering of the stem. Note that the stem was undersized, with more than 1 mm between the stem and the inner cortex. Scale-up of (B), marked by a white rectangle, is provided in (C) to better illustrate the dense line, most likely the hydroxyapatite (HA) coating, separated from the stem, marked by white arrowheads. These tissues could be sampled for further analysis. (D) shows the condition after revision. The osteotomy, which was necessary to retrieve the stem, is visible, as are the cerclage cables used for fixation of the fracture and the osteotomy. Additionally, note the thinner liner in the cup, to accommodate the larger head.

An osteoporotic bone in combination with an undersized stem, due to a subtle varus malalignment at the primary operation (Figure 1), may be seen as contributing factor to the fracture. Once loosened, the stem could act as a pestle, favoring the development of a periprosthetic fracture following a minor trauma. Uncemented THA is known to be associated with an increased risk of periprosthetic fracture, increasing steadily over the long term [25]. Undersizing of the stem might also be considered as a contributing factor to the fracture risk. Then, newly formed cancellous bone has to fill the space between the cortex and the stem, as observed in this case (Figures 1–5), instead of direct contact with cortical bone and integration by the inner side of the bone from the cortex. Osteoporosis primarily affects the metabolically more active cancellous bone, thus creating a supplementary mechanical weakness [26]. A detailed analysis of all available radiographies often provides many useful insights in case of failure of orthopaedic implants.

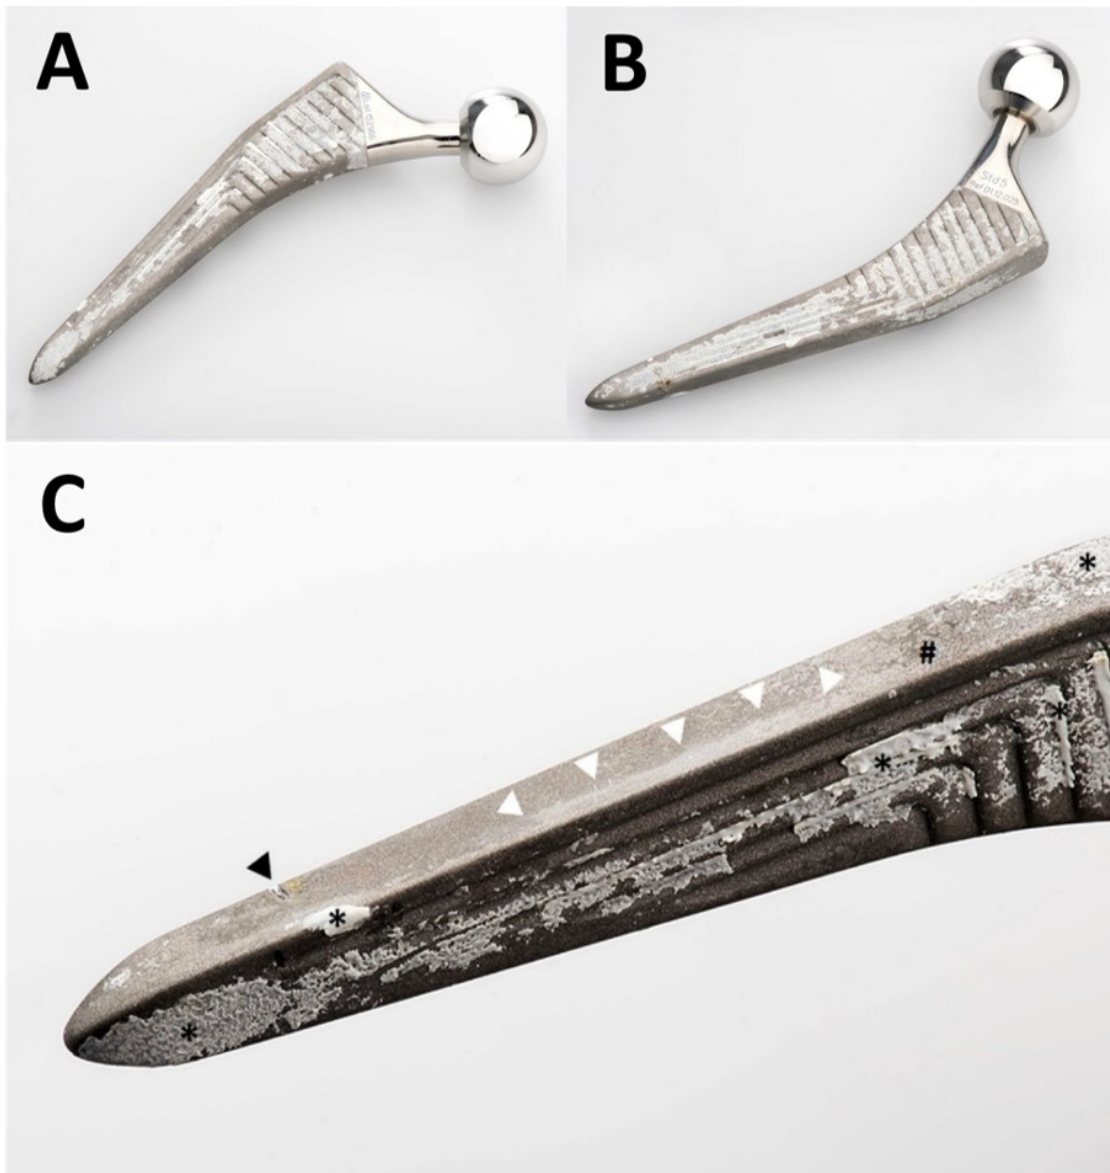
Macroscopic examination of the stem revealed various processes with heterogeneous distribution (Figure 2). Bone had ongrown in small patches on the stem, particularly anteriorly and posteriorly. Nearly no residues of the HA coating could be identified. Zones of partial polishing of the grit-blasted surface of the metal alloy were visible. Optical microscopy of the patches of ongrown bone revealed brittle residues of HA coating left only in these areas, the bone having a cancellous structure (Figure 3). Light reflections on the metal surface hindered obtaining useful microphotographs of the polished areas.

Figure 2. Photographs of the retrieved Quadra-H stem. An overview of the anterior aspect is shown in (A) and of the posterior aspect in (B). A greater magnification of the anterolateral aspect of the distal part of the stem is shown in (C). The femur had already fractured, and the stem could be retrieved without any instrumentation. The transverse nick near the tip (black arrowhead in (C)) was caused by the transverse osteotomy of the transfemoral approach. This was the only damage caused by instruments. Note unevenly distributed patches of ongrown bone on the stem's surface (* in (C)). Only small patches of residues of the HA coating (# in (C)) are visible. The near edge of the stem presents an extensive area of polishing (white arrowheads in (C)) of the grit-blasted surface of the metal alloy.

Proper photodocumentation of the retrieval is a simple and very useful tool. As illustrated in Figure 2, various elements of osteointegration and failure could be identified, and appear to have a heterogeneous distribution along the surface of the implant. Bone had grown onto most of the surface, particularly anteriorly and posteriorly. Virtually no more residues of HA coating were identifiable on the exposed areas without bone. Polishing of some areas of the grit-blasted surface could also be seen. This could not be analyzed further by optical microscopy due to light reflexes on the surface, a commonly known issue in retrieval analysis. As the stem was loose and could be retrieved without any instrumentation, no surgical artifacts interfered with interpretation. Chiseling off any ongrown bone would have left rough isolated marks on the surface of the metal, which were not present, except for the transverse osteotomy of the transfemoral approach (Figure 2) [19,20]. The initially roughened metallic surface of the titanium stem could have been polished only by repeated friction with a harder substance, which solely might be the HA from the coating or from the surrounding bone. This proves instability and fretting preceding the fracture, which required revision.

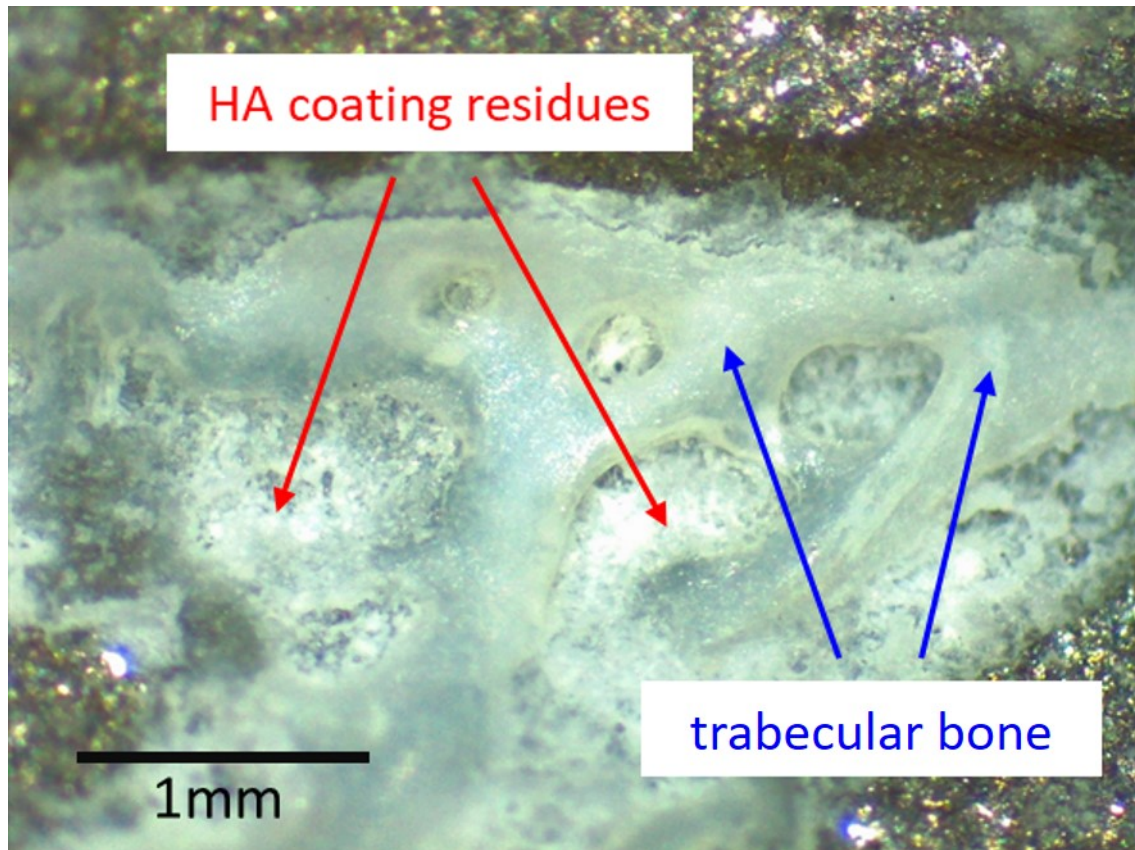
Figure 3. Optical microscopy image of one of the patches of ongrown bone at the surface of the retrieved stem. Light reflexes from the metal surface limit such analysis to areas with limited light reflection. No HA residues could be identified where no bone was present. Where trabecular bone was present, brittle residues of the HA coating could be identified. The same pattern was observable wherever ongrown bone trabeculae were present.

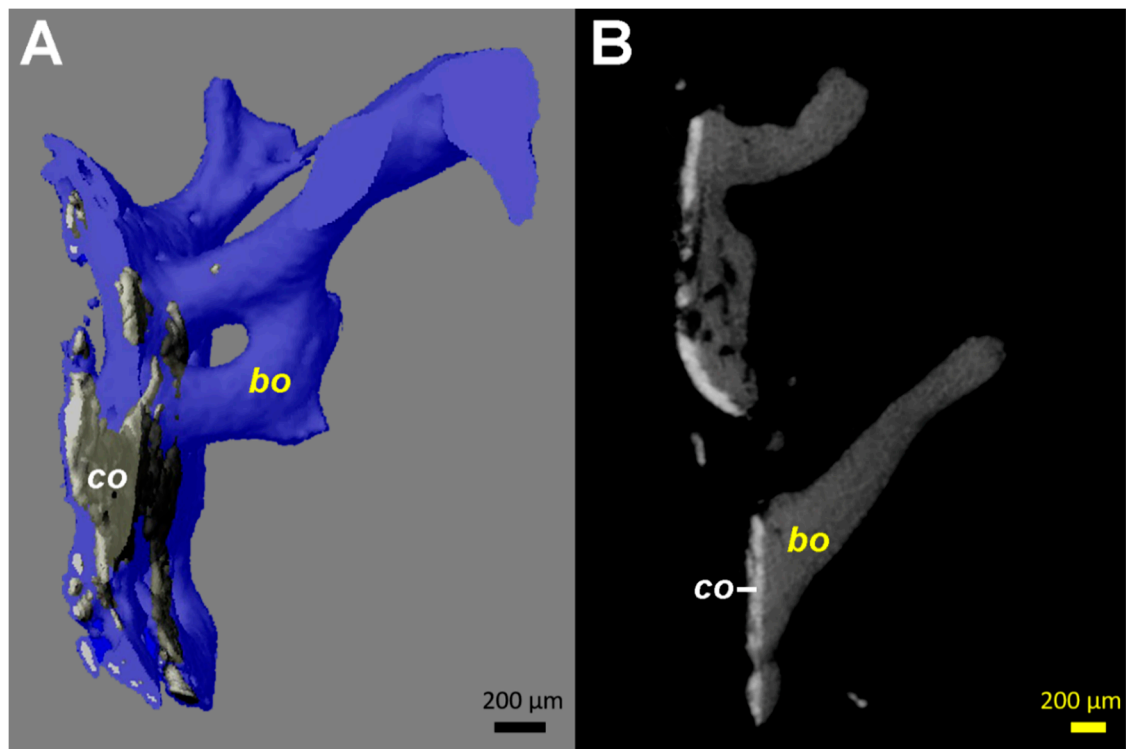
The μ CT reconstructions showed close contact of the radiologically dense layer, corresponding to the HA coating, with bone trabeculae (Figure 4). All coating fragments were oriented in one plane and were 60–100 μm thick. Few dispersed HA particles $<20 \mu\text{m}$ in size were scattered within the tissues adjacent to the layer of coating. No more HA coatings could be identified, within the bone trabeculae or in the depth of the tissue sample.

Figure 4. Computed tomography (μ CT) images from the tissue samples collected at the interface between the stem and the medial cortical bone (area marked by arrowheads in Figure 1C). Identical patterns could be identified on all fragments available, even if the images from only one are illustrated. (A) 3D reconstruction in semi-transparent mode shows the close contact of the coating material (co, colored in grey) with bone (colored in blue). The coating has a higher density (brighter appearance) than bone (bo). (B) 2D transverse reconstruction with section thickness of 10 μ m, showing bone ongrowth on the coating material, without an ingrowth or growth of bone structures through the layer of the coating. All coating fragments were oriented in one plane and were 60–100 μ m thick. Additionally, some small and globular fragments of the HA coating (size <20 μ m) are identifiable.

Undersizing of the stem allowed development of trabecular bone between the cortex and the implant, which was then accessible to sampling. The measurements performed by μ CT (Figure 4) showed a HA coating thickness between 60 and 100 μ m. This corresponds to the 80 μ m of coating thickness specified by the manufacturer of this particular stem model. The variability of our measurements may be explained by the variability of the coating thickness caused by the plasma spray application during manufacture [27], as well as by inaccuracies of the measurement on tissue biopsies by μ CT. While only one image is shown (Figure 4), the same pattern was identifiable on all fragments available for analysis. Thus, it can be derived that no relevant degradation of the HA coating occurred in the areas where bone had ongrown (Figures 3 and 4). However, the HA had dissolved between the bone trabeculae (Figures 3 and 4). This irregular dissolution pattern of HA coatings is also apparent in retrieval studies, even if not explicitly described by the authors [10,11,13,15]. A direct ongrowth of bone on the metal surface of the implant might therefore be impeded by the HA coating. If bone ongrown on the HA coating hinders its dissolution, then the coating represents a foreseeable failure point, as delamination will invariably happen, particularly as the bond of HA with the underlying metal weakens during *in vivo* degradation of the coating [16].

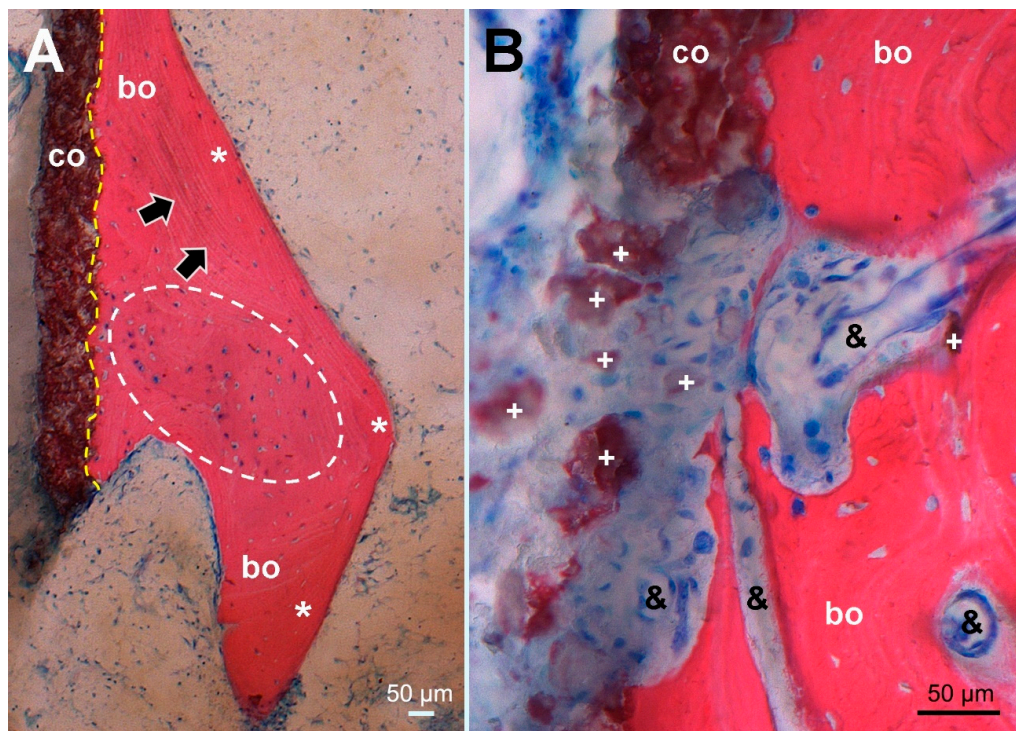
PMMA-embedded histological sections of the undecalcified tissue samples showed an intimate contact of HA coating residues with trabecular bone (Figure 5). Osteocytes present in nearly all osteocyte lacunae confirmed bone vitality. Bone trabeculae showed various stages of maturation, including woven bone, indicating ongrowth of newly formed bone structures. As is characteristic for an elderly patient, the bone marrow contained predominantly fat cells and additionally few isolated dark grayish particles $<20 \mu\text{m}$ in size localized near the HA coating, corresponding visually to residues of the coating. Focal fibrosis and vascular proliferation were also observed. No histiocytic, neutrophilic, or lymphoplasmocytic inflammatory infiltrates were present, and only sporadic multinucleated giant cells could be detected. No residues of hemosiderin (i.e., previous hematoma) were identified.

Figure 5. Histological picture (stained Giemsa–Eosin) of tissue sampled at the site corresponding to the dense line (arrowheads) in Figure 1C, maintaining the same orientation. (A) Overview of the HA coating (co, stained brown) showing firm bonding (dashed yellow line) to ongrown bone (bo, stained red) consisting of mature lamellar bone (*, black arrows marking lamellar orientation) surrounding newly formed woven bone (encircled by a white dashed line). In nearly all osteocyte lacunae, blue stained osteocyte nuclei indicate bone viability. (B) higher magnification of an HA coating defect with dispersed HA fragments (+) surrounded by fibrous scar tissue encompassing proliferated capillaries (&) and extending into resorption lacunae of remodeled woven bone without cellular inflammatory reaction.

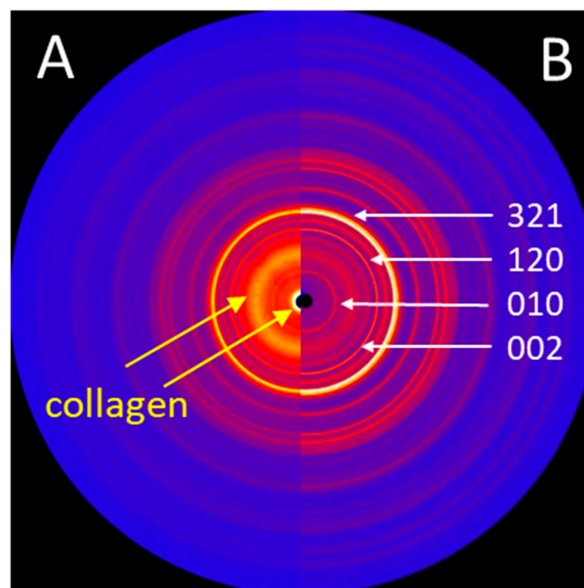
While the surface of a new implant was entirely covered with a white powder-like structure showing larger crystallites, the surface of the retrieved stem showed only residues of white powder-like substance, mostly overlaid by a darker, partially transparent trabecular structure, corresponding to cancellous bone (Figure 3). XRD analysis (Figure 6) confirmed the white crystalline powder as being pure but partially degraded HA, and the darker, more transparent structure as bone ongrown on the implant (Figure 6A). The x-ray pattern obtained from a scratched-off sample of the coating from a new stem showed sharp diffraction peaks, indicating the high crystallinity of the HA, with crystallites > 100 nm (Figure 6B). A low background signal indicated that no additional amorphous material was present. The HA diffraction patterns of the pristine coating and of the brittle residues of white powder on the explanted stem were nearly identical, indicating that the initial coating was still partially present in between and most probably also under the ongrown trabecular bone. The structure of the HA of the ongrown bone trabeculae showed much broader reflections than the HA from the coatings, which is related to its nano-crystalline character. Additionally, the presence of protein residues such as collagen was confirmed by the high background signal and the broad peak between 5° and 10° in 2Theta (Mo-radiation), as well as from the high scattering intensity in the small angle X-ray scattering (SAXS) region (Figure 6A).

Figure 6. (A) 2D X-ray diffraction image (IPDS-II, Mo-radiation) of the trabecular bone structures, showing structural features of both HA and collagen. (B) 2D X-ray diffraction image of the HA powder obtained from the surface of a new stem, showing sharp diffraction peaks. The main diffraction peaks (hkl) of the HA crystallographic phase are indicated.

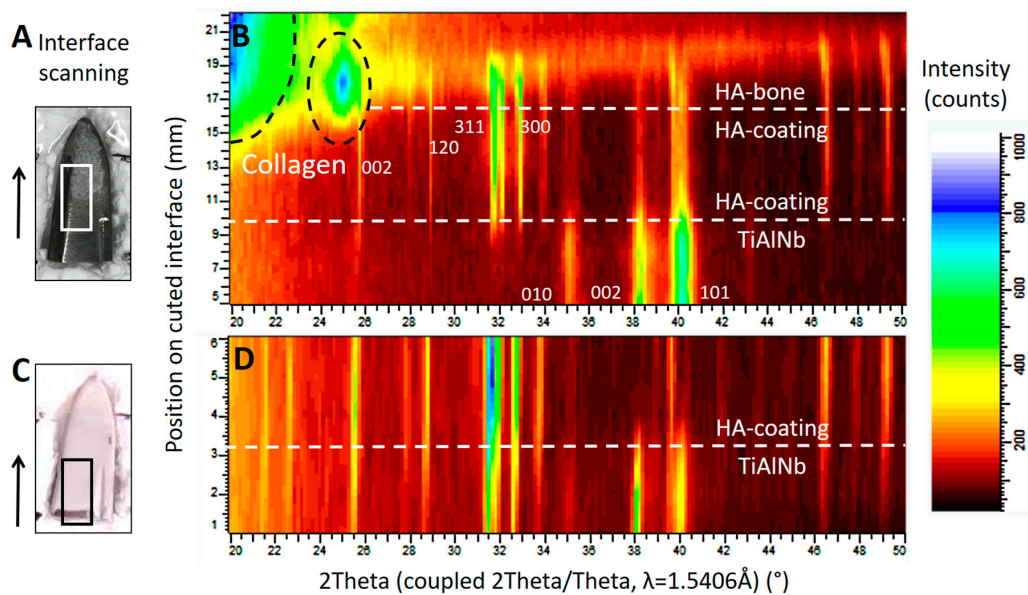
Diffraction patterns illustrated in Figure 7 show the successive transition from the phase of the TiAlNb alloy of the stem (hexagonal, $P6_3/mmc$ with $a = 2.95$ and $c = 4.69 \text{ \AA}$) to the highly crystalline HA coating (HA-coating, hexagonal, $P6_3/m$ with $a = 9.42$ and $c = 6.89 \text{ \AA}$) and finally to the HA of the ongrown bone (HA-bone). While the phase of the HA-coating is identifiable by sharp reflections within the diffraction profile, the HA from the ongrown bone shows wider reflections related to the nano crystalline character of the hydroxyapatite. The crystallite size can be calculated using the Scherrer equation (LIT). The (002) reflection of the hydroxyapatite is used, along with the LaB_6 for the correction of the instrumental broadening. The crystallite size determined for the growing (preferential) direction is 23 nm, and is a bit smaller than the one for human bone-derived HA with 31 nm (LIT). The appearance of a higher background signal and additional broad peaks at lower angles is related to the organic material within the osteoid, such as collagen fibers.

Figure 7. X-ray diffraction studies on the implant surfaces, in (B) the results corresponding to the area marked by a white rectangle from the tip of the retrieved stem in (A), and in (D) the results corresponding to the area marked by a black rectangle from the tip of a new, unused stem in (C). The scan was performed in the area of interest, following the direction marked by the arrow. The corresponding position may be read from the y -axis in (B) and (D). Both diffraction patterns (B) and (D) show the successive change from the TiAlNb of the stems' metal alloy to the HA phase of the coating. The scan progresses horizontally on a slightly oblique cut. In (B), structures from the ongrown bone can be seen on top of the HA coating. (—white) shows the phase change related to the position on the sample, and dashed black lines show the phase information retrieved from the organic material such as collagen. The main diffraction peaks of the TiAlNb and HA crystallographic phases (hkl) are marked by the corresponding hkl values.

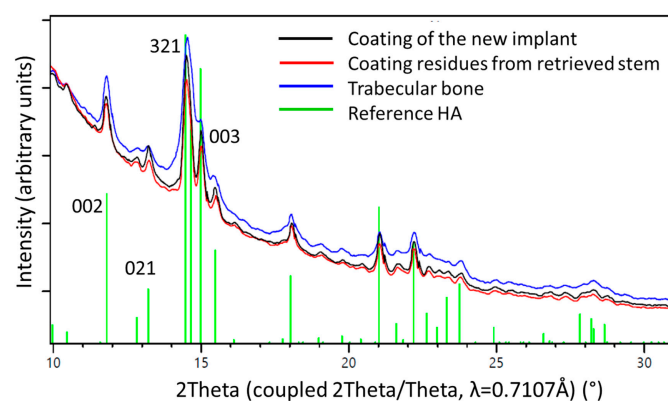
One-dimensional diffraction patterns for all three samples, the powder obtained from the coating of a new implant, as well as samples obtained from the two distinguishable structures on the retrieved stem, the coating residues, and the trabecular bone, as illustrated in Figure 3, were superposed in Figure 8.

Figure 8. 1D diffraction patterns obtained by a 360° integration of the 2D diffraction patterns (Figure 6). The indexing of the HA phase is shown in green. The peaks of the coating material from a pristine stem (black line) are higher and sharper than those from the materials residue recovered from the retrieved stem (red line) where the HA already was altered by biodegradation. The blue line marks results from bone trabeculae chipped of the retrieved stem. The observed peak broadening on the trabecular bone sample could be related to nano-sized crystallites and/or better nano-ordering due to strain probably formed during the growth process. Note the higher background signal from the bone sample, due to amorphous materials and proteins present within the tissue.

Analysis of the HA coating from a new stem with XRD showed a highly crystalline form of HA, with no additional amorphous phases being present at the interface between the metal surface and the coating. No alteration of the coating material occurred during manufacture. This was also true for the retrieved stem (Figure 7). When analysing the material chipped off the retrieved stem, additional smaller crystallites were visible, indicating degradation *in vivo*. Their derivation from the HA of the coating could be proven using XRD (Figure 8).

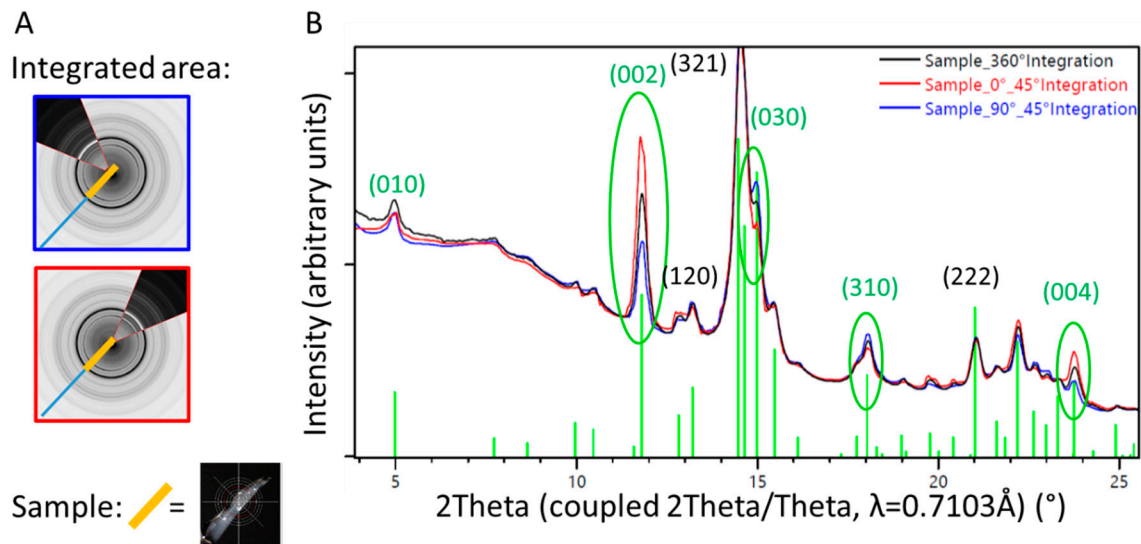
A piece of trabecular bone sampled from the surface of the retrieved stem was analyzed at various angles, without rotation during measurement. Different sectors of the diffraction image were integrated and resulted in one-dimensional diffraction patterns showing different intensity distributions (Figure 9). Preferred orientation was found for the (001) crystallographic direction (see the change in intensities of the reflections (002) and (004) in Figure 9), which can directly be related to directional or preferential orientation of the HA within the newly formed bone.

Figure 9. 1D diffraction pattern of a sample of trabecular bone from the surface of the retrieved stem. Diffraction patterns from specific sectors (blue and red lines, corresponding to the orientation of the detector illustrated on the left) are compared with results from the 360° integration (black line). The orientation of the HA within the ongrown bone is directional, which can be visualized by different intensity profiles in dependence of the direction of investigation, differing from the random orientation observed in the 360° integration (black line). (A) Illustration of the partial integration of the 2D X-ray diffraction profile, blue perpendicular to the sample orientation, and red parallel to the sample orientation. (B) 1D diffraction profile superposed for the 360° (black) and 45° integration of the sectors illustrated in (A).

We were able to show a preferential orientation of the HA crystallites within the newly formed bone on the implants surface (Figure 9), indicating a directional growth pattern of the trabecular bone. This might be due to physiologic strains on the implant, but might also be induced by the coating. Preferential orientation of the crystalline structure of the ongrown bone, however, represents a supplementary mechanical weakness to shear forces. This represents an additional potential failure point and a potential explanation for the concomitant presence of ongrown bone as well as polished areas (Figure 2). Preferential orientation of the surrounding bone trabeculae along a well-integrated stem also had been noticed in another retrieval study, but was not interpreted in detail [28]. In this case, suboptimal orientation of an undersized stem may, however, have contributed to this feature.
