Case Report

Fracture of a Femoral Revision Stem following a Technical Failure

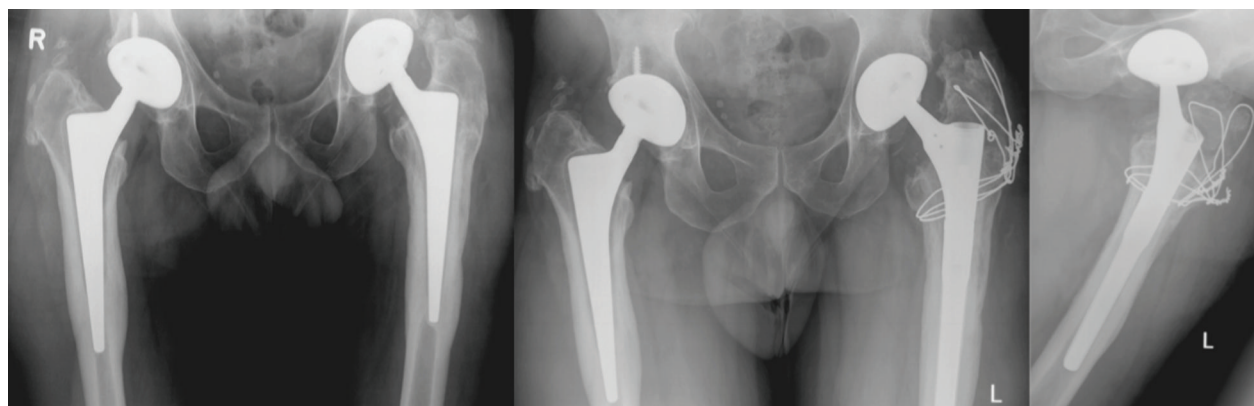
In March 2008, a primary total hip replacement was revised for loosening of the femoral stem in a 48-year-old carpenter (Figure 1). The old lateral incision with an

approach including an osteotomy of the greater trochanter was used. A Zimmer Revitan stem (distal part: diameter 14 mm, length 140 mm; proximal part: length 75 mm, conical, taper 12/14; head BioloX diameter 28 mm). The osteotomy was fixed with cerclage wires intraoperatively. The definite distal part was implanted first and tested with a trial proximal part. Then, the surgeon experienced difficulties with the connection of the definite proximal part of the stem to the definite distal part. Although it fitted, the screw to fix the two parts together could not be tightened. The surgeon even contacted the company during the operation but failed to find an explanation for the problem. As the 2 parts seemed to be fixed well together, he left the situation as it was. The postoperative radiographs (Figure 1) were acceptable, and no explanation for the intraoperative problem was found. The patient did well, and there were no complications.

FIGURE 1: Radiograph a.p. view with loosening of the left femoral stem, radiograph a.p. and axial view of first revision.

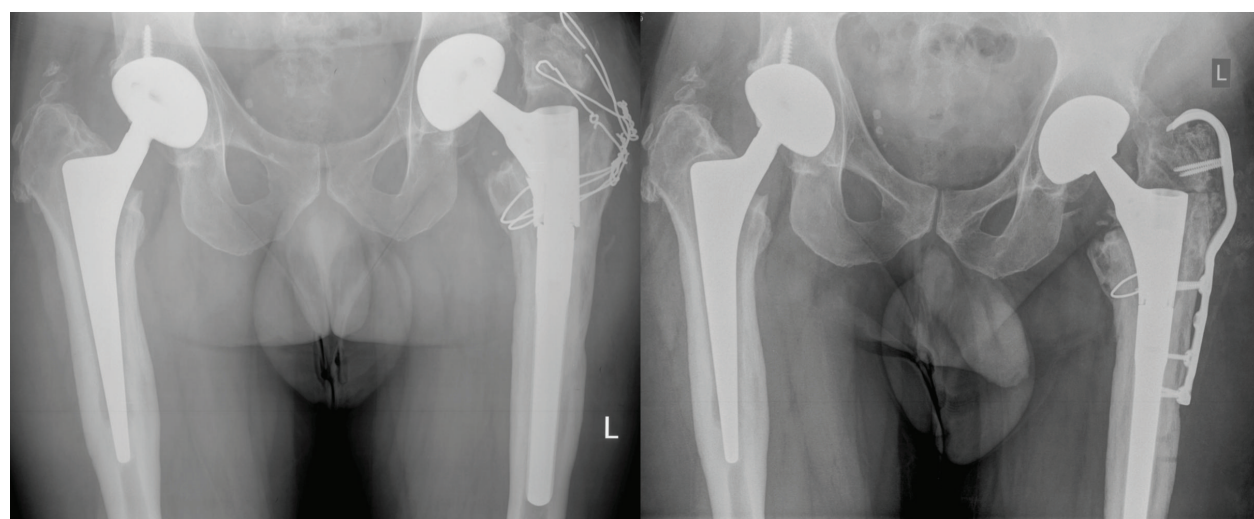
Two and a half years postoperatively, the patient felt a sudden pain while walking. He could only limp and hardly walk. He walked on without consulting a doctor for another 2 months, where after he presented to us. On the radiographs, a fracture in between the 2 modular parts of the stem was seen (Figure 2).

A rerevision was performed using the same approach and through the nonunion of the greater trochanter. Intraoperatively, the proximal part of the stem was found

FIGURE 2: Radiograph a.p. view with broken stem and radiograph a.p. view of the second revision.

broken on the medial side. The distal part was well fixed, and there seemed to be no need to change this part. Even the threaded part of the distal stem was intact. However, connection of a new proximal part to the distal part failed, as during the first revision. On further inspection, a small ring was suddenly born from the distal part. It was then discovered to be a part of the proximal trial part (Figure 3). Thereafter, connecting the two parts was easy. The nonunion of the trochanter was debrided and fixed with a hooked plate (proximal conical spout Revitan 75 mm, Biolox Delta Ceramic femoral head 28 mm medium, Trofix Trochanter Fixation plate large head 150 mm) (Figure 2).

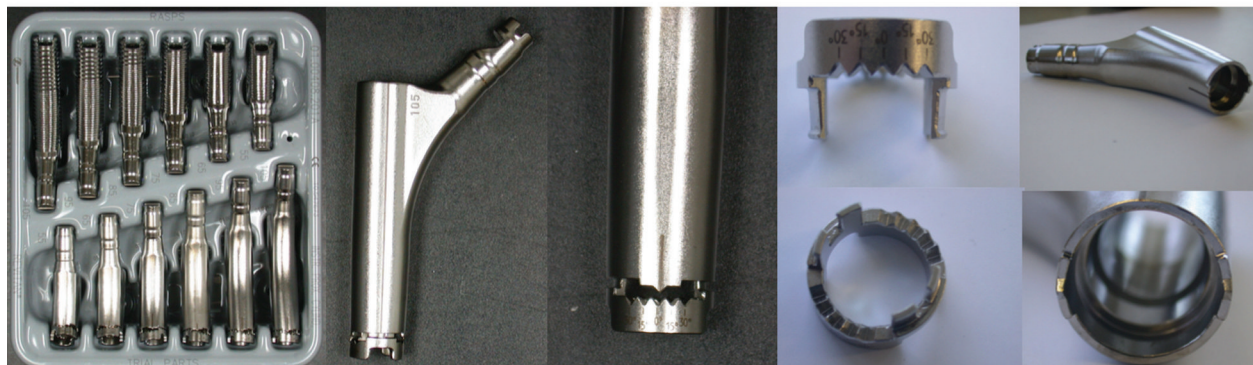
modular shaft, which provides the surgeon many options for restoring leg length, hip offset, and femoral anteversion and therefore good stability [5]. In general, and also with this stem, it is thought that the advantages of the modularity of the stem outweigh its susceptibility to corrosion, fretting, and fatigue fracture [1–4]. Several reports have been published about fractures of a modular femoral stem. Nearly always, the fracture is seen in the middle of the two parts of the stem [1, 2]. Although failure may be due to the morphological construction of the stem, nonunion of the proximal part of the femur to the proximal part of the stem is thought to be responsible for failure [4]. This is the first report of a fracture of the proximal part of the uncemented Zimmer Revitan revision stem caused by unrecognized loosening of the distal ring of the proximal trial part, which results in a stem fracture and disassociation (Figure 3).

In our patient, the fracture did not occur in between the two parts. There was a fracture of the proximal part of the stem following disassociation of the two parts that were never fixed together well. We were lucky to be able to use the distal part of the stem again, as it was still well fixed to the bone. It

FIGURE 3: Description of the manufacturer's operation manual [5]; small ring, part of the proximal part of the trial stem.

seems to us that this complication is due to the design of the trial prosthesis, although of course the surgeon is always responsible for proper handling of the instruments and trial implants. However, we call into question the necessity this ring on the proximal part, this particular trial part. One should always be sure that this ring is removed before assembling the complete prosthesis in vivo.
