## Reduction of downtime and improvement of the utility of a conventional radiotherapy simulator

The modifications made to a radiotherapy simulator that improve its functionality and minimize its downtime are described. Functionality was enhanced with some simple effective improvements. Decreasing the frequency and time spent on repairs reduced downtime. These “in-house” improvements were made to a Varian Ximatron simulator at the Tom Baker Cancer Center. Now there is easier access to the field light and optical distance indicator (ODI). Projections of the field light and ODI are much brighter and ODI adjustment is more reproducible. A crosshair was etched onto the clear x-ray exit window to optically overlap with the crosshair of the reticule. Now, the time required to replace a field light is up to seven times faster and the time to realign a reticule is reduced to the order of three times faster. Only one quality control (QC) check is required after these adjustments. Removal of excess heat within the gantry head has eliminated two major problems: (A) the metal rod supporting the mirror assembly for the field light no longer expands and contracts causing a misalignment of the f

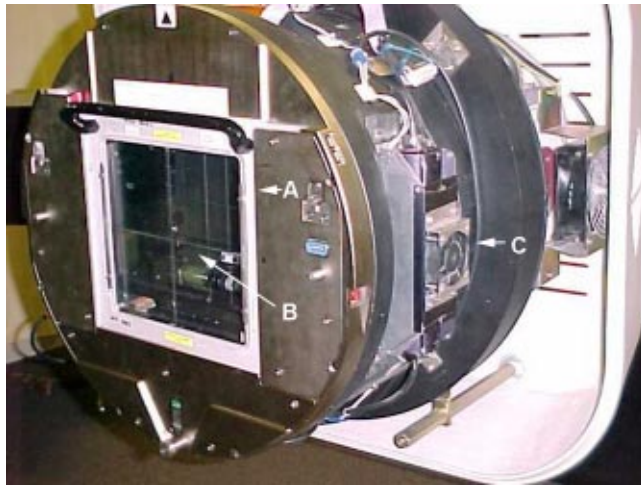
FIG. 1. (Color) Simulator gantry head with covers removed. A, reticule; B, exit window, and C, modified field light/ODI/cooling fan assembly.

The addition of the optical crosshair markings on the previously clear acrylic exit window facilitates an effective starting point for realignment and replacement of the reticule. The reticule crosshair is aligned optically with the projection from the acrylic window crosshair. Then centering of the crosshair is tested optically followed by a fluoroscopic test to verify that the optical and fluoroscopic crosshair images match.<sup>3</sup> Now only one attempt for the proper positioning of the reticule crosshair suffices. Previously this was often a multi-iterative approach between optical alignment and fluoroscopic alignment. Now after optical alignment the QC becomes simply a fluoroscopic check of the radio-opaque reticule position to verify that the x-ray center coincides with the optical center and the collimator axis of rotation.

The ODI mechanism for alignment was controlled from a single screw or pivot (Varian Oncology Systems. "Clinac 2100C/D." Systems Manual. Section "Technical Support Documents." Apr. 1990. Lamp Removal and Replacement.) It was modified to allow movements using two independently placed screws. This allows a push-pull dynamic facilitating more reproducible movements for alignment. Figure 2 shows the new bracket and locking nut added for stability. The cooling fan near the ODI assembly would only run when the ODI light was switched on. It has been adjusted to run continuously. The clear acrylic exit window (Fig. 1) has been etched with a

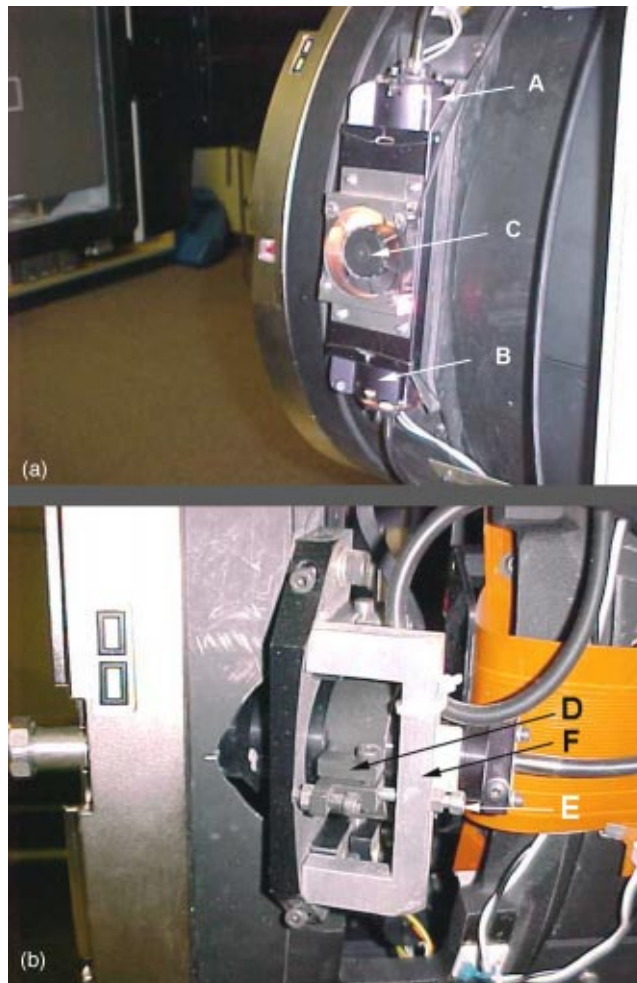
FIG. 2. (Color) Side of simulator gantry head with covers removed. (a) A, ODI, B, Field Light, C, cooling fan, (b) D, ODI assembly, E, ODI locking bracket, F, ODI clamp.

TM59610000 Issue 9. Sept. 1995. Collimator: Collimator Assembly. Drawing No. TM56088000) with the ODI and the cooling fan that is shown in Fig. 2. The fiber optic cable simply attaches to the housing with a clamping mechanism.

Any positioning adjustment of the ODI can now be done in a reproducible manner with the new dual screw push-pull mechanism. A large increase in efficiency is realized over that of the previous single screw trial and error mechanism.

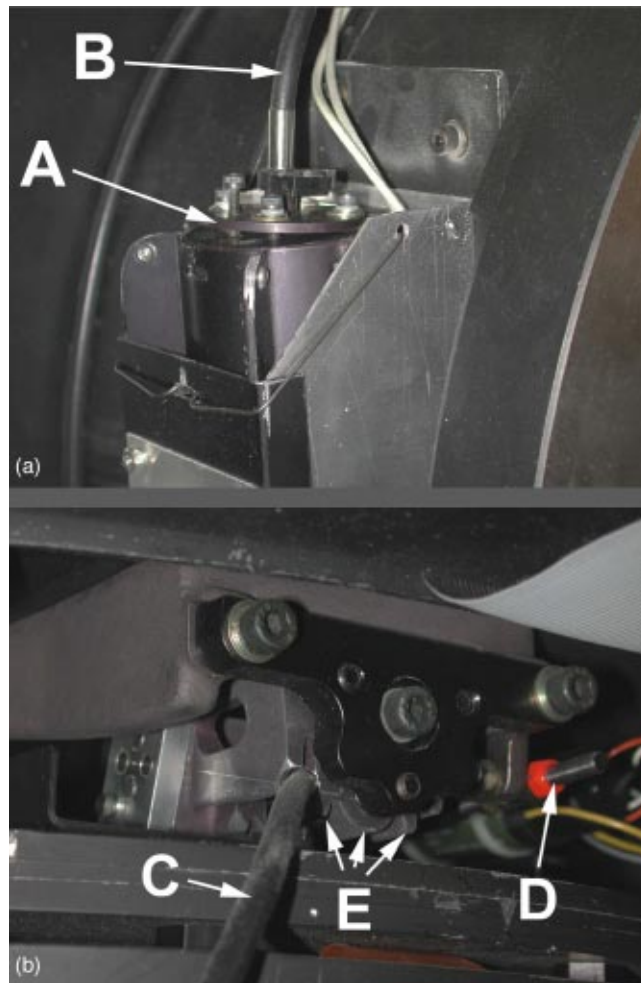
FIG. 3. (Color) Lamp assembly showing (a) A tilt mechanism and B fiber optic, (b) C fiber optic cable for field light, and D mirror supporting rod, and E metal cooling fins.

(see Fig. 3) that supports the mirror, making it move out of position. This in turn caused the projection of the crosshair to deviate from the collimator rotation axis. Thus, the field light could not be adjusted properly until the rod had cooled putting the mirror back into its original position. Using the previous design and waiting extra time for the rod to cool, which could take up to 30 min during an already lengthy and inconvenient field light adjustment process could increase frustration dramatically. Placing the field light in the same housing as the ODI and the cooling fan and keeping the fan running continuously allow immediate convection of the heat and total elimination of this problem. Removal of this heat has also increased the lifetime of the cooling fan since the bearing no longer fails prematurely.

A special tilting mechanism was added to the fiber optic inputs for the field light and ODI (Varian Medical Systems. "Ximatron C-Series." Product Manual. Section 10: Drawings and Diagrams. TM59610000 Issue 9. Sept. 1995. ODI Set-Up. Drawing No. TM55441000) shown in Fig. 3. The respective bulbs can now be fixed into a more optimal optical position. Special calibration procedures were not required following these modifications other than radiation/field light coincidence and cross-hair position checks.

The tilting mechanism for the field light and ODI is a very simple but significant improvement. This feature locks the corresponding light bulb into a position eliminating the fiber optic input falling on the optical shadow created by the apex of the bulb. A significant increase in brightness is achieved for both systems.
