Images in Cardiovascular Disease

Spontaneous Prosthesis Leaflet Detachment and Loss During Aortic Valve Implantation

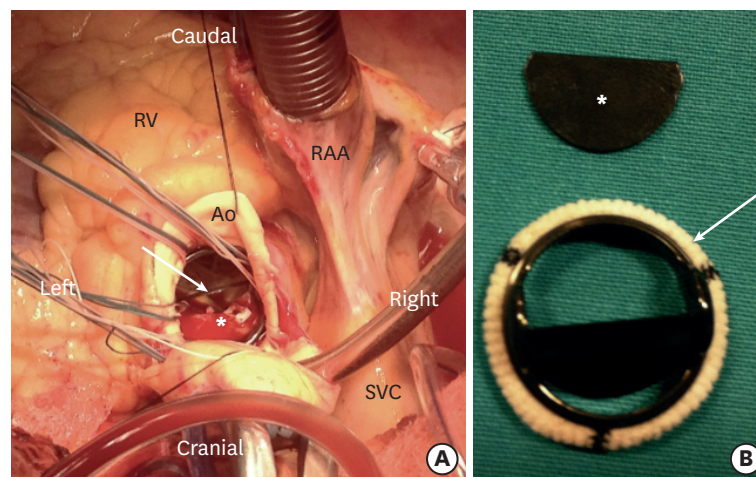
A 68-year-old patient with severe aortic valve stenosis underwent valve replacement. Intraoperatively, a 19 mm St. Jude Regent (St. Jude Medical, Minneapolis, MN, USA) mechanical valve was lowered at the aortic annulus following pledgeted stitches. Before the surgeon tied the knots of each stitch and during examination of proper positioning of the valve while gently lifting the leaflets with the tester, one leaflet detached from the pivoting system and was lost through the aortic root (**Figure 1A**).

Figure 1. (A) Surgeon's view with the mechanical valve in place, lacking one leaflet (white asterisk). Orientation annotated in image (cranial, caudal, left, right). White arrow marks the one attached leaflet. (B) Explanted mechanical valve with retrieved leaflet (asterisk). Arrow points at the suture ring of the mechanical valve. RV: right ventricle, RAA: right atrial appendage, Ao: aorta, SVC: superior vena cava.

Meticulous inspection of the explanted prosthesis and leaflet did not reveal fracture of the strut or pivoting system, and no problem was identified regarding the hinge space in the housing of the valve (**Figure 1B**). The dysfunctional prosthesis was sent back to the manufacturer, who provided oral confirmation that they could not find a manufacturing default or proof of potential misuse.

The surgical procedure was accomplished after implantation of a new 19 mm mechanical valve (same type). TOE confirmed a good surgical result. The patient had an uneventful postoperative course.
