## Case report

## Corrosion and adverse local tissue reaction after total hip arthroplasty with a modular titanium alloy femoral neck

Colin D. Canham, MD, Pavel I. Muradov, MD, Jordan B. Simpson, MD, Stephen J. Incavo, MD\*

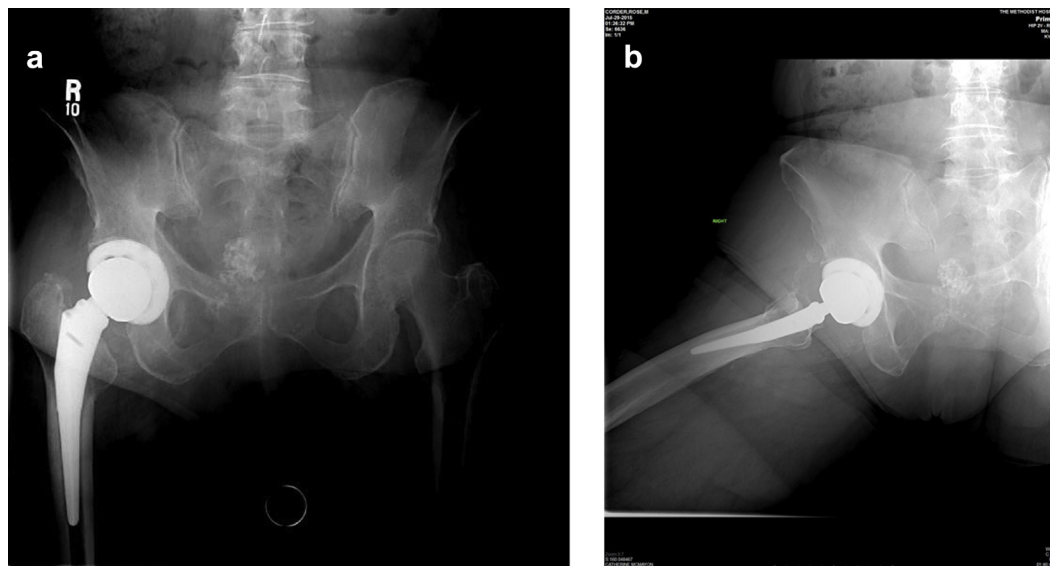
**Figure 1.** Anteroposterior (AP) pelvis (a) and lateral right hip (b) radiographs demonstrating a well-positioned right total hip arthroplasty with a bi-modular stem and a metal-on-polyethylene articulation.

The radiographs showed well-positioned implants without significant osteolysis (Fig. 1). A metal artifact reduction sequence magnetic resonance imaging scan at the time of workup revealed a characteristic periprosthetic pseudotumor formation consistent with ALTR (Fig. 2).

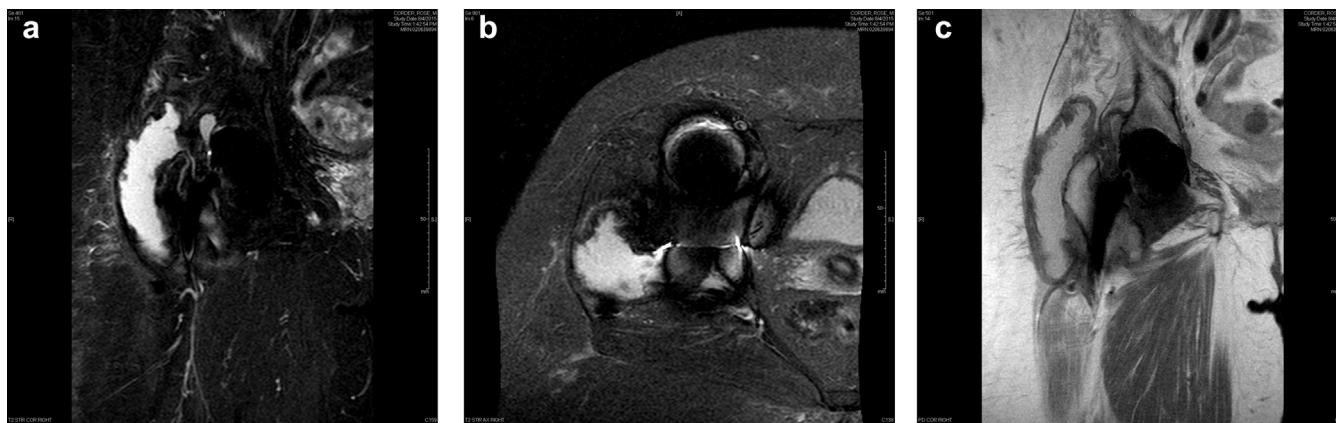
**Figure 2.** Coronal T2 (a), axial T2 (b), and coronal T1-weighted (c) metal artifact reduction sequence magnetic resonance imaging demonstrating a periarticular fluid-filled cyst consistent with a pseudotumor.

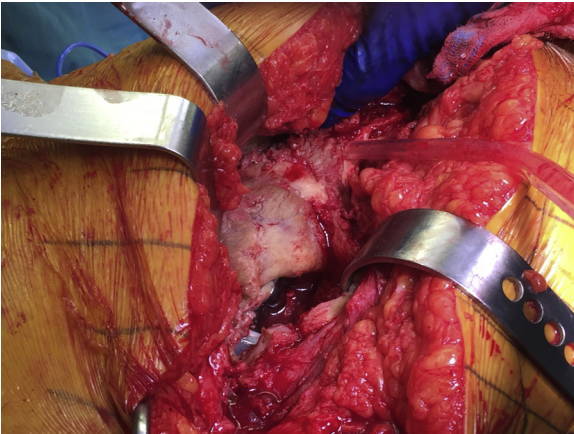
At the time of revision, the fascia was opened and a pressurized cavity that communicated with the joint was encountered. The large cyst contained a chalky fluid, consistent with ALTR. The abductor musculotendinous insertion was necrotic and only the anterior one-third of the fibers remained intact (Fig. 3). After

**Figure 3.** Intraoperative image of the large cyst containing a chalky fluid, consistent with a pseudotumor.

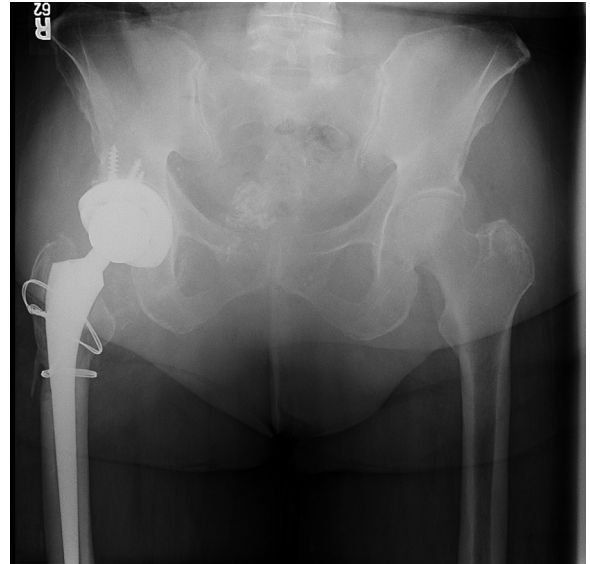
demonstrated stable position of components with healing of the extended trochanteric osteotomy (Fig. 5).

**Figure 5.** Follow-up anteroposterior pelvis radiograph of the patient's 10-month status after revision surgery.

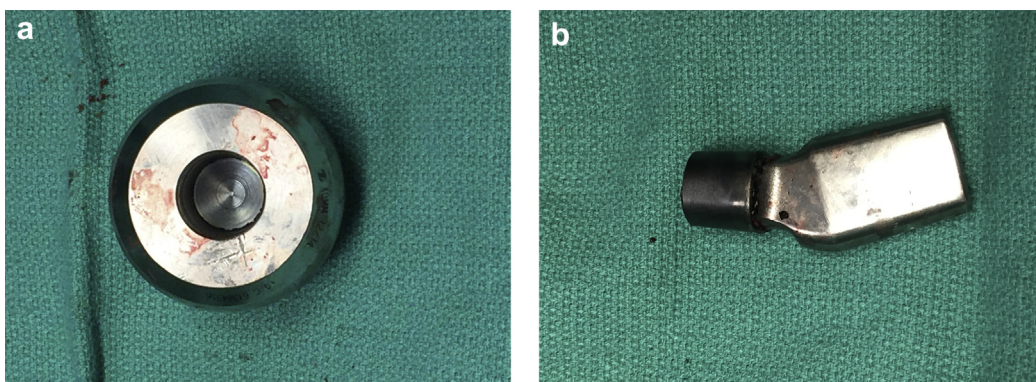
dislocation and head removal, inspection of the trunnion demonstrated severe damage and circumferential corrosion involving the head and trunnion. This was in contrast to the seemingly pristine neck-stem junction (Fig. 4). In order to minimize the risk of future implant-related complications, the decision was made to remove the femoral stem and replace it with a monolithic stem. Therefore, an extended trochanteric osteotomy was performed and the femoral component was revised to a nonmodular cementless Biomet Mallory-Head stem (Zimmer Biomet, Inc.). Due to the degree of abductor muscle destruction, the decision was made to use a constrained liner. The cup was gently tapped with a mallet and tamp to assess its stability and noted to be loose. Therefore, it was revised to a cementless Biomet G7 revision shell (Zimmer Biomet, Inc.) and fixed with multiple screws and a constrained liner was inserted. A one-piece ceramic head was used to minimize the risk of recurrent MACC at the head-neck junction.

**Figure 4.** Photographs of the retrieved modular head (a) and neck with a black staining at the trunnion (b) consistent with corrosion.

We chose to remove the entire stem in this patient in order to replace it with a monolithic stem that would not have the potential for further complications related to the modular neck-stem junction. A simpler option in this patient's case would have been to replace the cobalt chrome head with a ceramic head and place a new modular titanium neck. This would likely eliminate the problem of MACC at the head-neck junction, but the modular neck-stem junction would remain as a potential site of failure. Even though the Zimmer Kinectiv modular necks have not had the degree of problems other bi-modular stems have had, given reports of neck fracture with this implant and its uncertain long-term performance, we chose to revise it in favor of a monolithic stem in order to minimize the risk of future complications in this patient who had already suffered considerable morbidity from a failed implant. A third option would be to retain the modular neck, clean it thoroughly, and place a revision ceramic head with a titanium sleeve on it. Given that replacement modular necks exist for the Kinectiv implant, retaining the neck in our case is likely ill-advised, but it would be an option in a case where no replacement neck is available.
