Case Report

Dramatic Failure of an OXINIUM Total Knee Arthroplasty With a Massive Pseudotumor Formation

Marius Ludwig, MD*, Martin Faschingbauer, MD, Heiko Reichel, MD, Tobias Freitag, MD

Orthopaedic Department, University of Ulm, Ulm, Germany

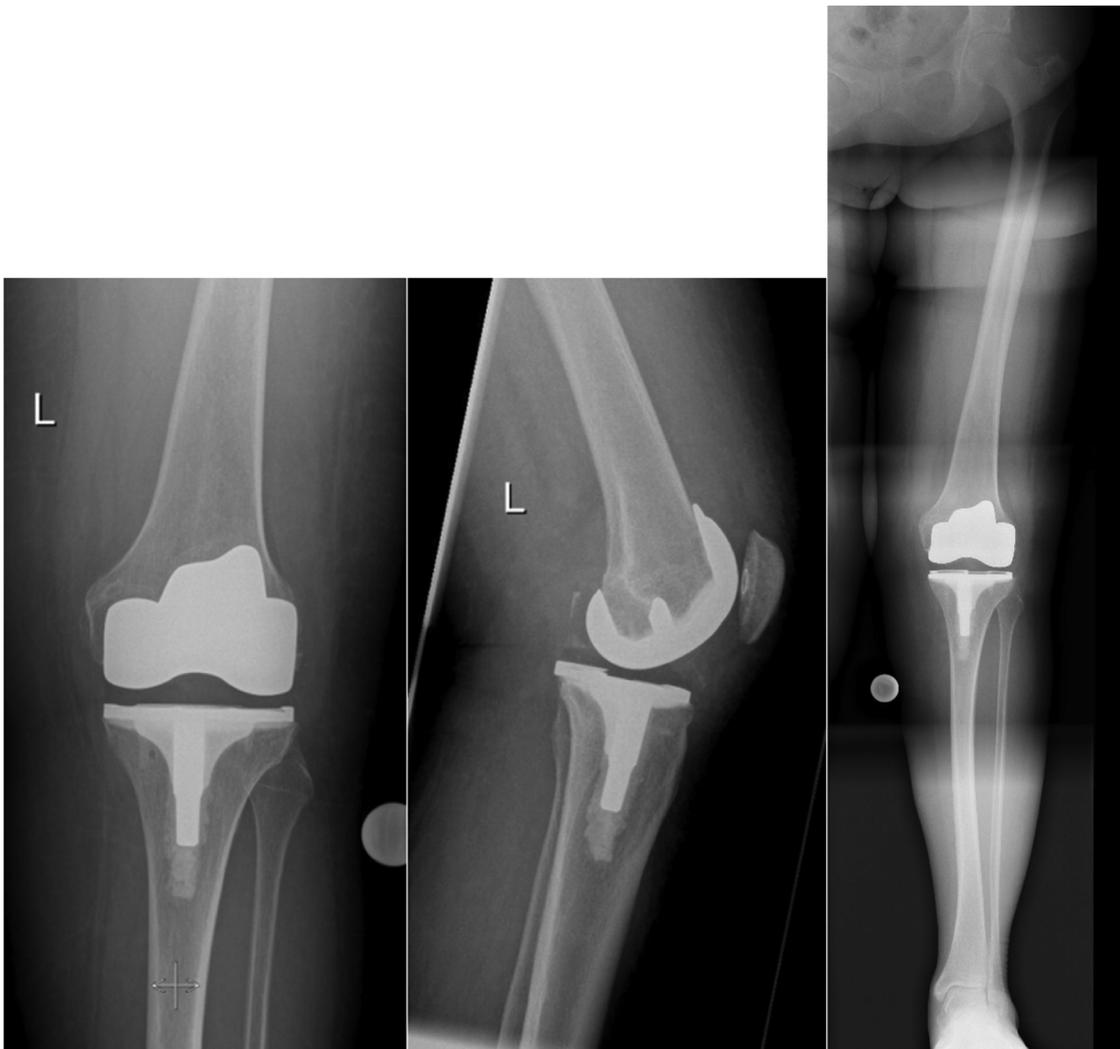
Figure 1. Radiographs of the left knee (anteroposterior, lateral, long leg stand) 5 days after primary TKA in 2010.

Malalignment has the potential to disrupt normal load distribution, thereby influencing the wear pattern of the endoprosthesis [21]. A postoperative full-leg stance radiograph of our case documented a slightly residual valgus axis of 3 degrees (Fig. 1). Particularly in combination with an imbalance in the mediolateral direction, characterized by a residual lateral contraction and medial joint laxity, it may have further compounded the issue, resulting in persistent valgus alignment and premature wear of the posterolateral insert due to heightened stress and shear forces [22].

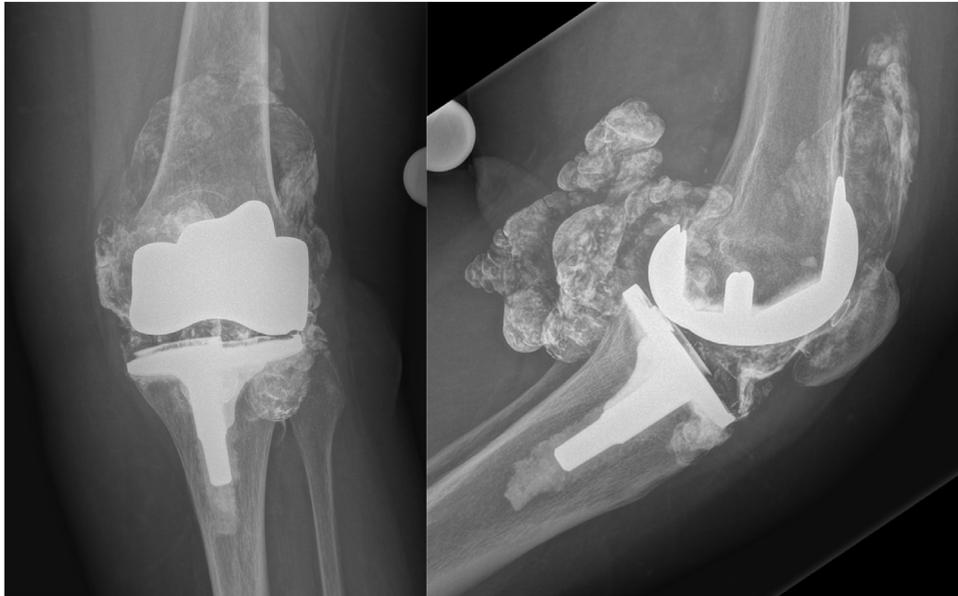
Radiographs in 2 planes (Fig. 2) revealed a cloudy, radiopaque structure measuring approximately 5 × 8.5 cm dorsally to the femur. This structure also occupied the superior recessus, measuring approximately 9 × 12 cm. Additionally, contact between the femoral and tibial metal components in the lateral compartment, along with a groove in the lateral aspect of the femoral component, was visible. A long-leg radiograph showed a valgus alignment of 10°.

Figure 2. Radiographs taken during the patient's presentation in June 2022 revealed a substantial pseudotumor and metal-metal contact in the lateral compartment.

Even though a periprosthetic infection seemed unlikely considering all the aforementioned findings, a staged revision was planned to prevent third-body wear due to the OXINIUM debris with metal and ceramic particles. We felt that a meticulous debridement of the anterior and the popliteal pseudotumor using an anteromedial and a posterior approach could not be performed

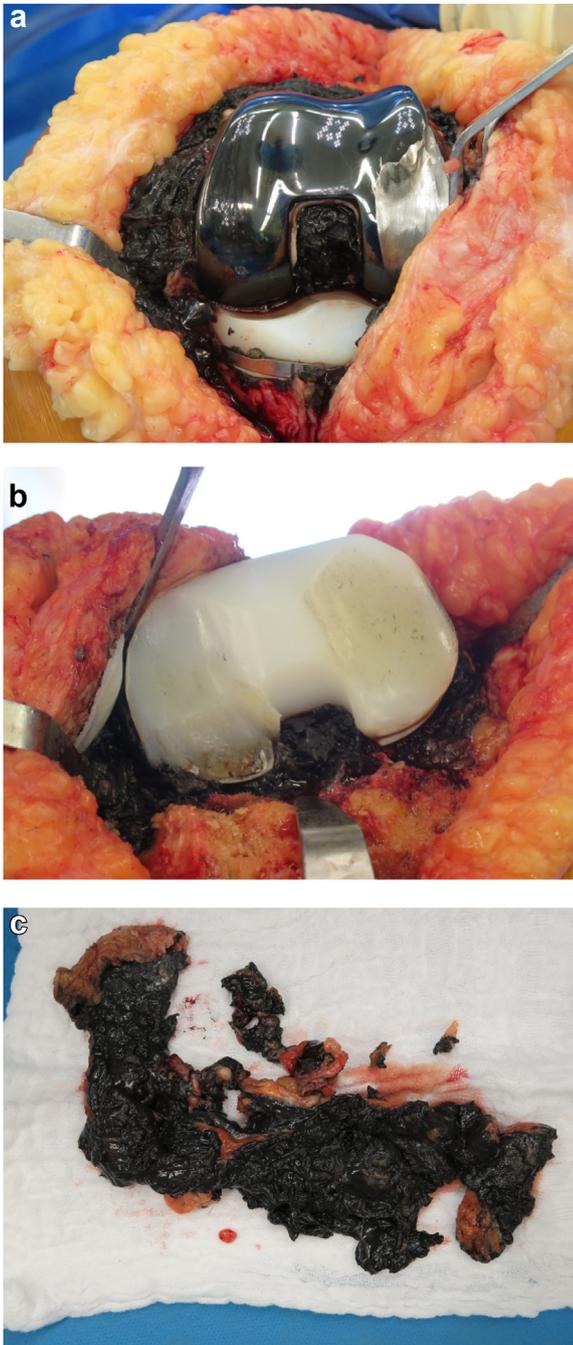
The first surgery was conducted under regional anesthesia with sedation. Following a medial arthrotomy, the synovia appeared predominantly black. The polyethylene inlay showed posterior lateral wear down to the tibial plateau, which also exhibited slight wear at the posterior end (Fig. 3a-c). The femoral shield displayed a defect measuring $6 \times 2 \text{ cm}^2$ with a depth of 0.3 mm (Fig. 4a). The lateral aspect of the inlay was abraded due to particle presence resulting from wear in the posterolateral corner (Fig. 4b), the tibial plateau itself revealed some slight damage. A complete synovectomy was performed, and the metal components were removed. A mobile polymethyl methacrylate spacer was implanted (Fig. 5), and samples were taken for microbiological and histopathological analysis.

Figure 3. (a-c) Intraoperative images illustrating the abrasion of the lateral aspect of the femur shield, the posterolateral extensively worn polyethylene insert, and the synovial tissue displaying complete black pigmentation.

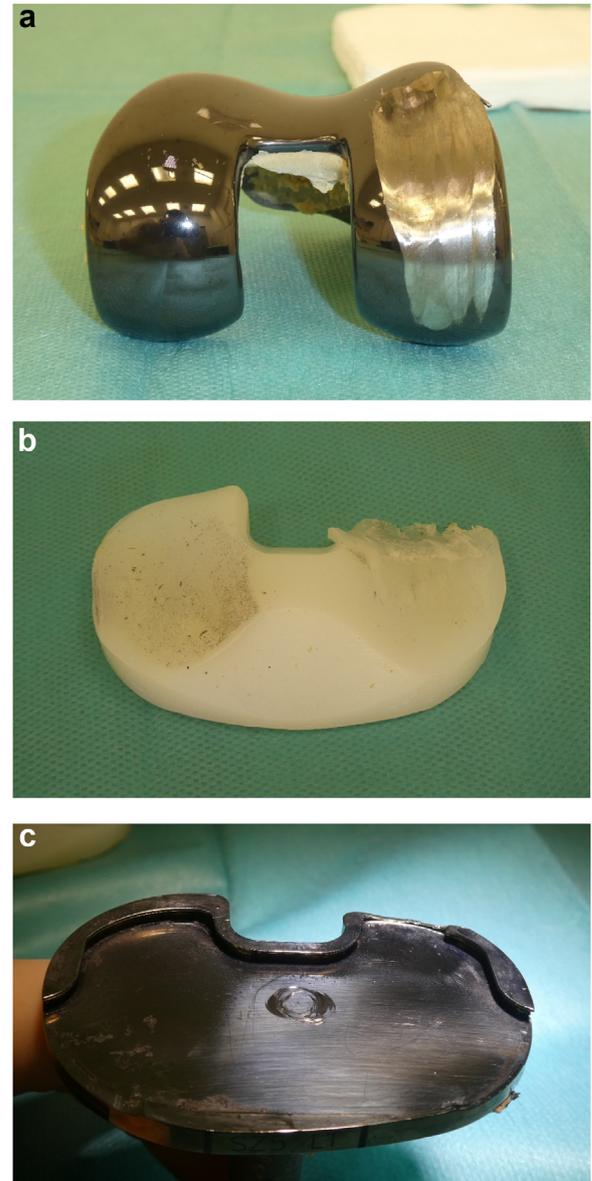
Figure 4. (a-c) Photographs postexplantation reveal a groove in the metal beneath the surface on the lateral aspect of the femoral component (a), massive polyethylene wear on the posterolateral aspect of the insert (b) and a defect of the posterolateral tibial plateau (c).

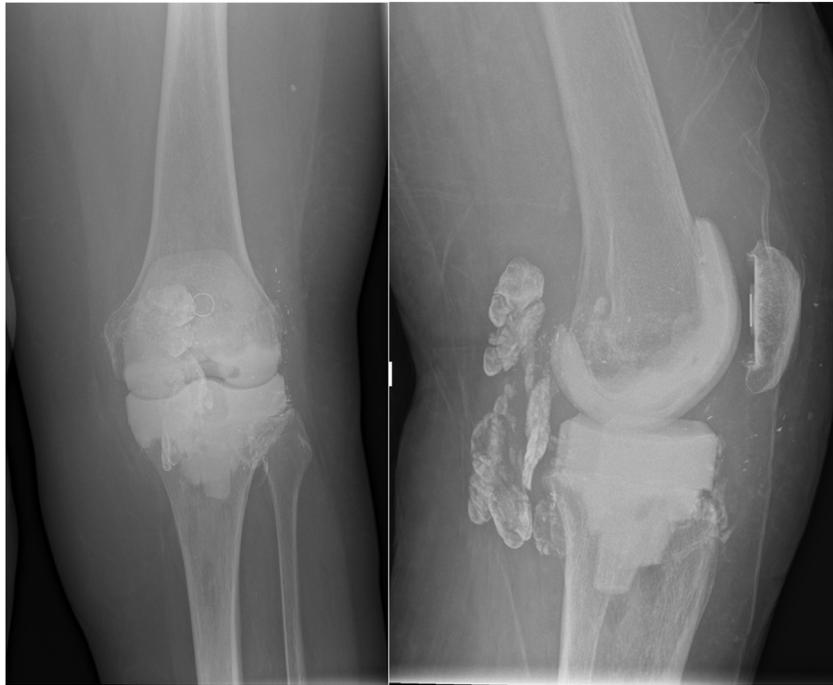
Figure 5. Radiographs in 2 planes after explantation and implantation of a mobile PMMA spacer, revealing a residual pseudotumor in the popliteal region. PMMA, polymethyl methacrylate.

In a second operation, performed 15 days after explantation, the remaining popliteal pseudotumor was addressed using a posterior approach and the macroscopically delimitable residual tumor was extracted. A postoperative radiograph showed an almost complete removal of the popliteal mass (Fig. 6).

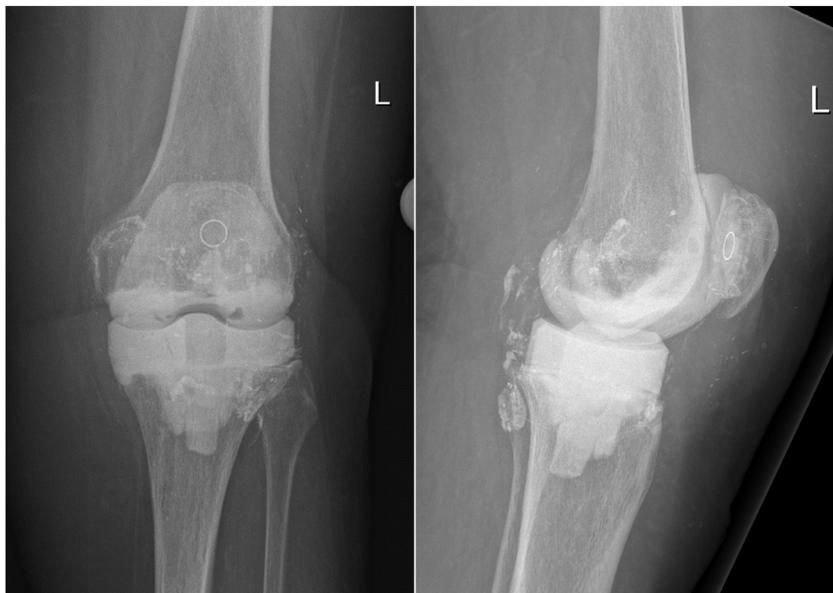
Figure 6. Radiographs in 2 planes after removal of the popliteal pseudotumor.

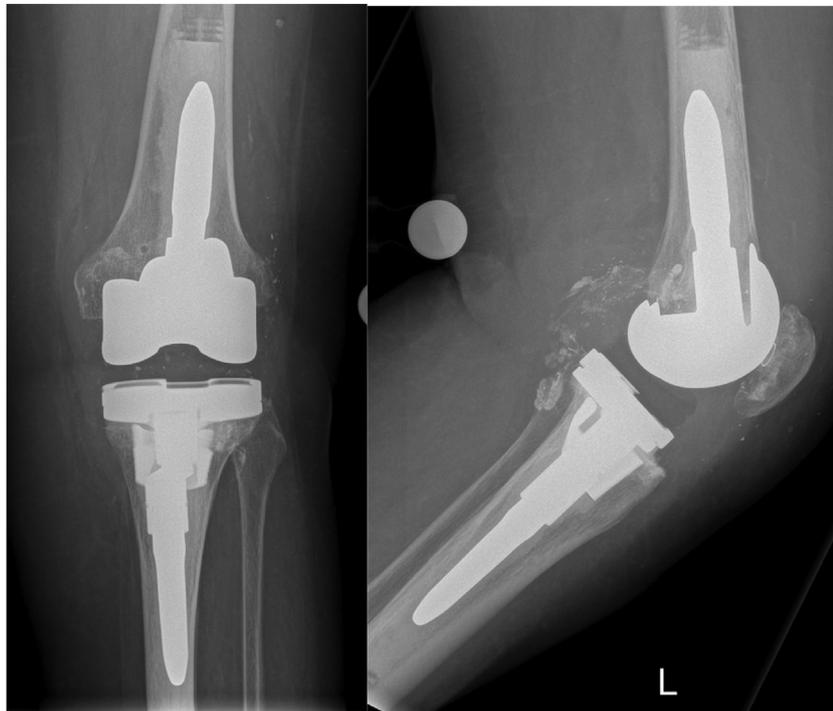
extension and flexion up to 120° . The knee joint demonstrated no signs of instability, with an initial residual mild general swelling and no signs of infection. Radiographs in 2 planes 1 year after reimplantation (Fig. 7) showed correct implant positioning without any signs of dislocation, malalignment, or component wear.

Figure 7. Radiographs in 2 planes 1 year after revision arthroplasty.

After a subsequent interval of 4 weeks the spacer was removed, and a condylar-constrained revision TKA (Legion Revision System, Smith & Nephew, Memphis, TN) was implanted. The components used were as follows: femur revision size 4 OXINIUM, tibia revision - size 3, polyethylene-inlay 13-mm condylar constrained. For improved metaphyseal force transmission, a 22-mm short tibial cone was employed, along with femoral ($120 \times 16 \text{ mm}$) and tibial ($120 \times 12 \text{ mm}$) cemented stems for diaphyseal fixation. We opted for an OXINIUM component again to prevent third-body wear because of possible residual ceramic particles, even though a meticulous debridement was carried out and because of the hypersensitivity to nickel.
