Research article

The fracture and perforation failure analysis of downhole tubes

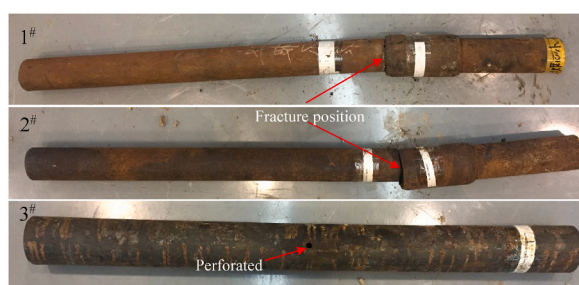
During the killing operation of a well in the western oil field, it was found that the 66th (approximately 630m) and 73rd (approximately 690m) tubes were fractured and failed. The fracture positions were all located at the root of the connecting thread of the tube. The 243rd (approximately 2310m) tube body was corroded and perforated. The specifications of the failed tubes were $\Phi 88.9 \text{ mm} \times 6.45 \text{ mm}$, and the steel grade was BG110S. They were marked as 1#, 2#, and 3#, respectively. The macroscopic morphology is shown in Fig. 1.

Fig. 1. The visual appearance of the failed tubes.

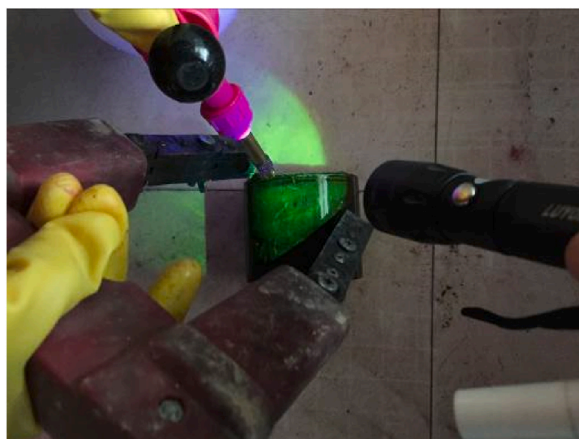
According to ASTM E709-2015 [20], the results of fluorescent magnetic particle testing (FMPT) near the fracture position are shown in Fig. 2. The test results indicate that aside from the primary fracture, no additional cracks or defects were detected on the outer surface of the affected tube segment.

Fig. 2. Magnetic particle testing around the outer surface of the fracture tube section.

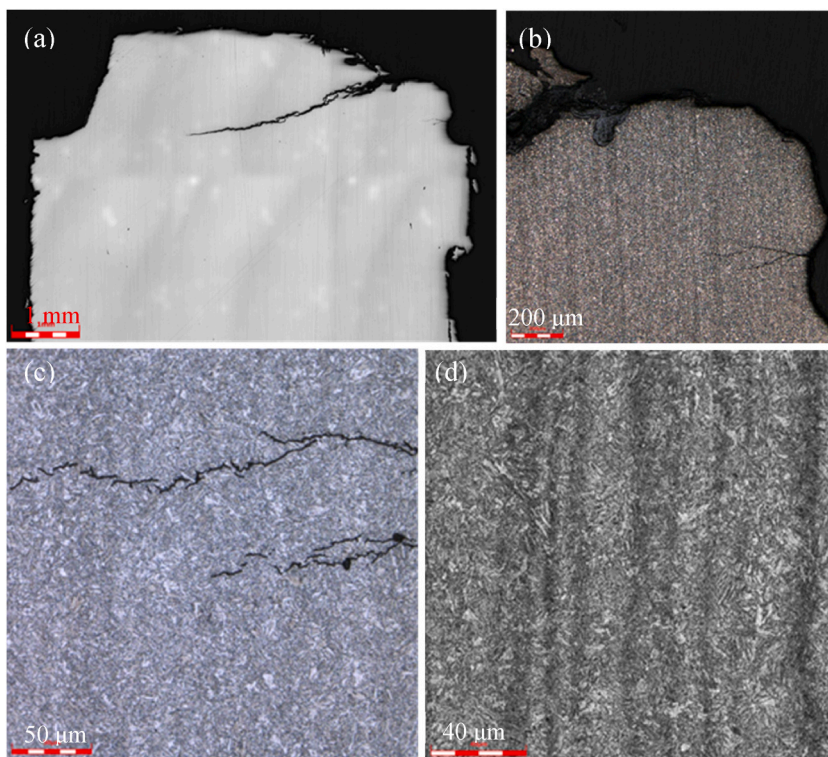
A sample was extracted and prepared from the fractured region of Tube 1 for further examination. The structure, grain size, and nonmetallic inclusion of the sample were analyzed. The analysis results show that the nonmetallic inclusions around the fracture are A0.5, B0.5, and D0.5. Visible cracks are evident on the outer surface of the fracture area. (Fig. 3a–3c), there are local intergranular cracks along the crack direction, and the cracks propagate downward along the fracture to the 2/3 position of the wall thickness. The microstructure around the fracture and crack is tempered martensite and some ferrite, and there is no abnormality in the microstructure (Fig. 3d). The grain size is 11.0.

Fig. 3. Fracture crack and metallographic structure analysis (a) Fracture appearance; (b) Crack morphology of the fracture surface; (c) Crack surface profile; (d) Metallurgical structure of the fracture.

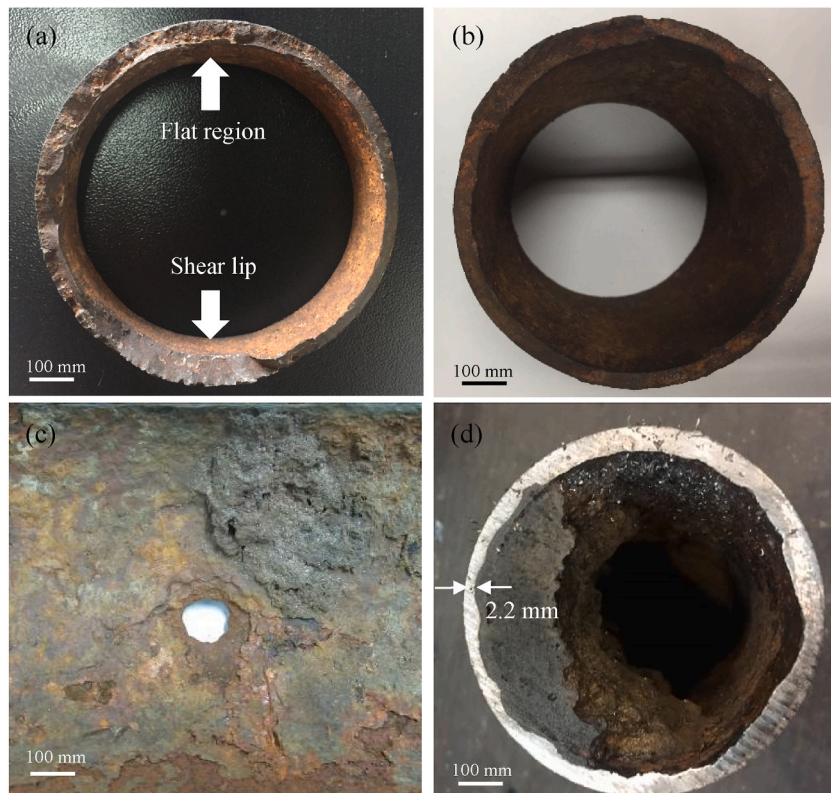
The overall appearance of the fracture on Tube 1# is illustrated in Fig. 4a, providing a macroscopic view of the damage. The fracture has completely traversed the material in the transverse direction, with its position specifically pinpointed at the segment housing the thread's common buckle recess groove. It is completely broken along the transverse direction, and the fracture position is located at the part of the thread common buckle retreating groove. Thread processing is first end-face processing, then boring inner hole steps and cones, followed by thread processing. The quality of thread processing is affected by processing technology, clamping methods, processing equipment, tools, and cooling methods. The fracture surface is dark brown, and there is no obvious necking deformation around the fracture. The section is divided into two characteristic areas: flat area and shear lip area. The flat area accounts for about 1/4 of the circumference of the fracture and has brittle cracking characteristics. The shear lip area accounts for about 3/4 of the circumference of the fracture, which is the instantaneous fracture area formed by the final fracture of the tube. The macro-morphology of the fracture of the 2# tube is shown in Fig. 4b. Due to the fishing operation, the fracture is smoothed, and the original fracture morphology is not observed. However, the cracking site is the same as the fracture site of the 1# tube, and it is also located at the part of the thread common buckle back groove. The inner surface of the perforation part of the 3# tube is shown in Fig. 4c. There are several corrosion products on the surface, and there is a scaling phenomenon. Fig. 4d shows the cross-section of the tubing at the perforation site. Observations reveal a substantial accumulation of debris within the tube, which has led to a notable thinning of the tube wall due to the buildup. The minimal thickness measured for the tube wall was merely 2.2 mm.

First of all, according to the fluid properties of the well, the well is high in Cl⁻, H₂S, and CO₂, and its working environment is very corrosive to carbon steel. Second, from the macroscopic morphology of the fracture, the fracture source area of 1# and 2# tubes is located at the cutter groove on the outer surface of the connecting thread of the tube. The finite element analysis of the stress distribution of the thread joint shows that this part is the highest stress part of the whole thread joint and the largest stress distribution point of the whole tube. In addition, it can be seen from the metallographic analysis results of the fracture that there are visible cracks on the fracture and the outer surface of the thread, and the crack extends to the position of 2/3 wall thickness, which further proves that the fracture of the tube originates from the root of the thread outside the tube. Microscopic analysis of the fracture surface shows

Fig. 4. Macroscopic morphology of fracture and perforation (a) Macroscopic fracture morphology of 1 # tube; (b) Macroscopic fracture morphology of 2 # tube; (c) Inner surface morphology of perforation site; (d) Internal scaling morphology of perforated tubing.

There are a large number of corrosion products on the inner surface of the 3# tube perforation part, and there is a scaling phenomenon (Fig. 4c). The wall thickness around the inner surface corrosion pit is thinned, indicating that the part is perforated from inside to outside. From the cross-section of the tube at the perforation site, it can be observed that there is a large amount of fouling material inside the tubing, and the inner wall of the tubing is thinned (Fig. 4d). The thinnest part of the tube section is only 2.2 mm, which is 1/3 of the original wall thickness of the tube. Microscopic analysis shows that there are a large number of corrosion products at the perforation site (Fig. 5b). The corrosion products at the perforation site are mainly composed of C, O, S, Cl, Ca and Fe. Therefore,

3. The perforation of the tube's inner wall can be attributed to a gradual thinning of the wall over time, brought about by the corrosive effects of hydrogen sulfide (H₂S), carbon dioxide (CO₂), and chloride ions (Cl⁻). This process leads to the accumulation of debris, or fouling, which ultimately culminates in the perforation of the wall.
4. It is recommended to prevent tube corrosion by injecting crude oil or diesel into the well during long-term shut-in.

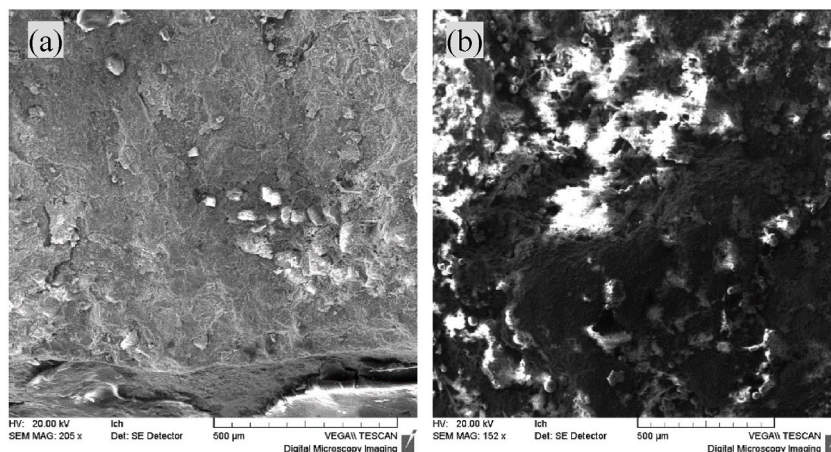
Samples were taken from the fracture site of 1# tube and the perforation site of 3# tube, respectively. The microscopic details of the fracture are depicted in Fig. 5a, where the fracture surface exhibits characteristics of brittle fracturing. Under magnification, there is no evidence of corrosion products covering the fracture surface. The morphology near the perforation site is shown in Fig. 5b, and the surface is covered by much loose white corrosion products.

Fig. 5. SEM photo of the failure tube (a) The fracture source area of 1# tube; (b) The perforation site of 2# tube.

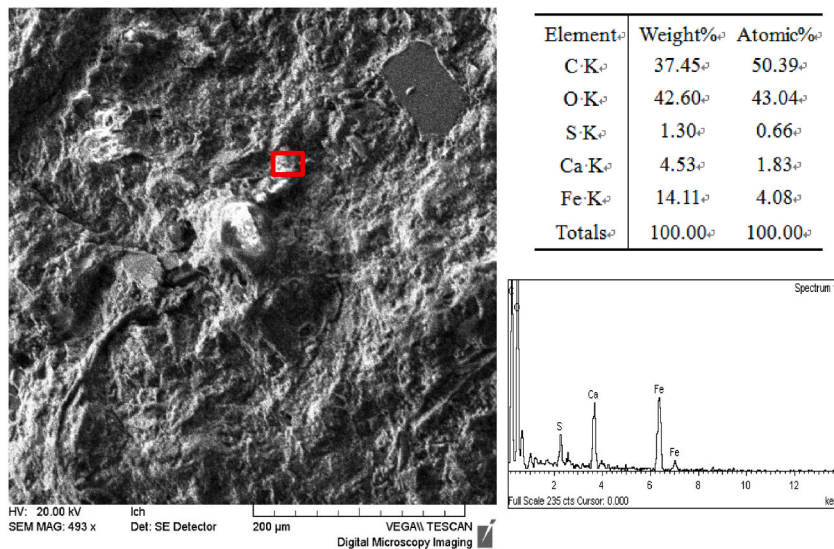
(EDS), with the findings illustrated in Figs. 6–8, respectively. Analysis revealed that the fracture surface is predominantly comprised of C, O, S, Ca, and Fe. The crack, on the other hand, contains primarily C, O, Fe, alongside trace amounts of S, Cl, and Ca. Furthermore, the corrosion products at the perforation site are mainly constituted by C, O, S, Cl, Ca, and Fe.

that its morphology is brittle cracking. The energy spectrum analysis of the fracture site reveals a surface composition primarily of Carbon (C), Oxygen (O), Sulfur (S), Calcium (Ca), and Iron (Fe) elements. Remarkably, this elemental profile mirrors that found within the crack on the outer fracture surface, with Sulfur (S) being a consistent constituent in both instances.

Fig. 6. The EDS analysis of the fracture surface.

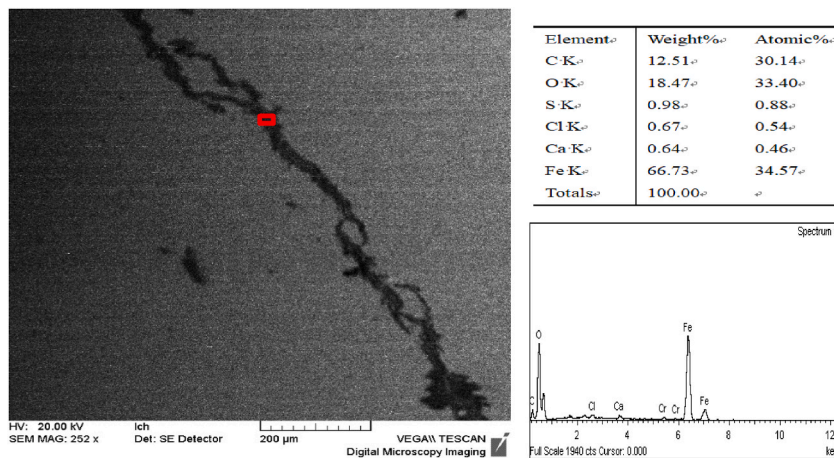
Fig. 7. The EDS analysis of the crack.

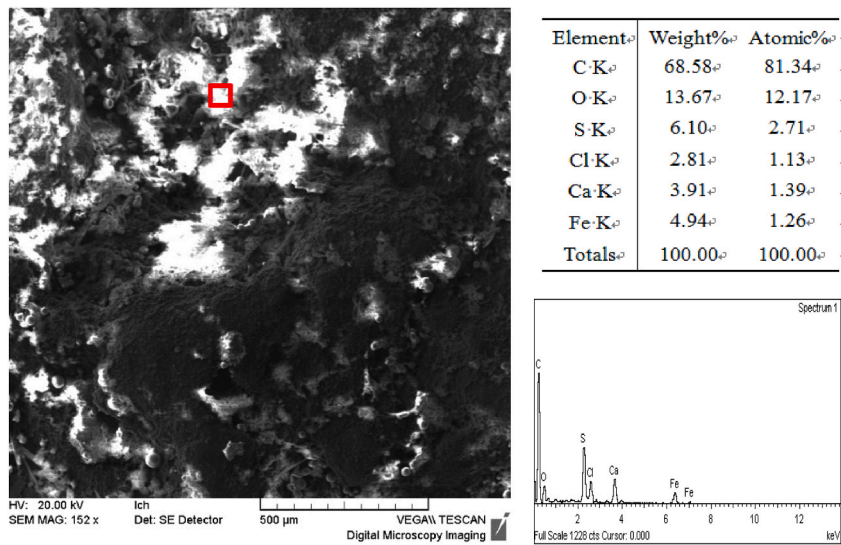
Fig. 8. EDS result of the perforation site.

the inner wall of the tube is gradually thinned under the action of H₂S, CO₂, and Cl⁻, forming fouling and eventually perforation.

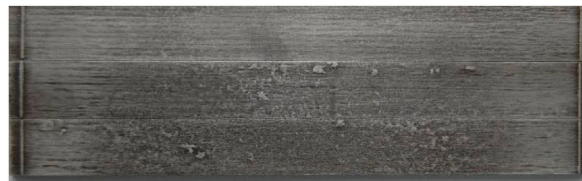
According to the NACE Standard TM 0177–2016 [25], the SSCC test was carried out on the samples near the fracture of 1# and 2# tube, respectively. The loading stress was 90 % of the measured minimum yield strength. After soaking in H₂S saturated solution (A solution) for 720 h, the test results are shown in Table 5, and the macroscopic morphology of the sample surface after the test is shown in Figs. 9 and 10. The test results show that all samples are not broken after soaking for 720 h and no cracks were found when magnified 10 times.

The results of the sulfide stress corrosion cracking (SSCC) test show that the four-point bending specimen of 1# and 2 # tubes did not break after soaking in A-solution for 720 h, and no crack was found after 10 times magnification. Indicating that the SSCC

Fig. 9. Macroscopic photos of the 1# tube sample after 720 h of SSCC.

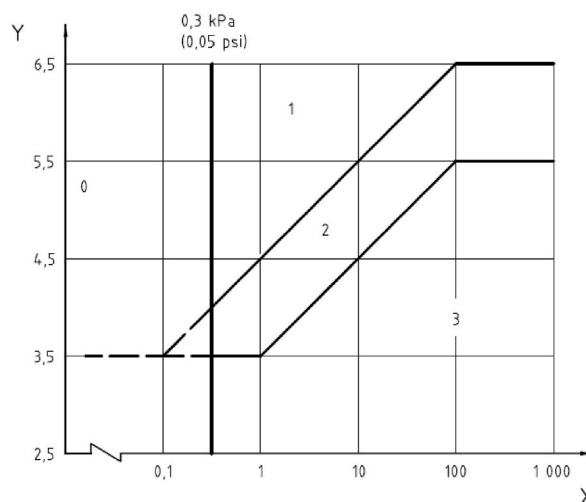
1. The physical and chemical properties of the 1# tube sample meet the requirements of TLM-JSXY-YG-2015-1.
2. The reason for the fracture of the tubing is that under the condition of low pH value, high hydrogen sulfide environment, the tubing is fractured due to stress concentration caused by cracks in the outer thread relief groove.

Fig. 11. SSC diagram of carbon steel and low alloy steel in different environments (X axis is H₂S partial pressure (KPa), Y axis is the solution pH value).
