## Modular titanium alloy neck failure in total hip replacement: analysis of a relapse case

Marco Ceretti<sup>1,\*</sup> and Francesco Falez<sup>2</sup>

**Key words:** Modular neck, Prosthesis, Fatigue fracture, Total hip arthroplasty.

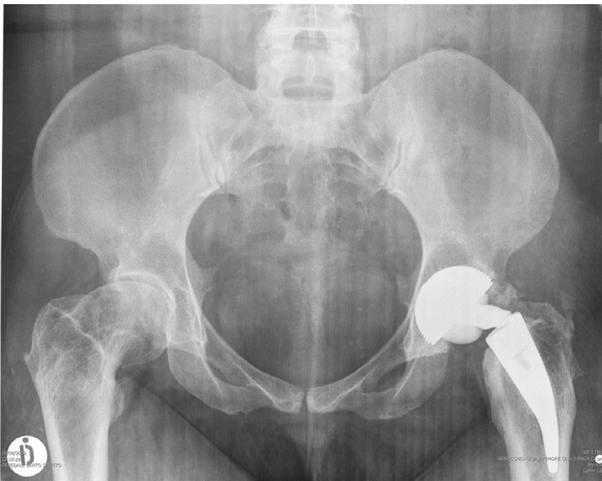
After two years and five months, the patient came back with atraumatic right hip pain described as unremitting and was associated with grinding and clicking sensation during ambulation with an instability feeling.

X-rays demonstrated deformity at the neck-stem junction with increased neck varus angulation suggestive of a femoral neck fatigue fracture (Figure 1).

**Figure 1.** Neck-stem junction breaking in the absence of traumatic injury after two years from the 1st THA (Total Hip Arthroplasty). The prosthesis is a Metha stem implant with modular neck. It was implanted in 2006 when the corrosion theory was not known and the modular neck was in titanium without CrCo.

The patient was taken to the operating room for revision surgery. During the procedure it was possible to remove a part of the fractured femoral neck from the hip stem. We removed all the femoral implant via the Hardinge approach and it was decided to implant a modular uncemented Modulus titanium hip stem (Lima Corporate, diameter 21 mm taper B) with titanium long 135° neck and a 36 mm medium ceramic femoral head (Figure 2).

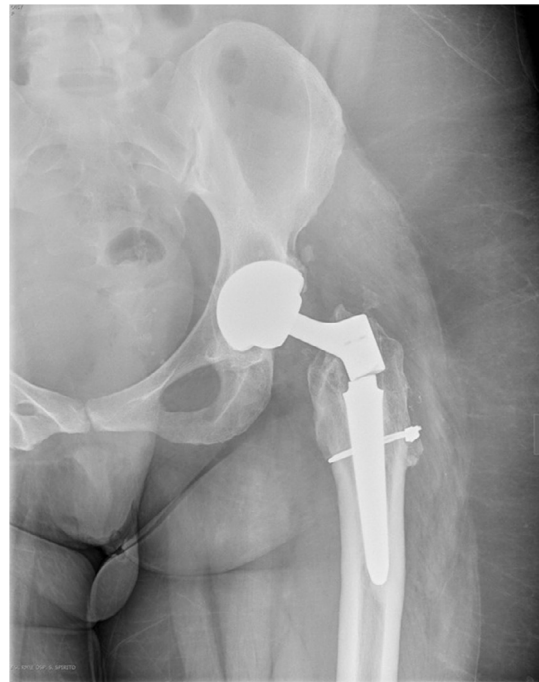
After six months, HHS was 88 points and ROM was: flexion 110°, abduction 40°, extension 10°, internal rotation 15°, external rotation 15°. After two years and six months, the patient felt the same non-traumatic right hip pain. X-rays demonstrated the stem rupture at the neck-stem junction (Figure 3).

**Figure 3.** Neck-stem junction breaking in 1st revision implant after atraumatic pain two years after the revision. The rupture is localized on the thread at the neck-stem junction. The neck was virus (135°) in Ti6Al4V.

Our strategy was to remove the modulus hip stem using a Wagner osteotomy and our choice was to implant a Wagner monoblock uncemented titanium stem (Wagner SL revision produced by Zimmer) with a 36 mm + 3.5 Biolox delta ceramic head (Figure 4).

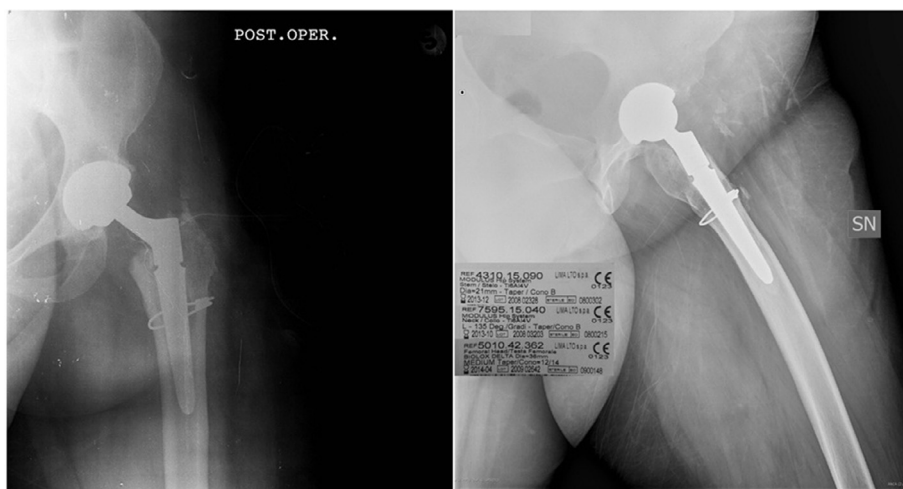
**Figure 2.** Postoperative X-ray after the Metha stem revision. The 1st implant revision was performed with Lima Modulus implant. Implant details: modulus stem 21 mm diameter, neck Ti6Al4V 135° taper B, Femoral Head 36 mm Biolox delta.

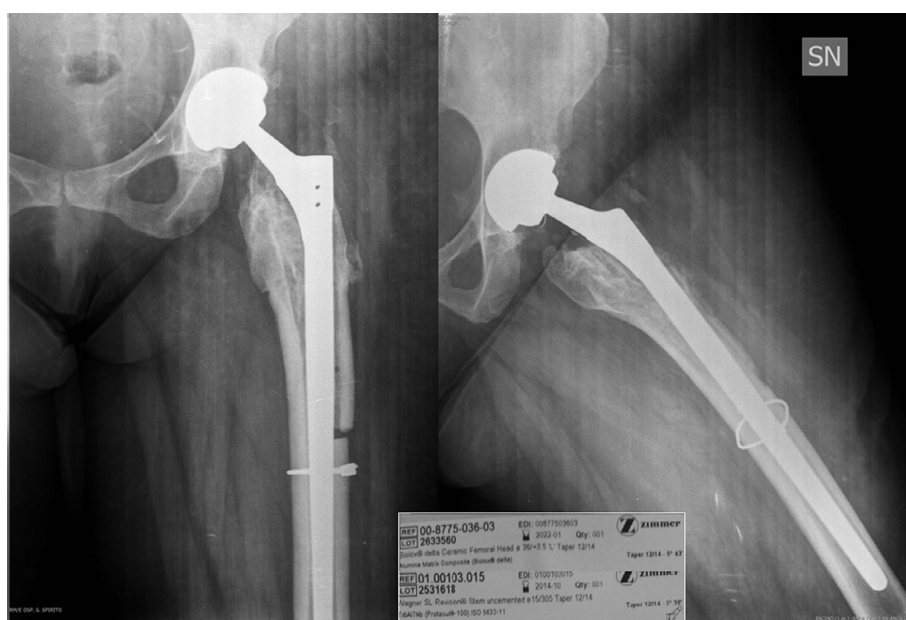
**Figure 4.** Postoperative X-ray after 2nd revision. The stem choice was a monolithic Wagner revision implant with the following details: femoral head 36 + 3.5, Lima Wagner SL revision stem. The Wagner stem is already hole.
