Journal of Mass Spectrometry and Advances in the Clinical Lab

Case Report

Surreptitious pipetting errors on a vendor-programmed liquid handler

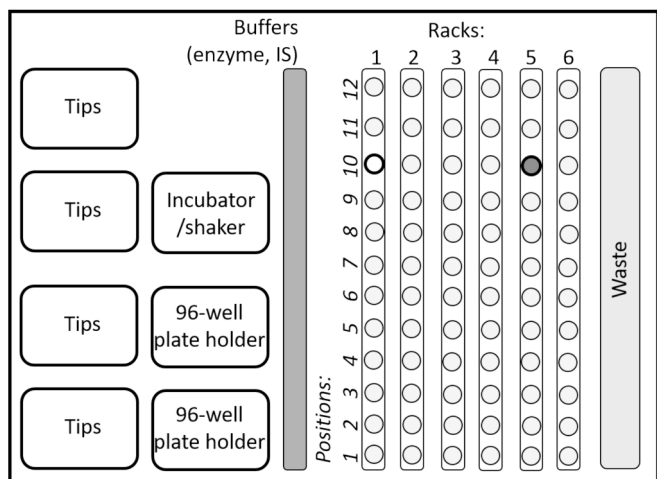
In both instances, the root cause of the problem was thought to be a manual sample mix-up by the CLS. In our method, samples are prepared using a vendor-programmed LH. Briefly, barcode-labelled samples in vacutainer tubes are loaded onto the deck of the LH (racks 1 – 6, Fig. 1). For small volume patient samples, samples are manually added to nesting cups placed on top of the barcode-labeled tubes (allowing for reduced dead volume). The CLS indicates which tubes utilize nesting cups when starting the program. The LH then performs a vendor-

Fig. 1. Liquid handler (LH) configuration used in the method. For this configuration, samples are taken from number racks and number positions using a four channel pipette. The pipette tip boxes are in an 8 x 12 layout.

remaining volume was insufficient to place the whole tube onto the LH. To further understand the error, the trace from the LH was opened (the programming tells the LH what it should do, and the trace records what it actually did). The trace showed that the LH had pipetted from the wrong rack of samples. Instead of pipetting the three calibrators in rack 1, positions 2 – 4, it pipetted samples from rack 6. It is worth noting that the samples it pipetted from rack 6 were the three QC samples in nesting cups. The laboratory was able to replicate this error by placing nesting cups in any position in racks 2 – 6 and observing that the LH would always take from these later racks instead of rack 1 (Fig. 2). So, if there was a nesting cup in rack 2, position 3, when it came time for the LH to add the sample from rack 1, position 3, it would instead take the sample from rack 2, position 3 (never even pipetting the actual sample in rack 1, position 3). This error did not depend on the position of the sample but on the rack number. So, as shown in Fig. 1, if a nesting cup was in rack 5, position 10, then the LH would incorrectly pipette that sample, instead of the correct sample in rack 1, position 10. Most disconcertingly, the LH would output an incorrect worklist that did not correlate to what was actually pipetted. Fortunately, an exhaustive review of records showed no instances of nesting cups being used outside of rack 1 in our health system, making this error a near miss.
