Case report

Failure at the femoral stem extension-condylar interface in a rotating hinge knee without radiographic evidence of loosening

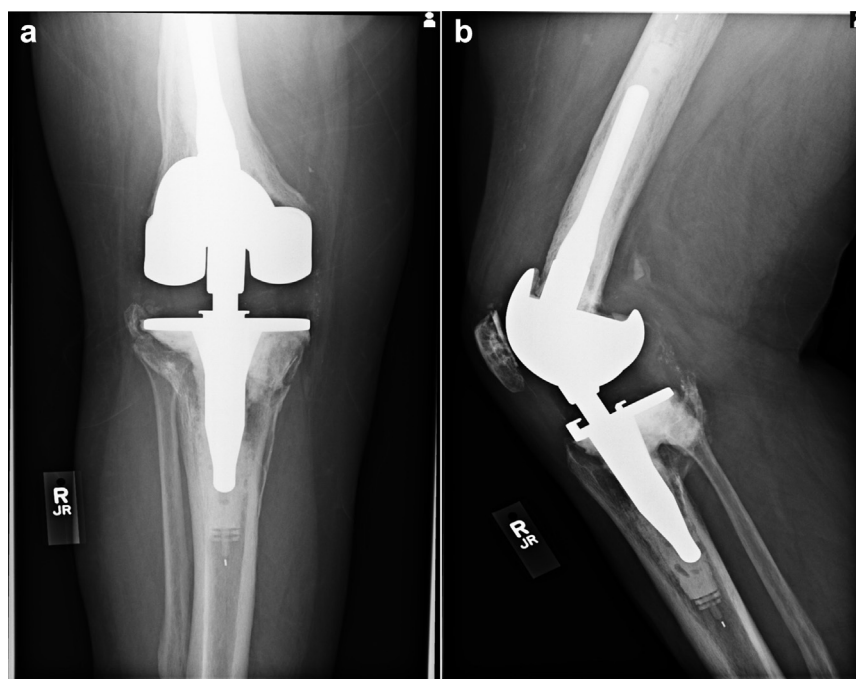
Physical examination revealed an antalgic gait favoring the right leg and use of a front-wheeled walker. Range of motion was from 10° to 80° of flexion with moderate laxity to varus/valgus stress testing through a full range of motion. There were no clinical signs of infection and serum erythrocyte sedimentation rate and C-reactive protein were normal. Knee aspirate yielded blue-green colored synovial fluid with a white blood cell count of 1160 cells/ μ L and 58% neutrophils. Synovial fluid culture was negative. Radiographs of the right knee (Fig. 1) revealed a hinged revision total knee with cemented femoral and tibial stems in satisfactory alignment with possible subtle asymmetry at the Morse taper junction on the anteroposterior (AP) radiograph. The tibial metaphysis and patella demonstrated significant osteolysis with minimal distal femoral metaphyseal bone. No significant osteolysis was adjacent to the femoral or tibial stem extensions.

Figure 1. (a) AP and (b) lateral radiographs of the right knee acquired during initial presentation demonstrating Anderson Orthopedic Research Institute type III femoral and tibial bone defects with very subtle radiolucent asymmetry involving the stem extension-condylar interface and a well-fixed femoral stem extension.

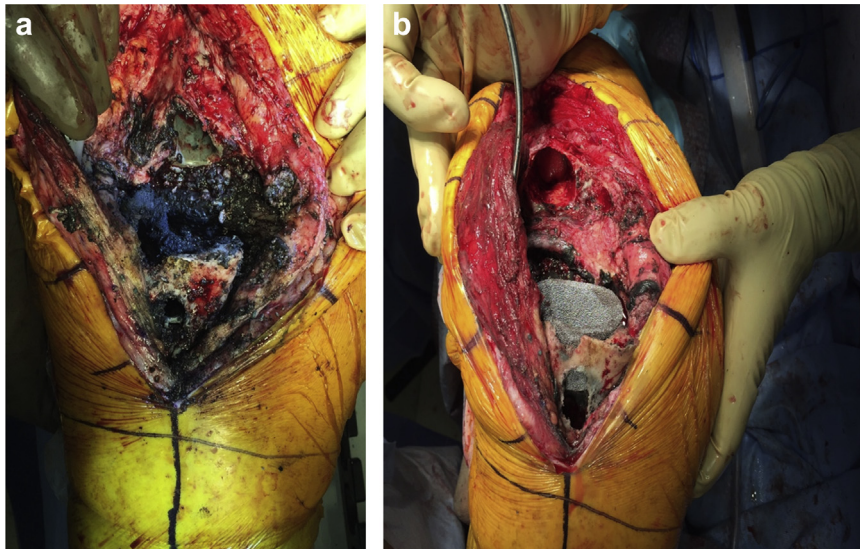
Intraoperative inspection of the components revealed that the condylar portion of the femoral component was grossly loose and toggling at the Morse taper junction, leading to extensive metallosis throughout the knee (Fig. 2). The modular hinge mechanism was intact. The tibial component was not grossly loose; however, there was significant metaphyseal osteolysis consistent with the findings on the preoperative radiographs. There was a significant amount of patellar osteolysis, but the patella component was not grossly loose.

Figure 2. (a) Intraoperative photograph demonstrating uncontained bone defects within the distal femur and proximal tibia with associated metallosis. (b) Intraoperative photograph following tissue debridement and placement of a fully porous tantalum metaphyseal cone used for reconstruction.

backslapping device was attached to the well-fixed femoral stem which was removed from the cement mantle with minimal difficulty. The tibial component was likewise removed with minimal difficulty. After debridement of all avascular tissue and as much metallosis debris as possible, the patient was found to have severe metaphyseal bone defects of both the femur and tibia, consistent with Type III Anderson Orthopedic Research Institute defects [7]. A Zimmer NexGen Rotating Hinge Knee was implanted with the use of metaphyseal trabecular metal cones to reconstruct the metaphyseal bone defects. The patella was revised to a modular trabecular metal-backed component in order to address the severe osteolysis and prevent future loosening. Five intraoperative tissue cultures were obtained and found to be negative.

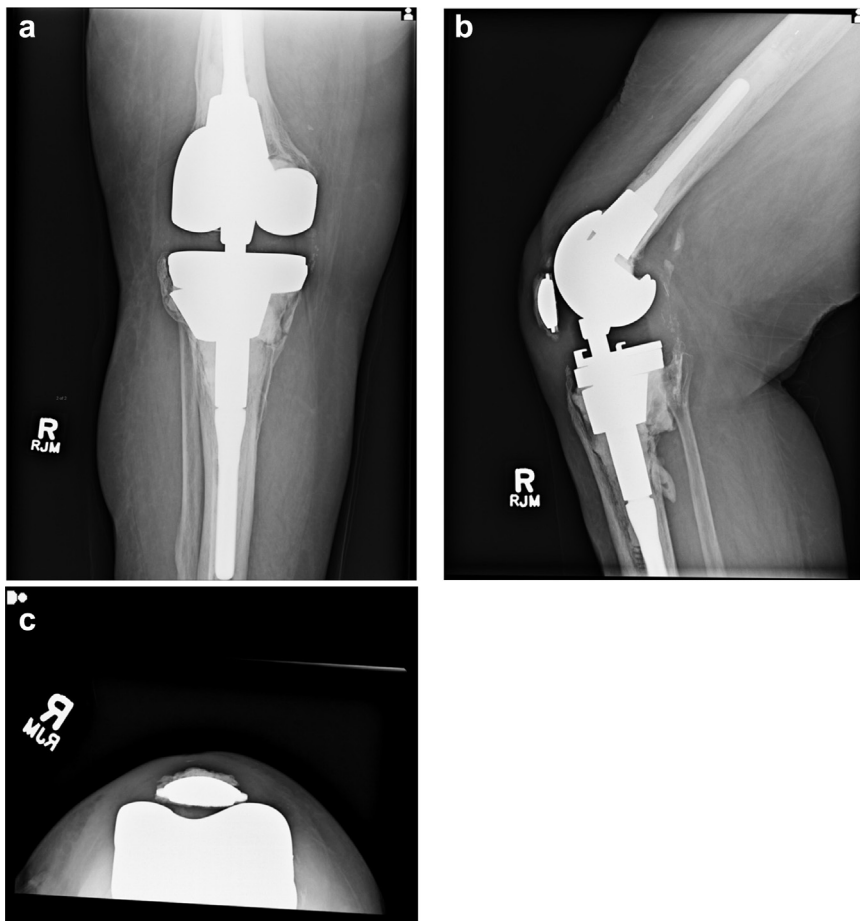
At 4 years of follow-up the patient had mild persistent knee pain, range of motion from 0° to 100°, and the knee was stable on examination. Radiographs remain stable and the implants appear well fixed (Fig. 3).

Figure 3. (a) AP, (b) lateral, and (c) merchant postoperative radiographs obtained at 4-y follow-up demonstrating the Zimmer NexGen Rotating Hinge Knee with associated metaphyseal cones and tantalum patella augment in maintained alignment without evidence of complication.
