## Case report

## Fracture risk of tapered modular revision stems: a failure analysis

Kilian Rueckl, MD, Peter K. Sculco, MD, Jonathan Berliner, MD, Michael B. Cross, MD, Chelsea Koch, BS, Friedrich Boettner, MD \*

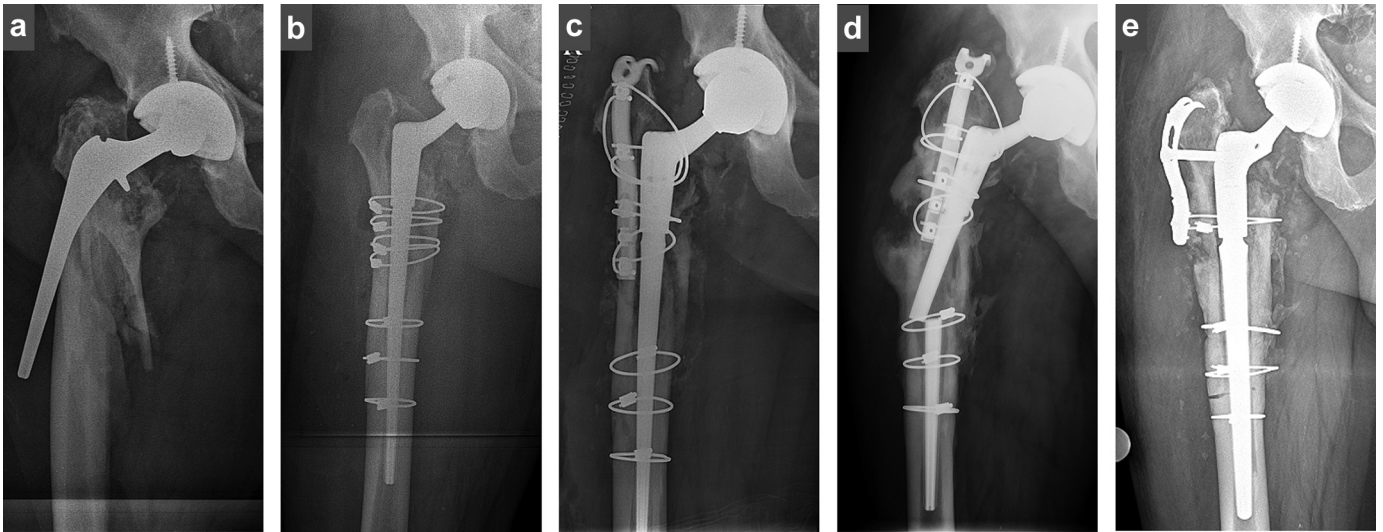
The first patient underwent primary THA for osteoarthritis of the right hip in April 2001. In November 2015, he was hit by a car and suffered a Vancouver B2 periprosthetic fracture of the right femur (Fig. 1a). At that time, the now 75-year-old male had a height of 182 cm, weight of 95 kg, (BMI of 28.5 kg/m<sup>2</sup>). After removal of the loose femoral implant at the time of revision surgery, the hip was reconstructed using a 14 × 195 bowed tapered stem and size 23 × 70 + 0 Standard Cone Body Restoration Modular Hip System (Stryker Corporation, Kalamazoo, MI). The well-fixed 60-mm Reflection acetabular component (Smith & Nephew Inc., Memphis, TN) was retained and a new 36 mm Reflection liner (Smith & Nephew Inc.) was inserted. The construct was further stabilized with 7 Dall-Miles cables (Stryker Corporation) and 30 mL of Orthovita cancellous chips (Stryker Corporation), as well as 60 cc of fresh frozen cancellous chips were used as bone graft (Fig. 1b). All intraoperative cultures returned negative.

**Figure 1.** Radiologic images case 1. (a) Periprosthetic fracture Vancouver B2, (b) 4-week follow-up image after revision surgery, (c) After secondary displacement of the trochanteric fragment, revision surgery with a 125-mm trochanteric claw plate (d) Fracture of the distal stem 14 months after original revision (e) Reconstruction with a tapered revision stem and a trochanteric claw plate.

returned to early full weight-bearing 5 weeks after surgery. This resulted in a symptomatic displacement of the proximal fracture segment. A second revision surgery was therefore performed in January 2016, during which the proximal fragment was reduced and secured with a 125-mm Accord Standard Trochanteric Claw Plate (Smith & Nephew Inc.). Orthovita cancellous chips and 60 cc of fresh frozen cancellous chips were used to augment bone healing (Fig. 1c). Postoperatively, he recovered uneventfully and was eventually progressed to full weight-bearing, which he tolerated well. In March of 2017, he suffered a sudden pain in his right thigh while ambulating without a history of trauma. Radiographic evaluation at that time demonstrated a fracture through the mid-portion of the tapered stem, with associated displacement of the proximal femur (Fig. 1d).

The distal part of the fractured stem measured 121.5 mm (Fig. 1d). An extended trochanteric osteotomy was performed, extending 20 mm beyond the broken stem to gain access to the distal stem. The stem was loosened using a gigli saw, trephine reamers, a needle-tip MIDAS burr, and K-wires inserted in between the splines of the stem. Using a diamond-tip drill, a hole was drilled in the lateral aspect of stem to facilitate the stem removal using the hook of the S-ROM Extraction instrument (DePuy Synthes, Warsaw, IN). The defect was reconstructed using a bowed tapered 18 × 190 mm modular stem (Arcos Modular Femoral Revision System; Zimmer Biomet Inc., Warsaw, IN) and a 17-mm cone body. After reduction and fixation of the osteotomy fragment with 2 Dall-Miles cables, the trochanteric segment was reduced and fixed with a 100-mm trochanteric claw plate that was bolted to the body with a 50-mm screw (Fig. 1e). The patient was mobilized toe-touch weight-bearing with abductor precautions for 12 weeks postoperatively.

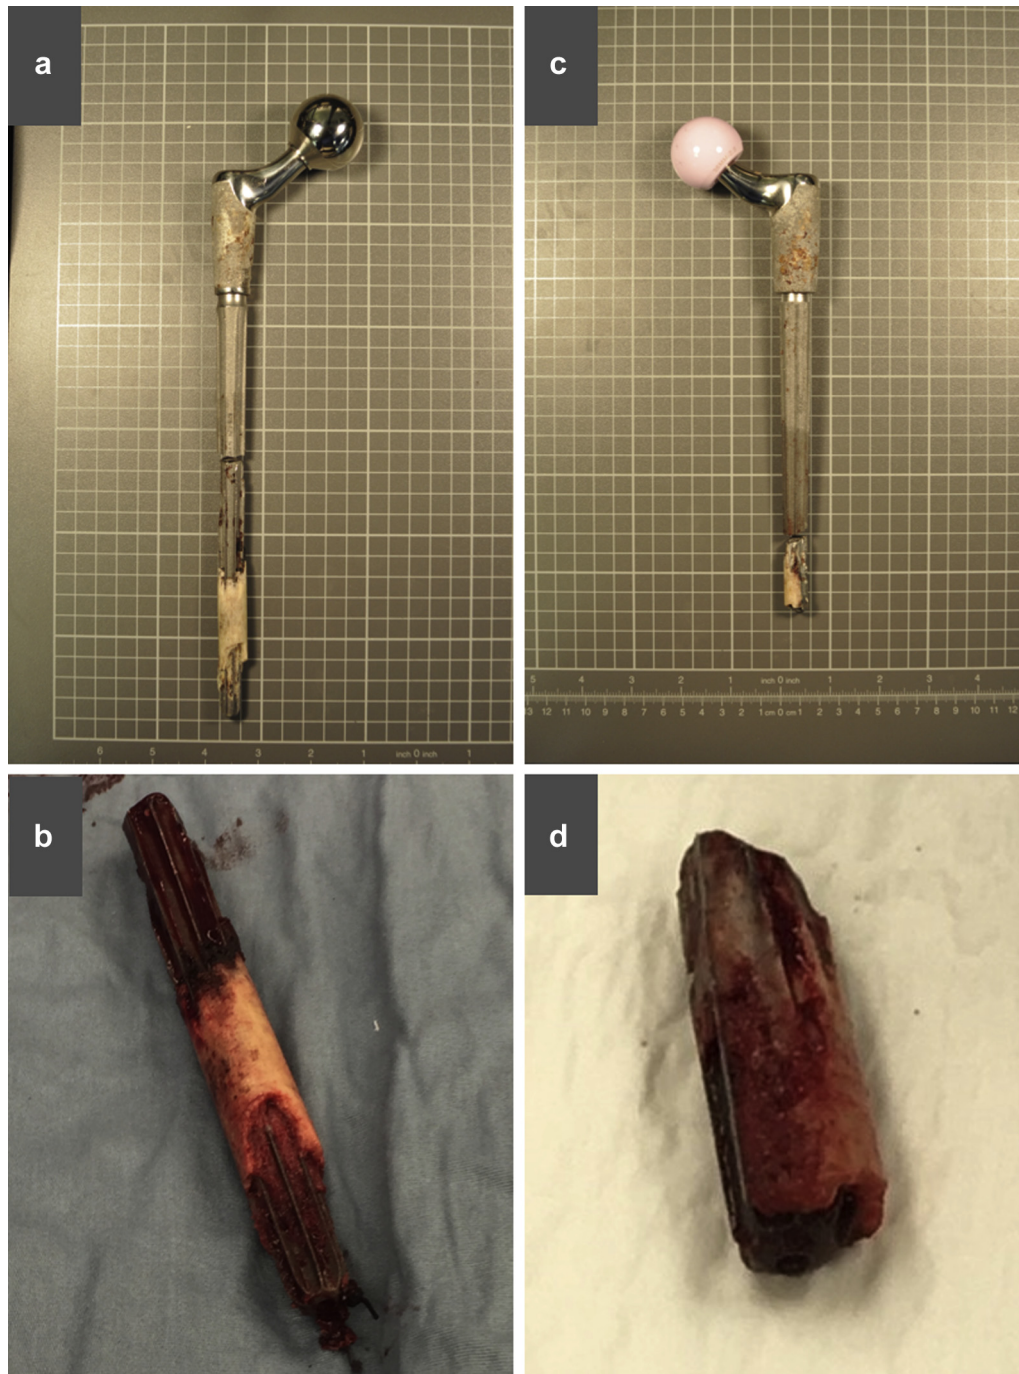
The fracture surface analysis was performed using a Keyence Digital Microscope VHX-5000 series (Keyence Corporation of America, Itasca, IL) at 10× and 15× magnification (Fig. 2).

The fracture occurred at 121.5 mm measured from the tip of the stem (Fig. 2a). The inner diameter at the fracture site was 10.7 mm, and the outer diameter was 14.1 mm including the splines. The

cross-sectional area at the fracture side was 90 mm<sup>2</sup> compared with 143 mm<sup>2</sup> for a reference 13.5-mm inner diameter (Formula 1). The damage patterns on the fracture surfaces of both the proximal and distal portions of the fractured stem were consistent with fatigue fracture due to cyclic loading. The clamshell marks span most of the fracture surface of the implant, indicating a low-load, high-cycle fatigue failure. Macroscopic imaging revealed the origin of the fracture at the lateral edge of the stem. No material defects or other stress concentrations were noted at the origin of the fracture. The clamshell marks show propagation of the fracture medially through the cross-section of the stem and a final fracture on the medial edge (Fig. 3).

**Figure 2.** Macroscopic photographs of the fractured Restoration Modular Revision Hip System: (a, b) is case 1. (c, d) is case 2.

The fracture occurred at 37.0 mm measured from the tip of the stem. The inner diameter at the fracture location was 9.0 mm, and the outer diameter was 12.2 mm (Fig. 2c). The inner cross-sectional area was 63 mm<sup>2</sup> compared with 143 mm<sup>2</sup> for a 13.5 mm inner diameter (Formula 1). Analysis of the fracture surface was not possible because the damage of the fracture surfaces incurred while the patient continued to ambulate with the fractured stem in place (Fig. 2d).

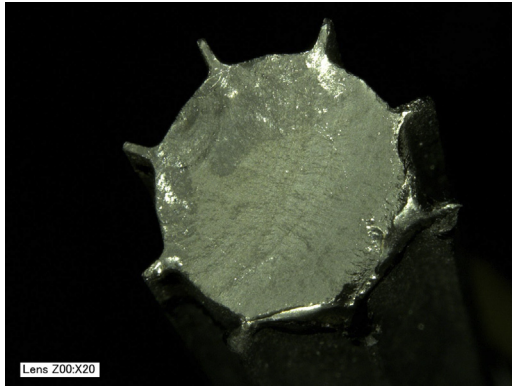
**Figure 3.** Microscopic imaging of the fracture surface. The clamshell markings showed a lateral origin and were consistent with fatigue fracture due to cyclic loading. The marks showed propagation through the cross-section of the stem from 11 to 5 o'clock.

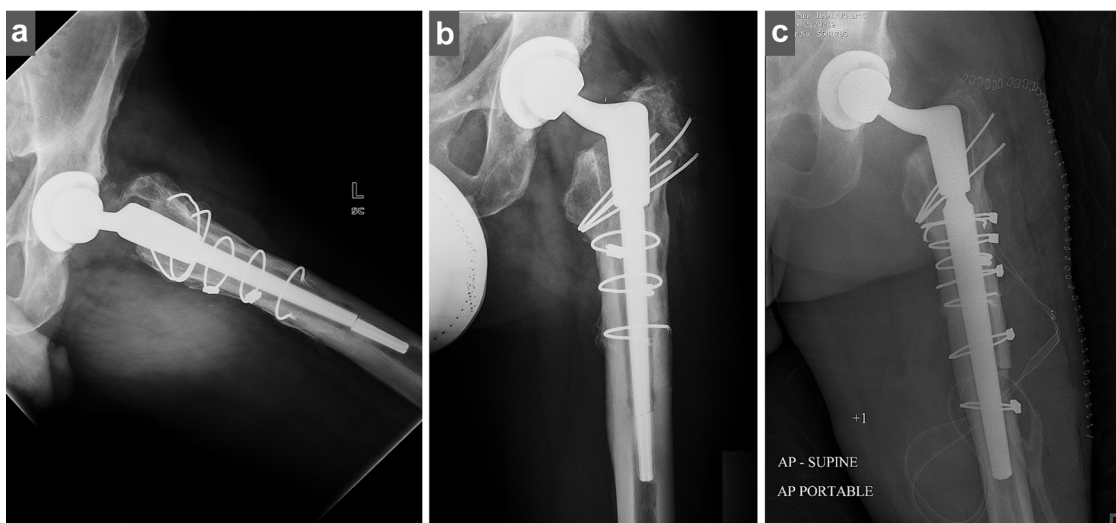
The patient presented in July 2017, reporting 2-3 months of left hip pain. Radiographs demonstrated loosening of the proximal and mid-stem portion of the femoral component with a fracture of the distal aspect of the stem (Fig. 4a and b).

**Figure 4.** Radiologic images case 2. (a, b) Frog and anteroposterior (AP) view of the left hip 7/2017, demonstrating loosening of the femoral stem with a fracture of the distal aspect of the stem, (c) postoperative AP view of the left hip after surgery.

The distal stem was removed using an extended trochanteric osteotomy. The revision was performed using a 21 × 195 mm Restoration Modular straight tapered stem (Stryker Corporation) and a 25 × 70 mm + 0 standard cone body. The osteotomy fragment was reduced and fixed in place with 4 Dall-Miles cables (Fig. 4c).
