Evaluation of the truebeam machine performance check (MPC): OBI X-ray tube alignment procedure

Michael P. Barnes^{1,2,3} | Dennis Pomare¹ | Frederick W. Menk³ | Buiron Moraro⁴ | Peter B. Greer^{1,3}

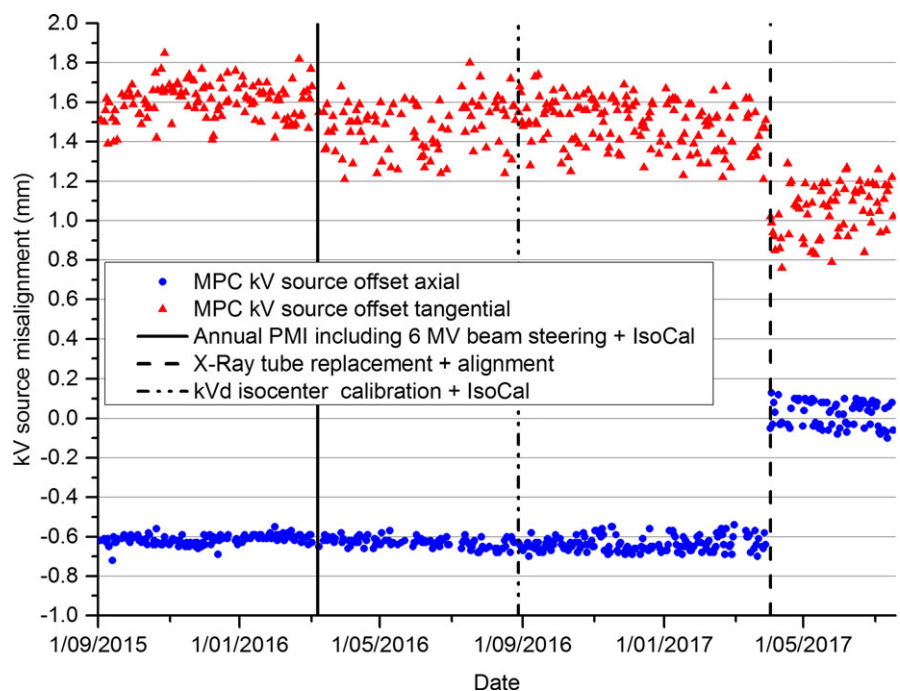
Figure 1 shows the MPC kV source offset results in both axial and tangential directions over a near 2 yr period. The magnitude of the changes in kV source and imager offsets at the maintenance events are presented in Table 1, where the mean and two standard deviations are presented between maintenance events. Vertical lines in Fig. 1 identify times when the X-ray tube was replaced and aligned, when there was an annual PMI including 6 MV beam steering and IsoCal calibration and when the kVd isocenter calibration was performed with IsoCal calibration. Corresponding changes in the axial (filled circles) and tangential (triangles) source offset are clearly seen. Neither axial nor tangential kV source offset were sensitive to a change in kV detector isocenter calibration, while the tangential offset appears to have changed with Annual PMI: 6 MV beam steering + IsoCal calibration. The mean values before and after this event are within two standard deviations so the results are inconclusive.

FIG. 1. Nearly 2 yrs' data for MPC kV source offset in axial and tangential directions. Relevant maintenance events are also indicated.

The near 2-yr kV source offset results presented in Fig. 1 and Table 1 indicates that the tube alignment measurement is more stable in the axial direction than the tangential direction. This may be because the tangential direction is in the plane of gantry rotation and hence components in this plane are subjected to greater variation in the direction in which gravity is acting. The results also show clear sensitivity of the measurement to realignment of the X-ray tube for a tube replacement. Figure 1 and Table 1 also indicate that within two standard deviations that there was minimal or no effect on the MPC source offset measurement due to 6 MV beam steering + IsoCal calibration or with kV detector isocenter calibration + IsoCal. Since both the kV detector isocenter calibration plus IsoCal work on the kV detector rather than kV source then it is expected that recalibrating them would have no effect on the kV source offset.

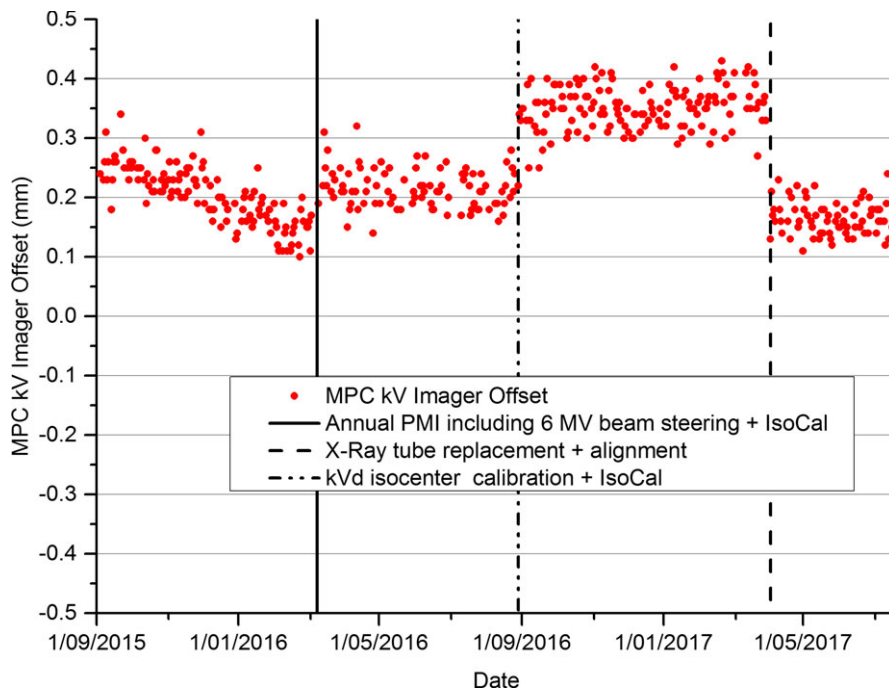
Figure 2 shows the MPC kV imager offset results over the same near 2 yr period as for Fig. 1. Figure 2 and Table 1 indicates that each of the maintenance events resulted in a change in the kV imager offset result.

FIG. 2. Nearly 2 yr data for MPC kV imager offset. Relevant maintenance events are also indicated.

The results of Table 1 indicate that within two standard deviations the MPC kV imager offset parameter was sensitive to all of the maintenance events listed except for the annual PMI: Beam steer and IsoCal calibration. However, for this event Fig. 1 seems to indicate a change in trend at this time, which indicates that the kV imager offset was sensitive to this event. Since the IsoCal calibration was updated at each event and the kV imager offset parameter provides a measure of the IsoCal validity then this result is as expected. In the cases where the kV imager offset increased after maintenance, such as for the Annual PMI and kV detector isocenter calibration, this would indicate that either the calibration performed was less accurate than previously and hence the IsoCal calibration had to work harder to correct, or that the IsoCal calibration itself was inaccurate.

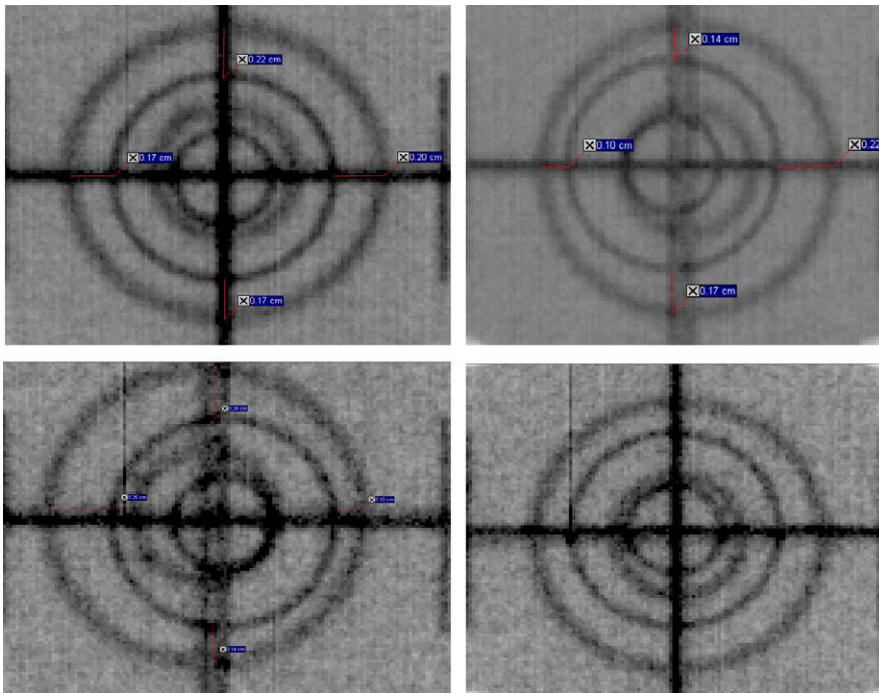
+0.09 mm in the tangential direction and axial directions, respectively. The 1 mm threshold on this measurement meant that tube realignment was indicated in the tangential direction. For the two-plate method performed prior to realignment, neither the head up nor down images indicate misalignment in the axial direction. The head up image shows misalignment in the tangential direction while the head down image indicates no tangential misalignment. When averaged, these results would indicate that adjustment is not required in the axial direction, but is required in the tangential direction. Both results are in agreement with MPC.

After tube realignment the two-plate method indicates no misalignment in the axial direction, which agrees with MPC. In the

FIG. 3. Images for the two-plate method of X-ray tube alignment performed before and after tube alignment and at both kV source head up and head down. Top Left = Before and head down, Top Right = Before and head up, Bottom Left = After and head down and Bottom Right = After and head up.

tangential direction the head up image indicates no misalignment while head down indicates misalignment. This is reversed compared to the pre-realignment images and is not in agreement with MPC.

The two-plate method results in Fig. 3 show opposing variations in the tangential direction for head up and head down before and after the tube realignment. This indicates that the tube was originally misaligned and after realignment it was misaligned in the opposite direction, which is not in agreement with MPC. Anecdotally the two-plate method is sensitive to setup inaccuracy. The method requires that the two plates be set up to have precise vertical alignment and this is difficult to achieve using lasers or cross hairs. The method also requires

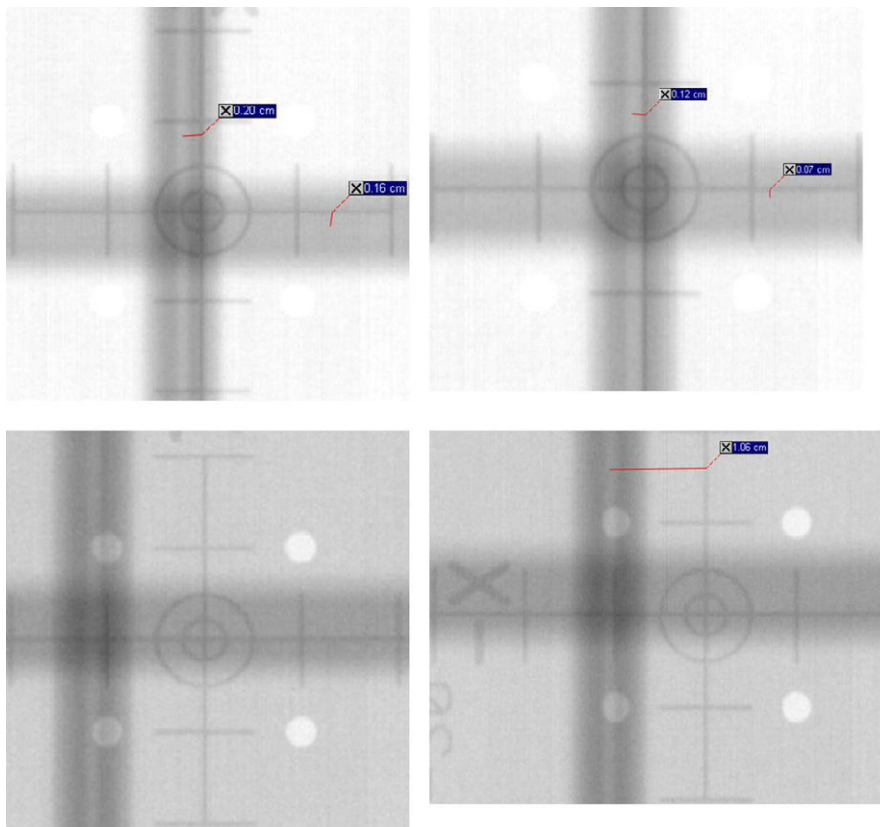
The images for the wire-on-faceplate method before tube realignment indicate misalignment in both axial and tangential directions for the head down orientation and for tangential only for the head up orientation. This would indicate that realignment is required in both planes, although greater in magnitude for the tangential direction. This is in agreement with both MPC and the two-plate method.

FIG. 4. Images for the wires on faceplate method of X-ray tube alignment performed before and after tube alignment and at both kV source head up and head down. Top Left = Before and head down, Top Right = Before and head up, Bottom Left = After and head down and Bottom Right = After and head up.

After tube realignment the wire-on-faceplate images show small axial misalignment in both head up and down positions, which within

qualitative assessment uncertainty can be considered in agreement with MPC. However, in the tangential direction the wire-on-faceplate method indicates greater misalignment in both head up and down positions compared to the pre-realignment results, which is in disagreement with MPC.

The wire-on-faceplate method results of Fig. 4 indicate an increased misalignment in the tangential direction after tube realignment. A possible explanation for this is misalignment of the tungsten wires. Since the wires are placed very close to the X-ray tube then any slight misalignment in their placement will be magnified at the imager plane and provide an inaccurate result. This is the main weakness of this method. In the axial direction the method is also affected by the kV source isocenter calibration. The kV source isocenter calibration places the kV tube faceplate at a known position relative to linac isocenter, but is not clinically important as long as the tube is correctly aligned. The effect of not performing the isocenter calibration is that the wires attached to the kV source faceplate are no longer aligned correctly between the X-ray tube and isocenter. This only applies in the axial direction, but is also a potentially prohibitive weakness of the method as it is difficult to perform isocenter calibration with sufficient accuracy.

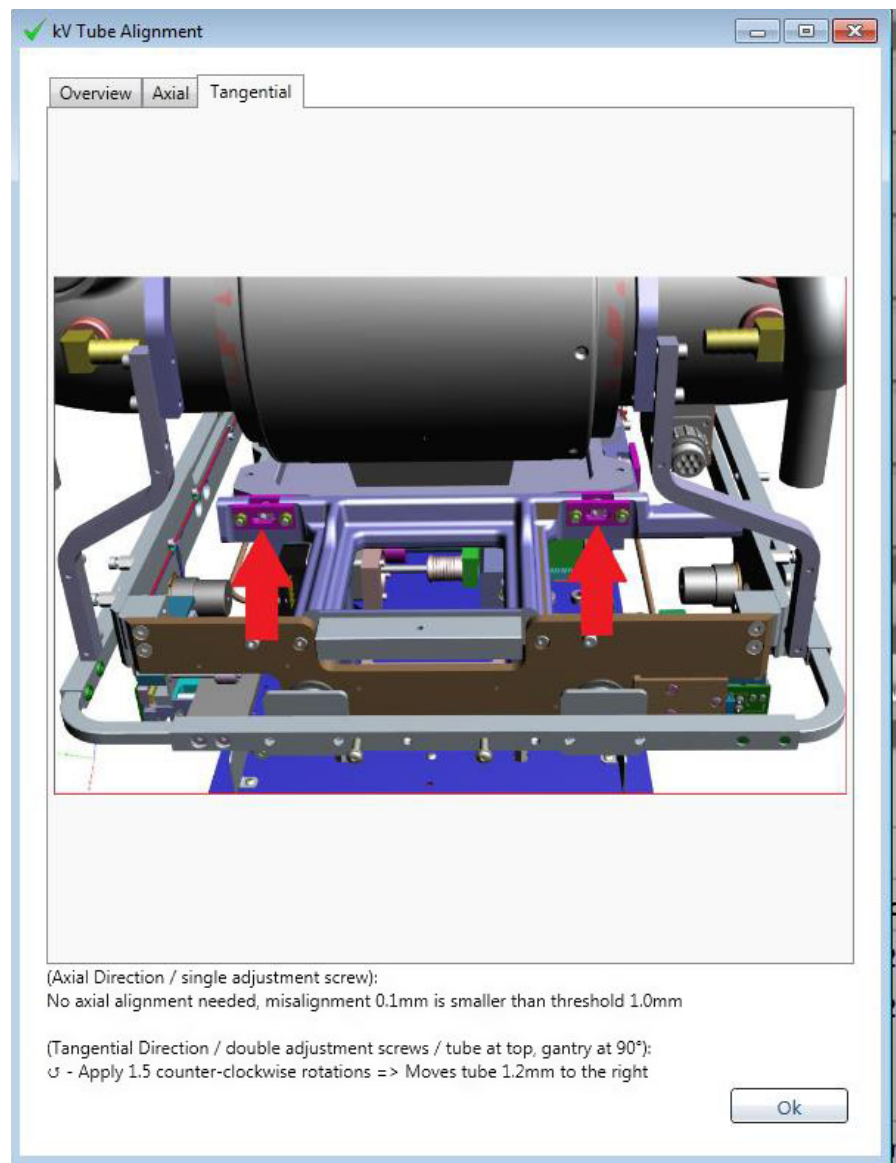
FIG. 5. Screen capture of the MPC kV tube alignment procedure in the tangential tab.

To realign the X-ray tube the MPC method was used. To do this the MPC kV tube alignment feature was chosen and a software wizard appeared. Figure 5 provides a screen capture of this wizard when the tangential tab is selected. The figure shows diagrammatically which screws need adjusting and the embedded text informs how many turns and in which direction the screws need to be turned to make the necessary adjustment. The wizard is unclear in two respects. First, at the points indicated for adjustment there are two opposing screws: one tightens and one loosens. It is not clear that the number of turns indicated applies to both screws. This was determined by trial and error. Second, it was found that there was take-up slack in the screws before they began to have any influence. It was found through trial and error that the number of turns indicated relates to the situation after the take-up has been used. As such, the full adjustment was made in two stages.

The MPC tube alignment procedure could be improved with enhanced clarity of instructions in the wizard. In particular it could be made more specific that the adjustment be made to both of the opposing screws. Also, a sentence stipulating that the number of screw turns to be made relates to after the point where the screws begin to engage would be clearer to the user.
