# Acquired platelet storage container leaks and contamination with environmental bacteria: A preventable cause of bacterial sepsis

## Abstract

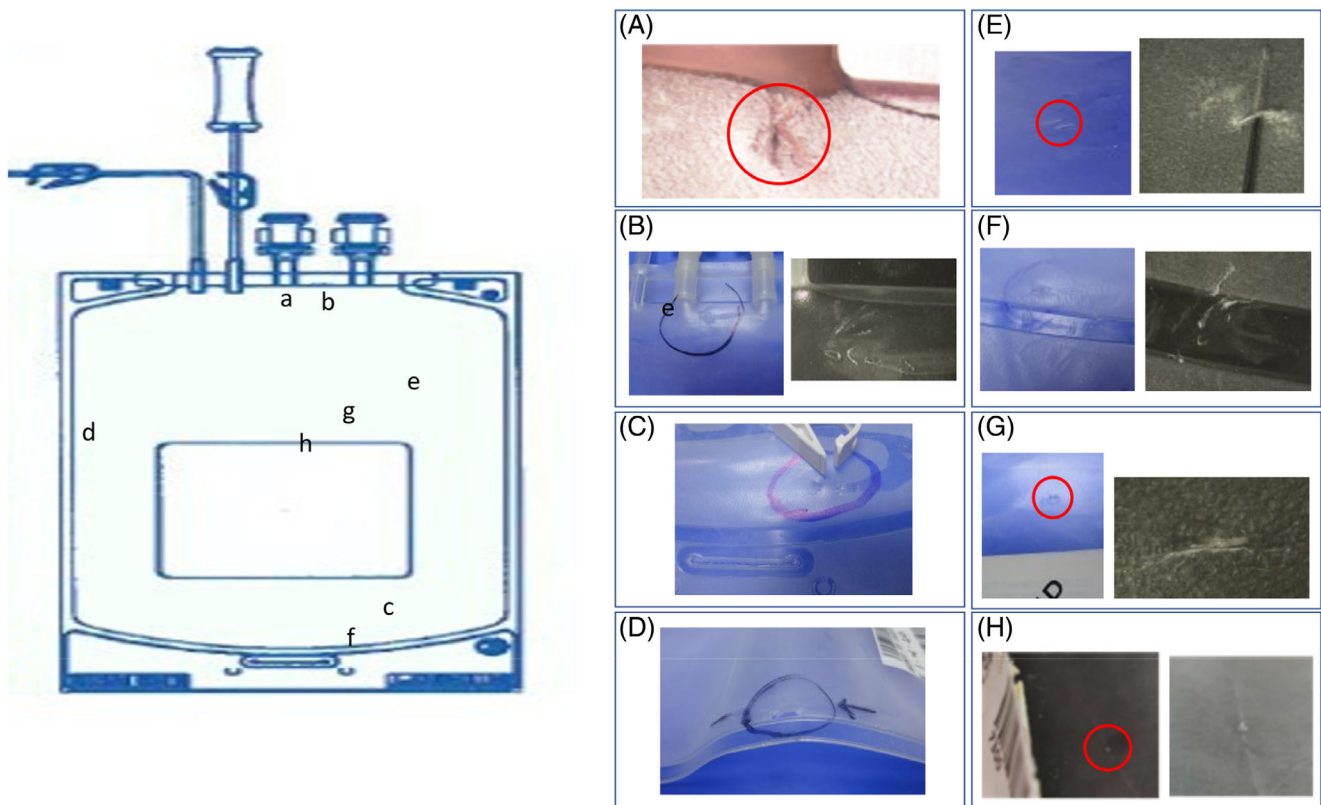
FIGURE 1 Site of damage and photographs of storage container damage as described in Table 1 under incident light and by microscopy

Reported case	Photograph <sup>a</sup>	Origin of complaint	Damage	Description	Cause
1 (index case)	A	Hospital	Scratch	No obvious leaks or damage to the container. Several scuff marks were noted on both sides. Abrasions were on the surface of the container and not very deep into the plastic.	Unknown Possible agitator damage
2	B	Hospital	Scratch	The sheeting bore a 18 mm-long horizontal scratch between the two outlet ports and a secondary scratch below the external outlet port. Magnification revealed that the sheeting had been pierced at the left side of the damage from left to right as if the front side sheeting had been pinched and had torn.	Unknown Possible agitator damage
3	D	Blood center	Scratch	Leak reported along the left part of the front side sheet. The container sheeting was crossed horizontally with a 5 mm-wide scratch above the base label, ended with large tearing of the plastic sheet along the bead of sealing and additional scratches on the flat seal. These observations suggested lateral friction effect on the container.	Unknown Possible agitator damage

4	F	Hospital	Scratch	The bottom right part of the container was seriously scratched with several deep imprints in both sides. Many long oblique scratches and the main imprint had pierced the two sheets, leading to the observed leak.	Unknown Possible agitator damage
5	n.s.	Hospital	Scratch	The container leaked from the back side, along the left side bead of sealing at the extremity of long horizontal scratches crossing the container width. The bead of sealing had been crushed and sliced, piercing the plastic sheet, and leading to the observed leak.	Unknown Possible agitator damage
6	n.s.	Hospital	Scratch	Container leaked in the top part of the front side through a little tear in the sheeting. Similar damage, lighter and not leaking, could be observed approximately 3 cm below. Oblique scratches formed of aligned curves led to these damages.	Unknown Possible agitator damage
7	e	Blood center	Imprint	Two little imprints, slightly oblique, could be observed in the top right part of the container, one in front and one in back, with similar aspect but a little lower in the back side. Magnification of the damages confirmed 3–4 mm wide tearing through the two sheets with upward scratch on the backside sheeting. The container looked pierced from the back with little upward friction effect.	Unknown Possible damage on agitator or during transport

8	C	Blood center	Imprint	Two deep oblique imprints in the bottom part of the container, at the back. The location and aspect of these imprints, piercing the back sheet and causing a leak, corresponded to the location and shape of the clamps in the individual overwrap.	Improper storage during illumination step

Reported case	Photograph <sup>a</sup>	Origin of complaint	Damage	Description	Cause
9	G	Blood center	Imprint	Two containers bore a similar horizontal cut, in the same location, a little above the base label. No other scratch, imprint, or any other damage observed. The location of the two cuts matched when both containers were stacked. These data suggest the containers were pressed between two sharp, 2 mm-long elements.	Unknown Possible damage on agitator or during transport
10	H	Hospital	Pierce	Pin hole located at the top of the manufacturers label, covered by blood center label.	Unknown possible needlestick
11	No bag	Blood center	Unknown	Container leaking at level of external inlet port.	Unknown
12	No bag	Hospital	Unknown	Pinhole leak at the port.	Unknown
13	No bag	Hospital	Unknown	Pinhole leak at the port.	Unknown
14	No bag	Blood center	Unknown	Leaking through the port of the bag.	Unknown
15	No bag	Hospital	Unknown	Pinhole leakage at the top underneath the port of the unit.	Unknown

Six containers, five of which were reported by hospitals (Figure 1B,D,F), showed evidence of scratches consistent with damage inflicted by platelet agitators, that could occur if the containers were squeezed between shelves or between a shelf and the incubator walls with repetitive reciprocal motion leading to container damage. Four container leaks described in three reports by blood centers (Figure 1C,E,G) had holes or cuts associated with imprints into the plastic, compatible with contact with a foreign object with applied pressure, leading to damage. In a pair of cases reported by a blood center, the imprint was consistent with the outline of a plastic hemostatic clip used to stop flow from one bag to another. These cases suggest improper folding or stacking of platelet containers with a foreign object or the clip situated between the containers and applied pressure.

One case reported by a hospital described a pin hole leak in the plastic sheeting. Microscopic examination revealed a cored-out hole compatible with a needlestick injury in one sheet only (Figure 1H) underneath the blood center's label, suggesting injury before labeling. In 13 reports, the containers were not returned and the damage could not be assessed; however, five cases described the leaks as being related to the ports, four related to a seam, three had pinhole leaks in the sheeting, and one was not described.

All efforts should be made to avoid damage to AP storage containers. These include common sense advice such as avoiding the proximity of blades and needles; avoiding using box cutters to open packaging; minimizing handling of AP by storing with the label side up or down as recommended by the manufacturer to reduce the need to turn over the containers to read the label or to maximize gas exchange, respectively; ensuring agitators and their incubators are level to prevent movement, are cleaned and disinfected regularly with a disinfectant capable of killing *Acinetobacter* spp. and inspected for sharp edges or burrs; ensuring that containers are not in contact with each other or the incubator; positioning container ports to avoid their falling over an edge; not using clips or weights to hold containers in place as these may imprint or tear the sheeting; inspecting agitators regularly to ensure that containers have not moved; avoiding or controlling how AP are folded or stacked when shipping and ensuring that AP are not packed in shippers too tightly; ensuring that clips or extraneous objects are not trapped between containers; avoiding PC centrifugation in the storage container when “washing” platelets as storage containers are usually not validated for centrifugation while containing platelets; and packing carefully whenever using a pneumatic tube transport system. This list is not exhaustive, and blood centers and hospital transfusion services should consult their suppliers for specific advice on handling their products. A set of basic recommendations is included (Figure S1). One supplier has recently released lateral agitator guard barriers that may be magnetically attached to existing shelves to limit PC movement. A simple method of detecting leaks by applying manual hand pressure to AP concentrates resting on paper towels, by moving platelets to one-half of the bag with a sweeping motion of one hand and gently pushing the platelets with the fingertips of the other hand as described by Fadeyi et al., may enhance detection.<sup>7</sup> An active role by the blood center and hospital transfusion service to promote education at the time of hire and on a periodic basis regarding the importance of proper handling of blood containers may help to mitigate some of these cases of contamination and potential unnecessary loss of a donated unit.
