Case report

Bead debonding from a modern cementless total hip femoral component with concomitant taper corrosion

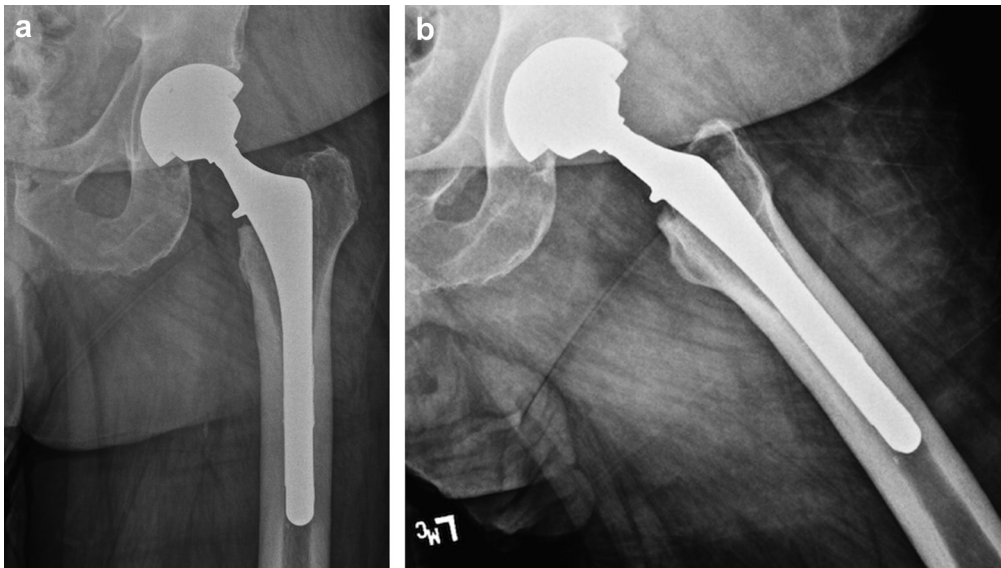
Figure 2. (a) AP and (b) frog lateral hip radiographs taken 3 months postoperatively demonstrate a left cementless primary total hip arthroplasty. There is irregularity at the surface of the femoral component in zones 2 and 3 suggestive of possible bead dissociation.

Review of prior radiographs from 3 months after surgery (Fig. 2) demonstrated irregularity at the surface of the femoral component in zones 2 and 3 suggestive of possible bead dissociation. Radiographs taken at the time of presentation in 2016 demonstrated multiple areas of osteolysis around the proximal and midfemoral stem and metallic debris collecting at the most distal areas of osteolysis. The acetabular component appeared well-fixed with decreased anteversion (Fig. 3). Inflammatory markers included a C-reactive protein level of 3.29 mg/L (normal 0–10 mg/L) and erythrocyte sedimentation rate of 9 mm/h (normal 0–20 mm/h). Serum metal ion levels included a cobalt level of 6.6 parts per billion (ppb; normal <1.0 ppb) and chromium level of 2.0 ppb (normal <0.3 ppb). A hip aspiration resulted in a white blood cell count of 163 with 10% polymorphonuclear leukocytes and no growth on culture. Magnetic resonance imaging with metal artifact reduction sequencing demonstrated a small hip effusion and trace fluid surrounding the femoral component in zones 1 and 7, but no definitive evidence of capsular thickness >4 mm or synovitis (Fig. 4). There was no fluid collection noted surrounding the contralateral hip. After a prolonged discussion with the patient, the decision was made for revision left total hip arthroplasty.

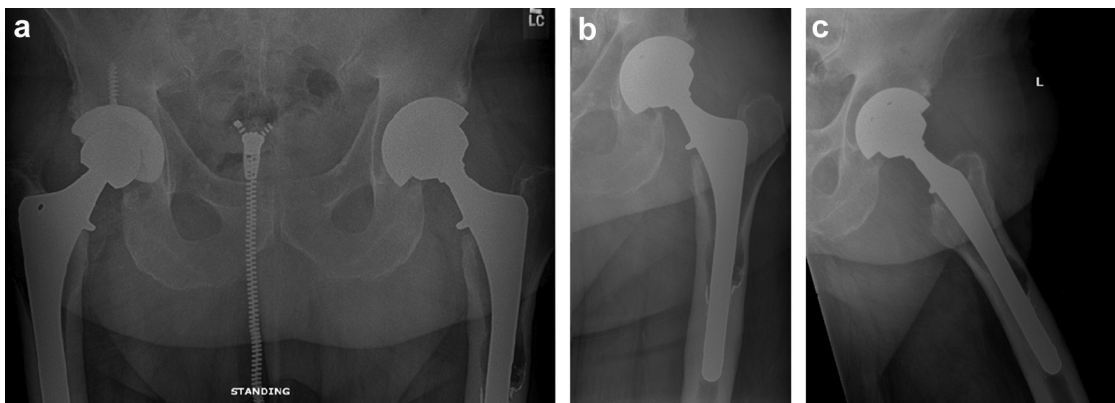
Figure 3. (a) AP pelvis, (b) AP hip, and (c) frog lateral hip radiographs taken at the time of patient presentation, 4 years after total hip arthroplasty, showing multiple areas of osteolysis around the proximal and midfemoral stem and metallic debris at the most distal areas of osteolysis.

It is our hypothesis that osteolysis occurred secondary to corrosion products in this case patient. One possibility is that initial aseptic loosening occurred secondary to head-neck taper corrosion. In this scenario, the proximal osteolysis would then have concentrated stresses on the distal aspect of the stem, causing it to receive the full burden of weight-bearing. This increased force may have exceeded the fatigue tolerance at the bead-implant interface resulting in debonding of the distal beads and gross implant loosening. This theory is further supported by the patient's obesity, a risk factor for trunnionosis, as well as the particular use of the initial femoral stem, which has a higher than expected rate of corrosion [26]. An alternate explanation is that nonintegration of

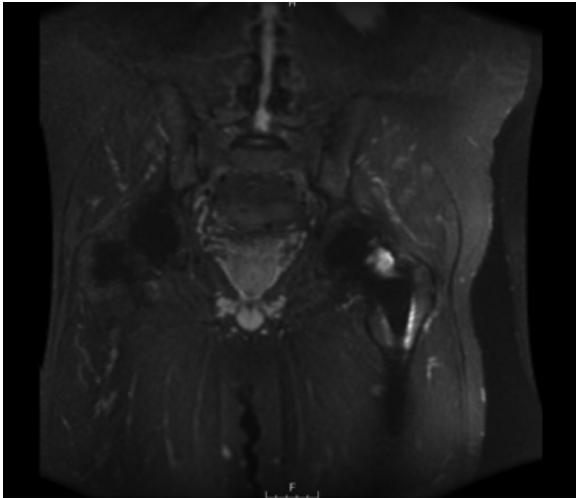
Figure 4. Coronal metal artifact reduction sequence magnetic resonance image demonstrating a small hip effusion and trace fluid surrounding the femoral component in zones 1 and 7. There was evidence of capsular thickness >4 mm and synovitis; there was no fluid collection noted surrounding the contralateral hip.

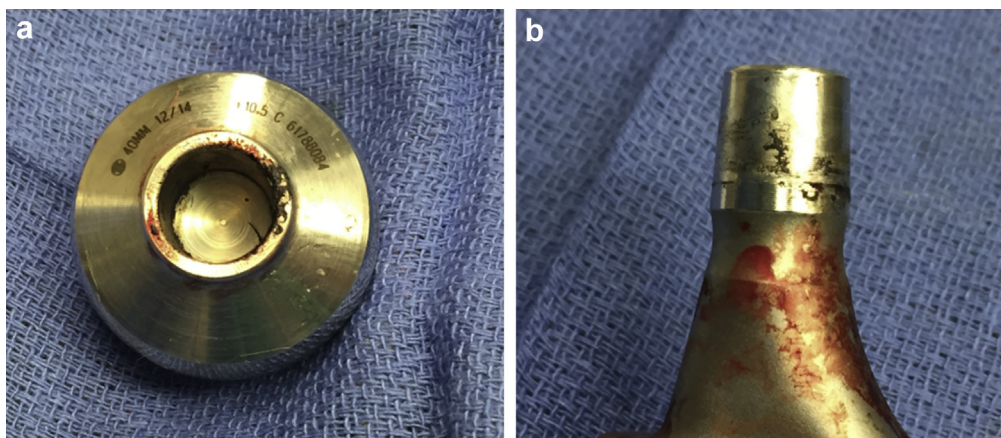
Our patient was found to have taper corrosion at the modular head-neck junction. Modular hip implants provide intraoperative flexibility to optimize hip biomechanics and joint stability.

Figure 5. Photographs of the explanted (a) femoral head and (b) trunnion demonstrating debris consistent with corrosion products.

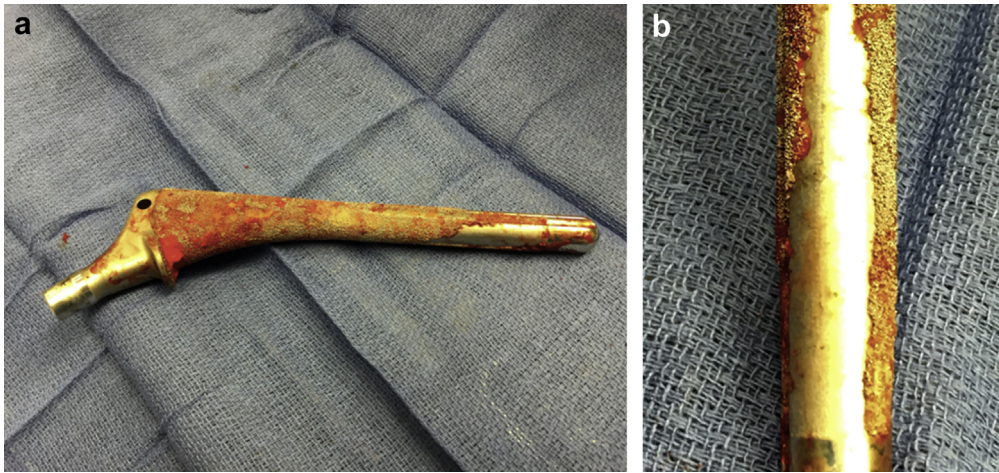
Figure 6. (a) Explanted femoral component with visible bead loss at the distal portion of the stem. (b) Close-up of the distal medial phase of the explanted femoral stem with bead loss.

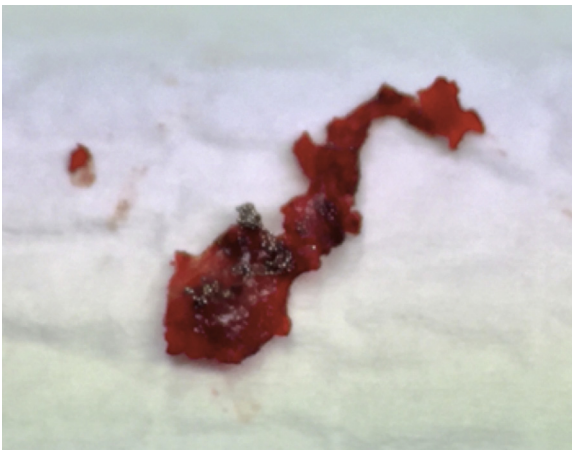
Figure 7. Photograph of removed contents of the femoral canal after component explant showing debonded metallic beads.
