Primary hip replacement stem taper fracture due to corrosion in 3 patients

Michael M MORLOCK¹, Dennis BÜNTE¹, Harmen ETTEMA², Cees C VERHEYEN², Åke HAMBERG³, and Jeremy GILBERT⁴

¹Institute of Biomechanics, TUHH Hamburg University of Technology, Hamburg, Germany; ²Isala Hospital, Zwolle, the Netherlands; ³Östersund Hospital, Östersund, Sweden; ⁴Syracuse University, Syracuse, NY, USA.

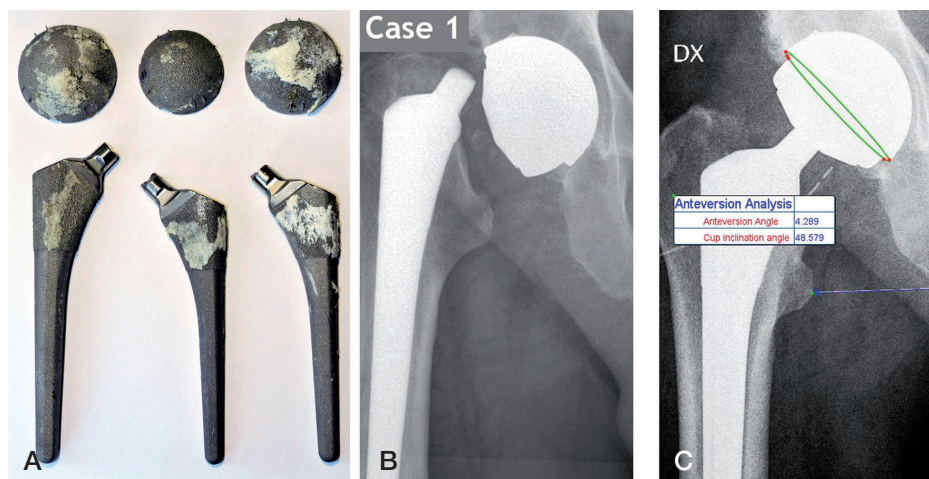
The patient was a 62-year-old physically active man who had had an uneventful primary hip replacement until he felt a sudden snap in the right hip followed by intense pain, 4 years after surgery. Radiographs showed the broken stem taper. The

Figure 1. A. The 3 revised stems (left to right: case 1, case 2, and case 3). The bone attached to the implants is an indication of the ingrowth of the implants and the extent of bone defect caused during revision. B. Post-fracture radiograph of case 1. C. Pre-fracture radiograph of case 1. Cup angles were measured using image analysis software available at www.imatri.com (Joubert 2013).

hip was revised to an uncemented KAR stem and a Pinnacle cup with a ceramic-on-ceramic 36-mm bearing articulation (DePuy, Leeds, UK). The surgery was uneventful. Blood serum metal ion concentrations at revision were as follows: Co, 0.9 µg/L; Cr, 2.0 µg/L; and Ti, 61 µg/L.

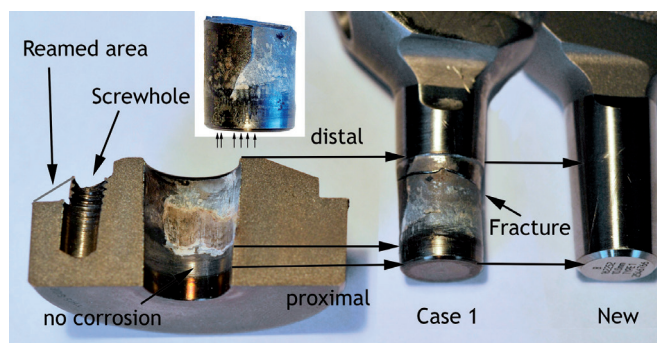
Figure 2. The cut ball head insert and stem taper (with broken-off piece placed in original position) together with a new stem taper. The screw hole was drilled into the ball head insert for removal (which was unsuccessful); reaming of the slope of the insert allowed holding on to the insert and successful removal. The distal edge of the ball head insert is imprinted circumferentially onto the stem taper (arrow). The proximal edge of the contact between male and female taper and also the edge of the corroded area are marked on the taper insert together with the corresponding position on the stem taper. The insert shows the scratches in the non-corroded area originating from entrapped bone pieces (small arrows) in the broken-off stem taper piece.

The taper contact area is divided into a small intact region (proximal) and a large corroded region (distal, Figure 2). Signs of small bone fragments were identified in the intact contact region, suggesting contamination that prevented incomplete seating (“jamming”) during assembly. The male stem tapers showed a circumferential impression of the distal edge of the female insert taper (Figure 2).

Case 1 showed pronounced scratches at the proximal end of the male stem taper interface, probably due to contamination with bone during assembly. This may have prevented the taper from fully seating, resulting in increased micromotion during in vivo loading (Jauch et al. 2011) and thus promoting the observed formation of thick layers of TiO₂ (Grupp et al. 2010). In the other 2 cases, biological material was also found in the taper interface, but not in such a clear form as in case 1. The high fixation strength of the broken-off stem taper tip in the ball head insert was due to the thick layers of TiO₂ (Figure 4). Conversion of the Ti alloy to oxide creates high pressure at the taper interface, since the volume of oxide is 70% higher (Ti has a Pilling-Bedworth ratio of 1.7), making it almost impossible to disassemble the components (“cold welding”).

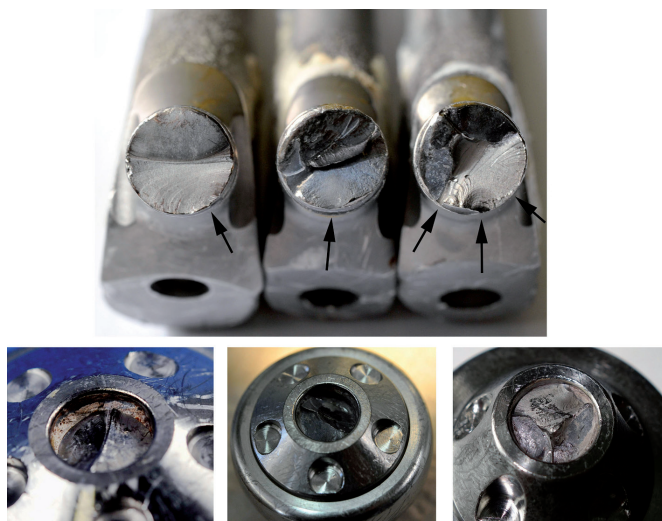
The fracture surfaces revealed fatigue fractures with rest lines radiating out from the origin of the crack (Figure 3). The location of the crack origin was always located on the lateral side, with the highest bending load during activities. All fractures occurred about 1–4 mm inside the taper contact (Figure 3). White deposit identified as titanium oxide (TiO₂) by EDX analysis was always found at the taper interface (Figures 2 and 3).

Figure 3. Upper panel: Stem fracture surface with fatigue cracks radiating out from the origin of the crack (black arrows) as a series of concentric rings (rest lines; left to right: cases 1 to 3). Case 3 had 3 crack origins, which subsequently coalesced into a unified fracture.

Lower panel: All the fractures occurred slightly inside the female taper (about 1–4 mm proximally from the open end). The broken-off male stem taper piece remained inside the female ball head insert taper.

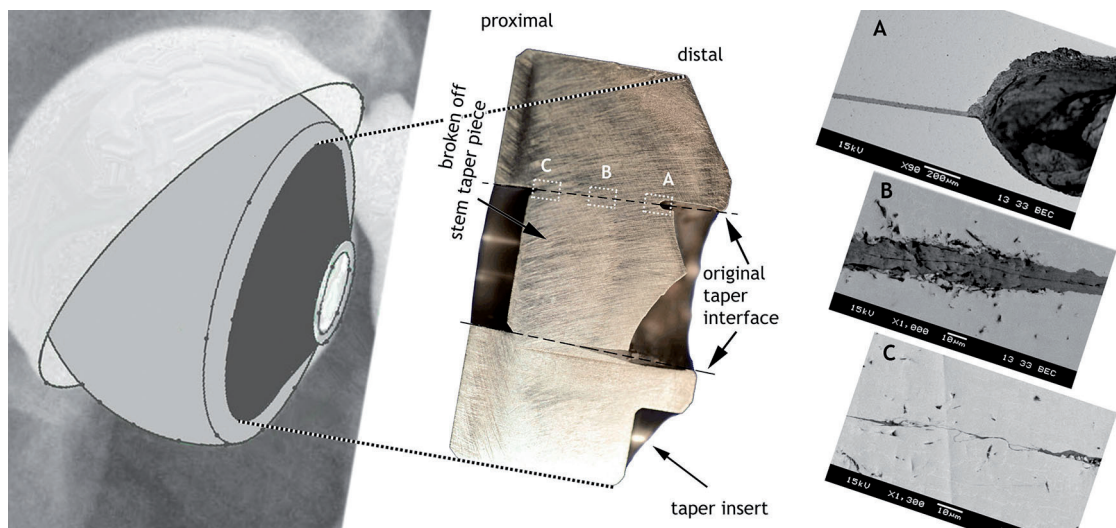
Figure 4. Left panel: Orientation of cup and head in case 2. Middle panel: Aligned orientation of the cut ball head insert with the fractured stem taper piece (dashed lines: original taper surface; areas A, B, and C for SEM are highlighted). Right panel: A. SEM of the corrosion cavity at the location of conversion to a smaller gap. B. SEM image of the middle of the taper articulation. The line down the middle of the dark TiO₂ layer marks the location of the original metal interface. The bulk titanium material was converted directly to TiO₂ by corrosion. C. SEM of the proximal end of the articulation. Tight junction between male and female taper surfaces with asperity contact and thin oxide layer.

The cut, assembled taper interface from case 2 was analyzed using SEM. The fracture originated in the large corrosion cavities (up to 500 μ m wide), which were found close to the distal end of the taper (Figure 4). The gap between the male and female taper surfaces narrowed to about 40 μ m in width at the proximal end of these cavities. The thin gap was filled with titanium oxide. Moving proximally at the taper interface, the oxide layer narrowed and became very thin until there was direct contact between asperities at the most proximal intact region (Figure 4C).
