Fracture of cobalt-chrome modular neck in total hip arthroplasty

Summary. Despite the advantages of modular total hip arthroplasty in terms of neck version, offset and length precise reproduction, titanium necks breakage became a concern. Consequently, titanium has been replaced by cobalt-chrome (Co-Cr). However, four cases of Co-Cr modular neck breakage have been reported in the literature. In the present paper, two cases of Co-Cr modular neck fractures are described together with a literature review. The aim of this work is to discuss the risk factors and characteristics of this rare complication. We described two cases of fracture of long varus Co-Cr modular femoral neck connected with cementless press-fit stem. Some risk factors, such as long varus type of modular neck, overweight and/or high demanding physical activity, might have contributed to implant failure. (www.actabiomedica.it)

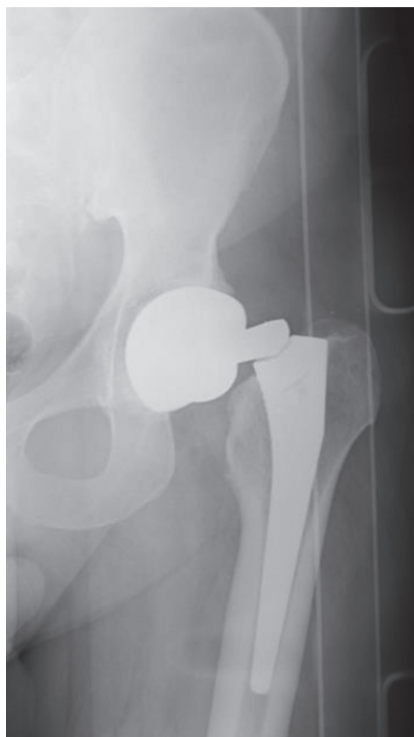
a BioloX Delta size 36 head. Postoperative radiographic control showed a correctly placed hip prosthesis, with a regular post-operative course. The patient resumed his daily activities without limitations or pain. In June 2015 (4 years postoperatively), the patient heard a crack from his left hip while he was jumping from a one-meter high wall. Thereafter, he referred severe hip pain with motion and inability to weight bearing on the affected limb. The patient came at the emergency department at our Institution, where left hip radiographs were taken demonstrating a fracture of the modular neck at the stem-cone junction (Fig. 1a). Both acetabular and femoral components seemed to be well fixed, and the femoral head remained attached to the proximal fragment of the modular neck. There were no clinical, radiographic or laboratory signs of infection.

Figure 1a. Case 1. Left hip AP view radiographs showing a fracture of the modular neck at the stem-cone junction

After 4 days, the patient underwent revision total hip arthroplasty through a postero-lateral approach to the left hip. The modular neck fracture resulted to be complete with fragmentation at the stem-neck junction.

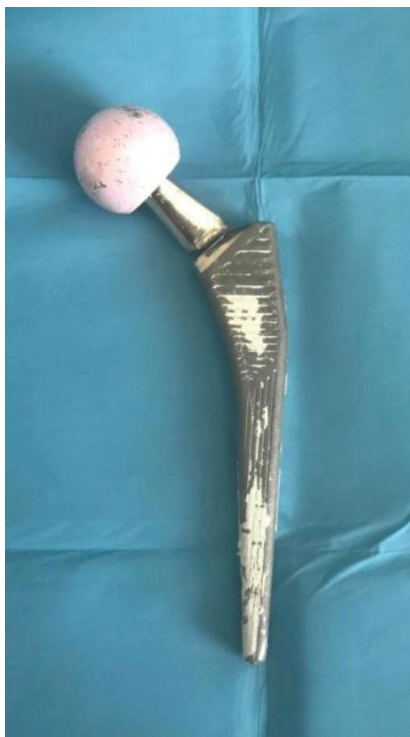
Minimal fretting and corrosion damage on the surface that had mated with the femoral stem was observed (Fig. 1b). No macroscopic signs of metallosis were observed, thus no serum metal levels were obtained. Surgical intervention included femoral head and neck removal, accurate debridement of soft tissues and removal of the well-fixed stem through a Wagner femoral osteotomy. Finally, a cementless Lima Revision stem (Lima Corporate, Udine, Italy) with cerclage wires to stabilize the femoral osteotomy was implanted (Fig. 1c). The bearing surface was ceramic on poly with a BioloX Delta head size 36 head. Intraoperative microbiological cultures confirmed the absence of infection.

Figure 1b. Case 1. Photograph showing the removed stem, neck and prosthetic head. A complete fracture of the modular neck occurring at the stem-neck junction is visible

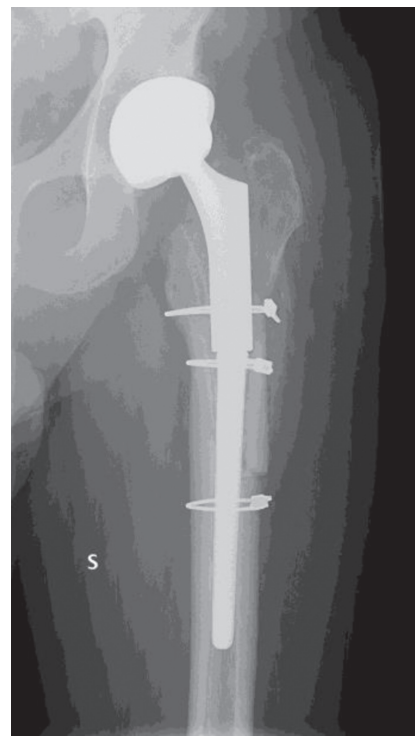
Figure 1c. Case 1. Left hip AP view post-operative radiographs showing implant revision
