Inappropriate subcutaneous implantable cardioverter defibrillator shock due to incomplete sealing of the seal plug: a case report

Division of Cardiology, Cardiovascular and Aortic Center, Saiseikai Fukuoka General Hospital, 1-3-46 Tenjin Chuo-ku, Fukuoka 810-0001, Japan

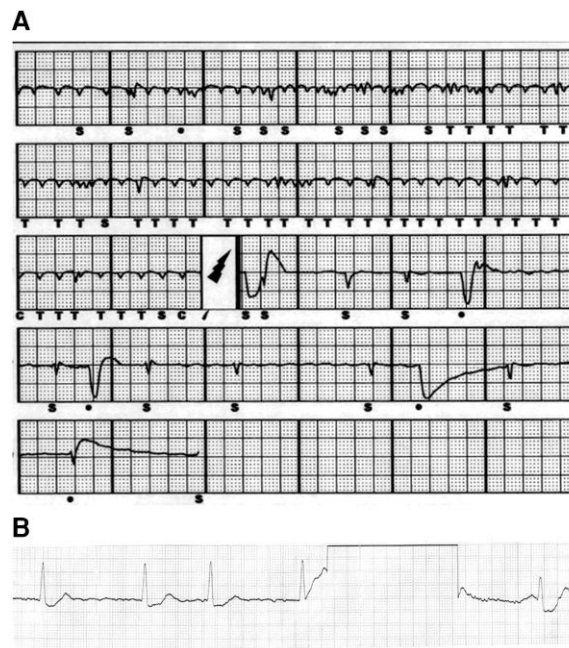
Figure 1 (A) Continuous noise oversensing observed on the seventh post-operative day. The marker channel indicates that the device mislabels noise as ventricular tachyarrhythmia, leading to inappropriate shock (lightning bolt). (B) The monitor electrocardiogram at the same time. The basic rhythm was atrial fibrillation and no ventricular tachyarrhythmia was observed.

On the seventh post-operative day, inappropriate shock was delivered again (Figure 1). Device interrogation revealed that a reproducible noise could be detected by tapping at the generator but not at the proximal or distal electrodes. There was no obvious evidence of lead dislodgement, air entrapment around the devices, or a loose pin at the connector on fluoroscopic imaging (Figure 2). Because the reproducible noise was observed in both the secondary and alternate vectors, the sensing vector was changed from the alternate vector to the primary vector. Appropriate shock delivery without a sensing abnormality was confirmed by a defibrillation test. On the sixteenth post-operative day, the patient was discharged from the hospital with optimal medical therapy in accordance with the current guidelines, including amiodarone (200 mg per day), which was initiated in the current admission. No β -blocker therapy was introduced because of sinus bradycardia below 50 bpm.

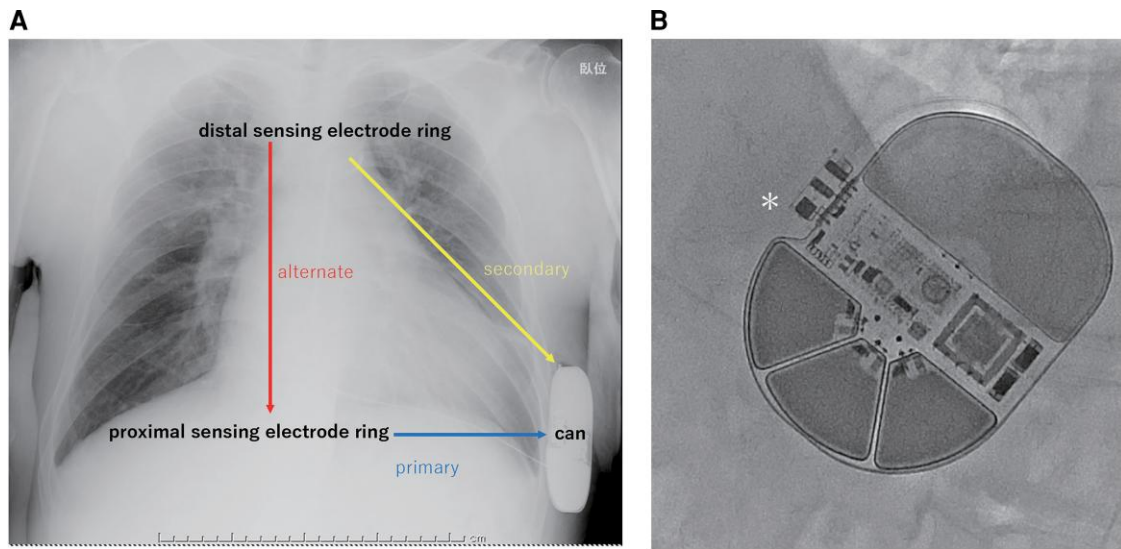
Figure 2 (A) Chest radiograph post-device implantation. Arrows indicate sensing vectors. (B) A fluoroscopic image of the S-ICD generator. Neither air entrapment nor loose pin was observed at the connector (*).

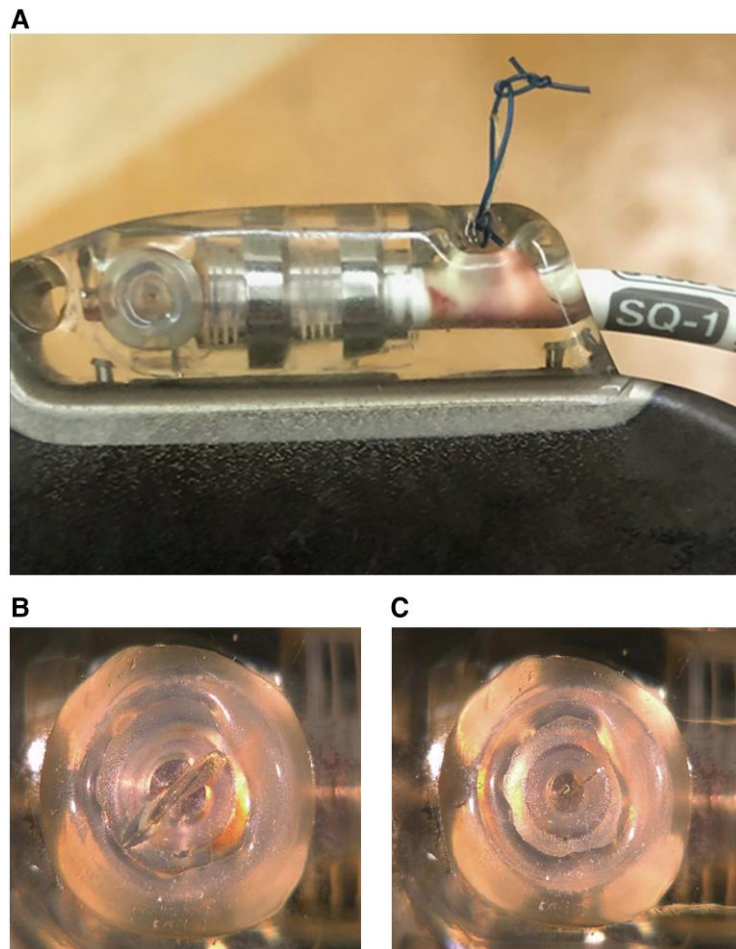
Figure 3 (A) The header of the removed device. The tip of the connector was inserted appropriately. There was no evidence of a loose pin. (B) The seal plug in close-up. The slit was slightly open. (C) The seal plug after reinsertion of a torque wrench. The slit was closed without any damage.

Two months after the discharge, the patient died of VF after receiving appropriate S-ICD shock delivery seven times. The S-ICD was retrieved from the body (Figure 3A), and it was revealed that the seal plug was incompletely sealed (Figure 3B). However, after reinsertion of a torque wrench, the seal plug returned to its normal closed position without any damage (Figure 3C).

In the present case, incomplete sealing of the seal plug caused lead noise and inappropriate therapy. The electrocardiograms illustrating our patient's events are similar to those previously reported.⁶ Because the seal plug returned to its normal closed position without any damage after reinsertion of a torque wrench, the inappropriate shock therapy might have been prevented if we had checked the seal plug carefully at the time of implantation. Therefore, we advocate confirming the seal plug routinely after the removal of the torque wrench.
