Making a Molehill out of a Mountain: A Case of Transesophageal Echocardiographic Probe Malfunction

Prabhakaran Gopalakrishnan, MD, Swathi Jothi, MD, Thelma Lasko, RDCS, and Stephen Denning, MD, *Canton, Ohio*

We report a case of technical malfunction during TEE leading to potential misdiagnosis of mitral regurgitation (MR) severity. TTE in a patient being evaluated for coronary artery bypass surgery showed severe MR. TEE showed trivial MR. Probe malfunction affecting color Doppler was suspected. After second probe insertion, MR was reclassified as severe. Timely recognition of probe malfunction avoided underestimation of MR severity. The patient underwent successful surgical revascularization with mitral valve replacement.

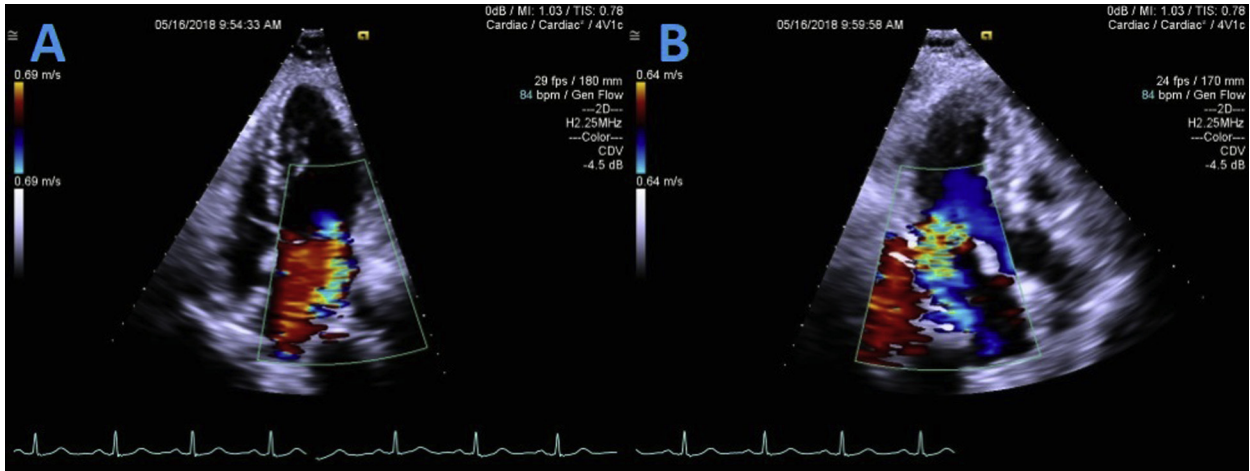
A 75-year-old woman with exertional dyspnea was found to have severe multivessel coronary artery disease and moderate (2+) MR during ambulatory cardiac catheterization. TTE demonstrated severe MR with an eccentric jet and preserved systolic function with an ejection fraction of 60% to 65% (Figure 1). Cardiothoracic surgery was consulted for coronary artery bypass grafting (CABG) with possible mitral valve repair. TEE was performed to assess the severity and mechanism of the MR.

Figure 1 Transthoracic images with color Doppler showing severe MR with eccentric posteriorly directed jet. **(A)** Apical four-chamber view. **(B)** Apical three-chamber view.

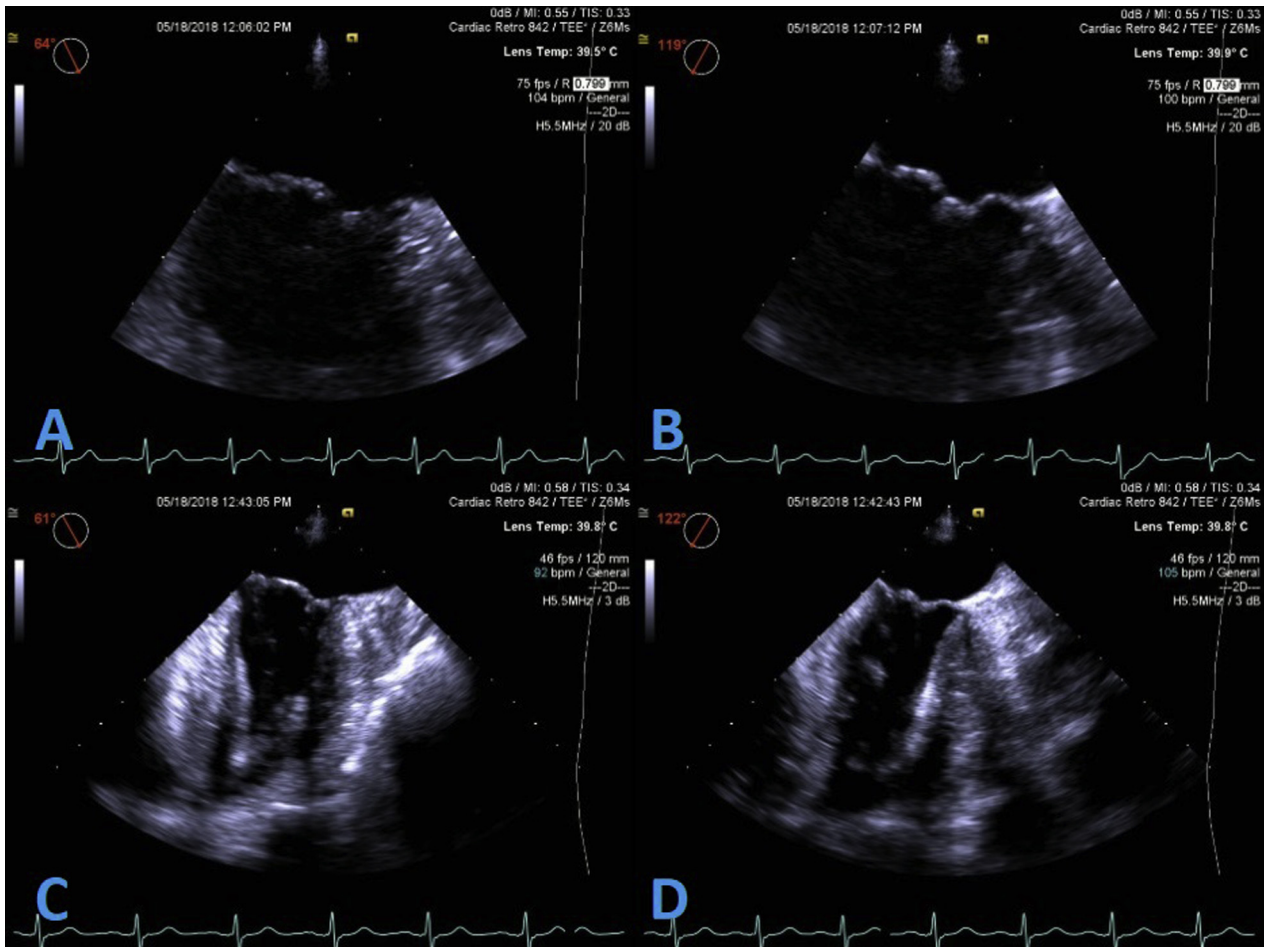
Figure 2 Transesophageal 2D images showing mild A2 prolapse in commissural and long-axis views with first transesophageal probe **(A, B)** and second transesophageal probe **(C, D)**.

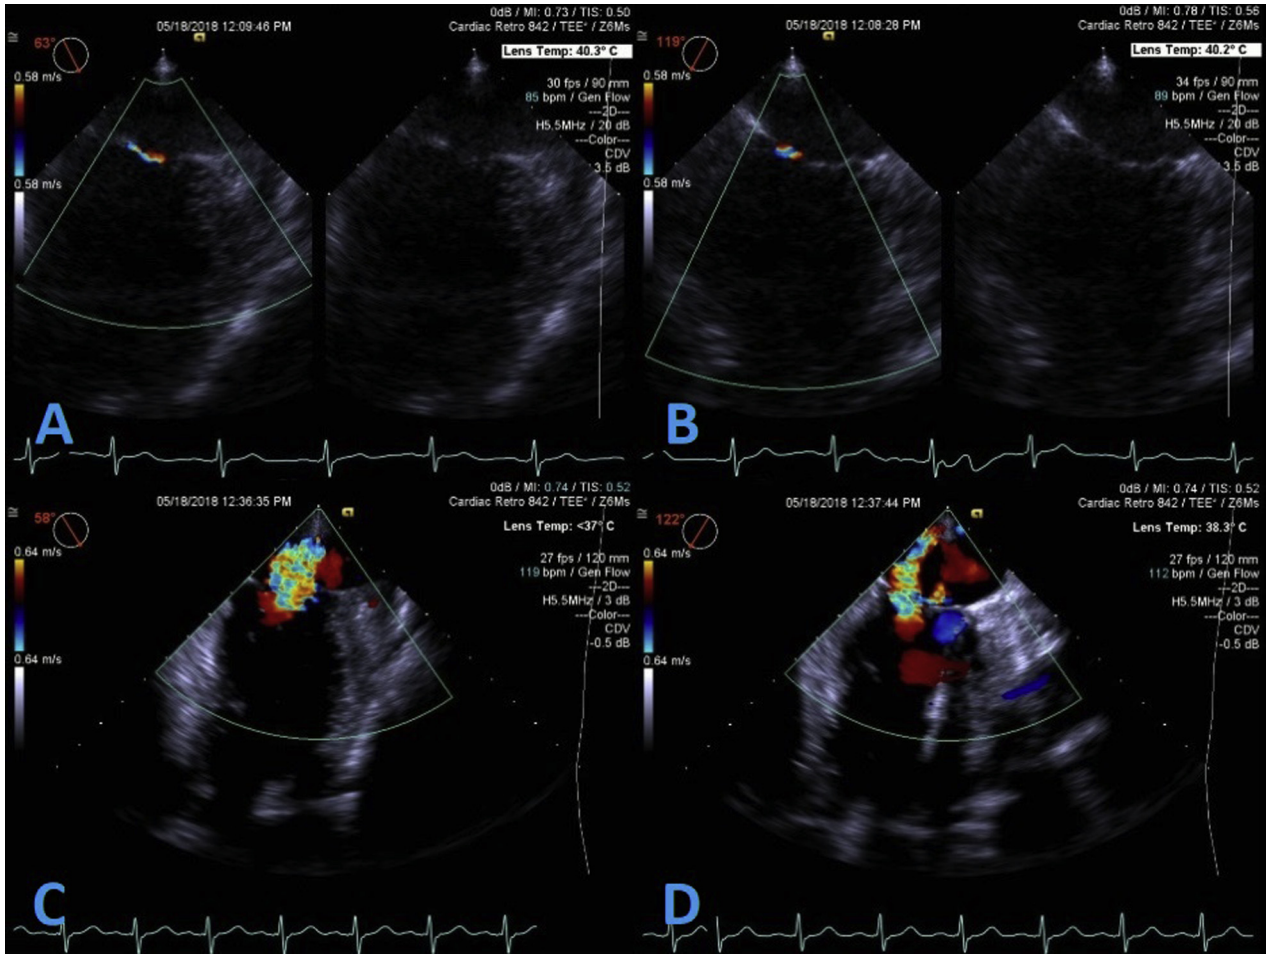
severity. The patient was extubated, and a new probe was inserted. Color Doppler evaluation (color Doppler gain -0.5 dB) of the mitral valve with the new probe showed significant MR

with an eccentric, posteriorly directed jet (Figure 3, Videos 4 and 5). The effective regurgitant orifice area was 0.33 cm², and regurgitant volume was 67 mL (Figure 4). The patient successfully

Figure 3 Transesophageal images with color Doppler in commissural and long-axis views showing trivial MR with first transesophageal probe (A, B) and severe MR with second transesophageal probe (C, D).

MR severity was significantly underestimated on TEE in our patient with the initial probe. Timely identification of probe malfunction

underwent CABG with mitral valve replacement with a 27-mm Magna Mitral Ease pericardial tissue prosthesis (Edwards Lifesciences, Irvine, California). The malfunctioning probe was replaced by the manufacturer.

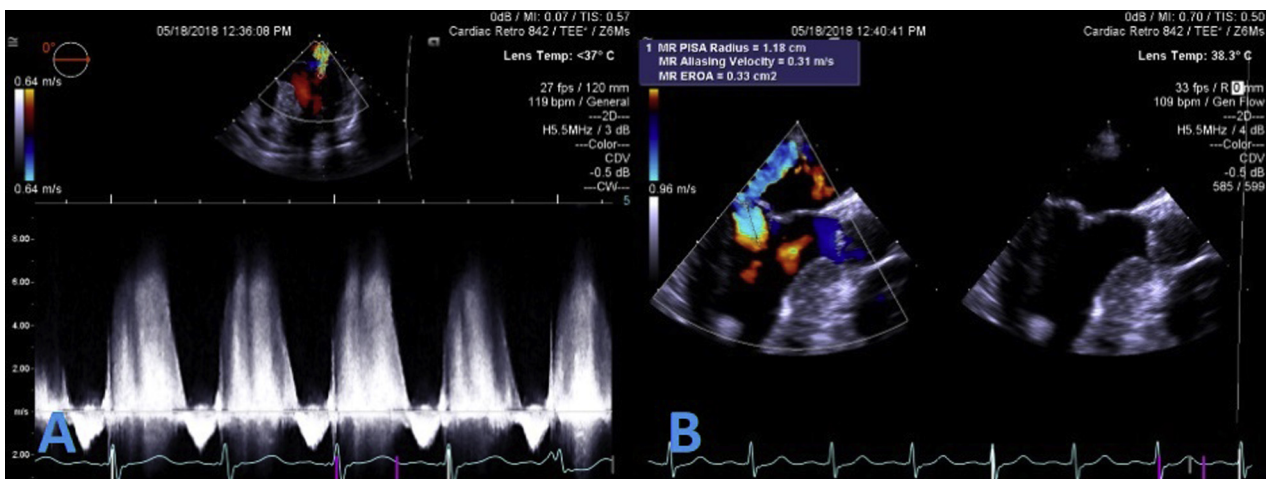
Figure 4 Quantification of MR. (A) Continuous-wave Doppler. (B) Proximal isovolumetric surface area measurement.
