# Sudden loss of the deep brain stimulation effect with high impedance without macroscopic fracture: a case report and review of the published literature

**Abstract:** The number of deep brain stimulation (DBS) hardware complications has increased during the past decade. In cases of abnormally high lead impedance with no evidence of a macroscopic fracture, optimal treatment options have not yet been established. Here, we present the case of a 49-year-old woman with a 12-year history of Parkinson's disease who received bilateral subthalamic nucleus DBS in March 2006. The patient showed good control of parkinsonism until December 24, 2010, when she awoke with abrupt worsening of parkinsonian symptoms. At telemetric testing, lead impedances were found at  $>2,000 \Omega$  in all four leads on the left side. Fracture of a lead or an extension wire was suspected. However, radiological screening and palpation revealed no macroscopic fracture. In June 2011, the implantable pulse generator (IPG) was changed under local anesthesia without any complications. Postoperatively, her parkinsonism immediately improved to the previous level, and the lead impedance readings by telemetry were also n

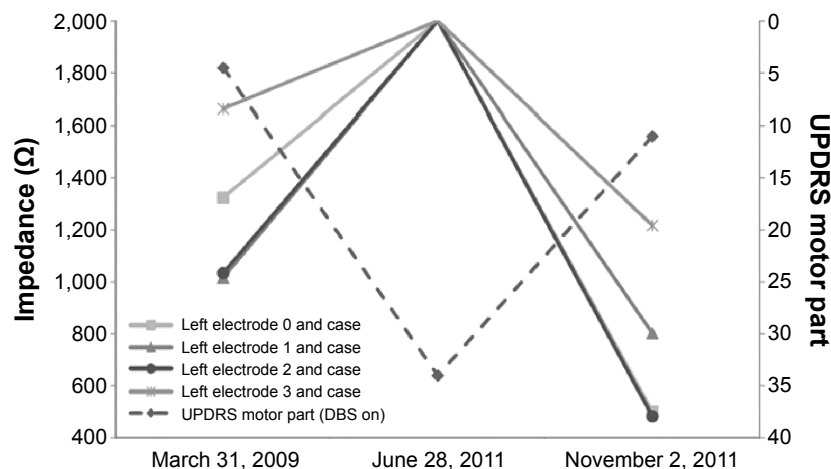
The patient was well until December 24, 2010, when she awoke with an abrupt worsening of her parkinsonism with no clear precipitant. Five days later, she visited our movement disorder center. On testing, the battery voltage levels were intact. Impedances were increased to  $>2,000 \Omega$  in all four lead contacts on the left side, indicative of an open circuit. The results did not change in multiple body positions.<sup>5</sup>

Prior to reoperation, her UPDRS motor scores with DBS stimulation were 34 with medication and 30 without (Figure 1). The scores without stimulation were 48 and 45, respectively. On June 29, 2011, the IPG was replaced under local anesthesia without any complications. Postoperatively, the patient's parkinsonian symptoms immediately improved under the same neurostimulator settings. The lead impedance readings on the left side were normalized. The extracted neurostimulator showed no visible signs of deformity. When tested with an oscilloscope at 1,000- $\Omega$  load impedance, the neurostimulator could produce stimulation waveforms. The destructive analysis by the manufacturer revealed that the case feed-through wire was lifted on the hybrid side, and this finding was consistent with the disconnection between the IPG hybrid circuit board and the connector block of the IPG header.

**Figure 1** Changes in lead impedances and UPDRS motor part scores before and after neurostimulator replacement.

During a follow-up period of 4 months with amantadine at 300 mg/day, no recurrence of parkinsonian symptoms or high impedance measurements were reported. On November 2, 2011, her UPDRS motor scores were 11 with DBS stimulation and 34 without (Figure 1). In the 2 years after

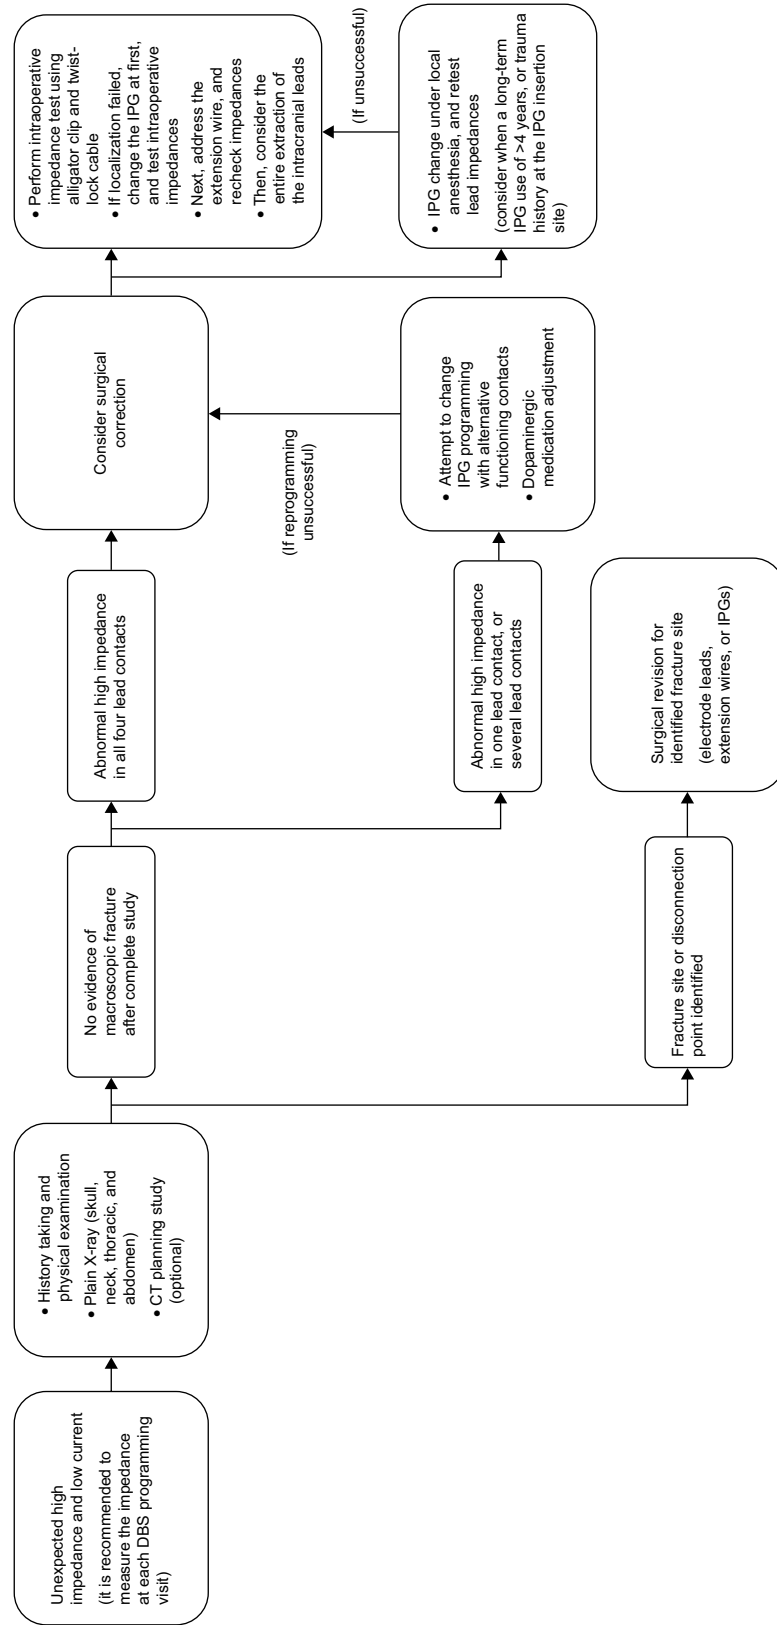
**Figure 2 A** suggested algorithm for assessing and troubleshooting hardware failures with high lead impedance and open-circuit state in a DBS system. **Abbreviations:** CT, computed tomography; DBS, deep brain stimulation; IPG, implantable pulse generator.

In cases of abnormally increased lead impedance and open circuit without a macroscopic fracture, the optimal treatment options are still not established. A proposed algorithm for assessing and troubleshooting those specific cases is presented in Figure 2.<sup>1,2,6,17</sup> Conventional IPG replacement under

local anesthesia is simple, and it can be performed in cases with unexplained high lead impedance before the decision is made to replace the electrode leads or extension wires. This approach may be preferred in patients with either a long-term IPG use of more than 4 years,<sup>20</sup> or a trauma history at the neurostimulator insertion site (Figure 2).<sup>8,15</sup> On the other hand, some cautionary notes should be sounded. The neurostimulator replacement procedure can cause several complications, such as infection or damage to the lead extender. If there is no clinical improvement after the IPG change, the extension wire replacement with a direct intraoperative testing of the intracranial leads during surgery should be the next step of management (Figure 2).<sup>1,6,14</sup> This staged approach can spare intact leads and extensions, and avoid unnecessary replacements and complications.
