# A novel cause of inappropriate subcutaneous implantable cardioverter-defibrillator therapies after a generator change

Timothy M. Markman, MD,\* Jeffrey Smietana, MD,\*  
Andrew E. Epstein, MD, FAHA, FACC, FHRS\*†

From the \*Division of Cardiovascular Medicine, Section of Cardiac Electrophysiology, Hospital of the University of Pennsylvania, Philadelphia, Pennsylvania, and †Cardiology Division, Corporal Michael J. Crescenz VA Medical Center, Philadelphia, Pennsylvania.

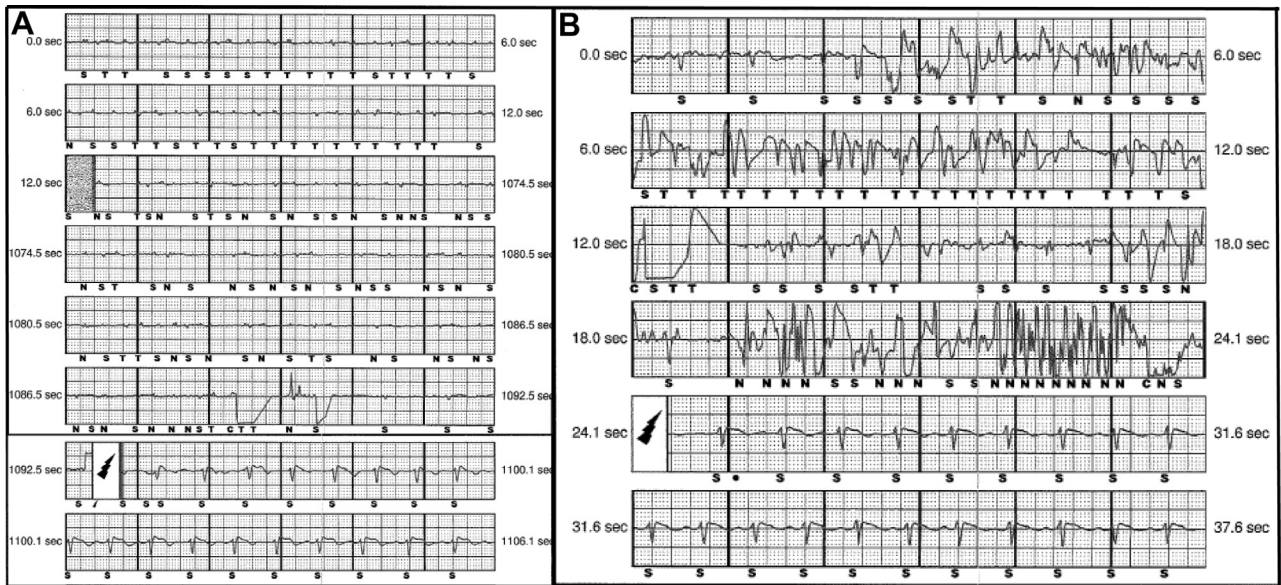
**Figure 1** Subcutaneous implantable cardioverter-defibrillator electrograms of inappropriate shocks. **A:** The first inappropriate shock occurred while standing. The device was sensing in the “Alternate” vector with low-amplitude signals and oversensing that had occurred for greater than 15 minutes followed by a brief period of electrical noise artifact before the shock was delivered. **B:** The second inappropriate shock occurred while supine in the emergency department. The device was sensing in the “Alternate” vector with high-frequency noise that lasted for approximately 20 seconds prior to the shock.

Device interrogation identified 2 inappropriate S-ICD shocks that occurred approximately 10 hours apart. Sensing was programmed to the “Alternate” vector for both shocks and the SMART Pass filter was programmed off. The first

shock occurred in the setting of low-amplitude signal with associated oversensing that had occurred for greater than 15 minutes followed by a brief period of electrical noise artifact before the shock was delivered (Figure 1A). The second

shock occurred in the setting of high-frequency electrical noise artifact that lasted approximately 20 seconds prior to the shock (Figure 1B).

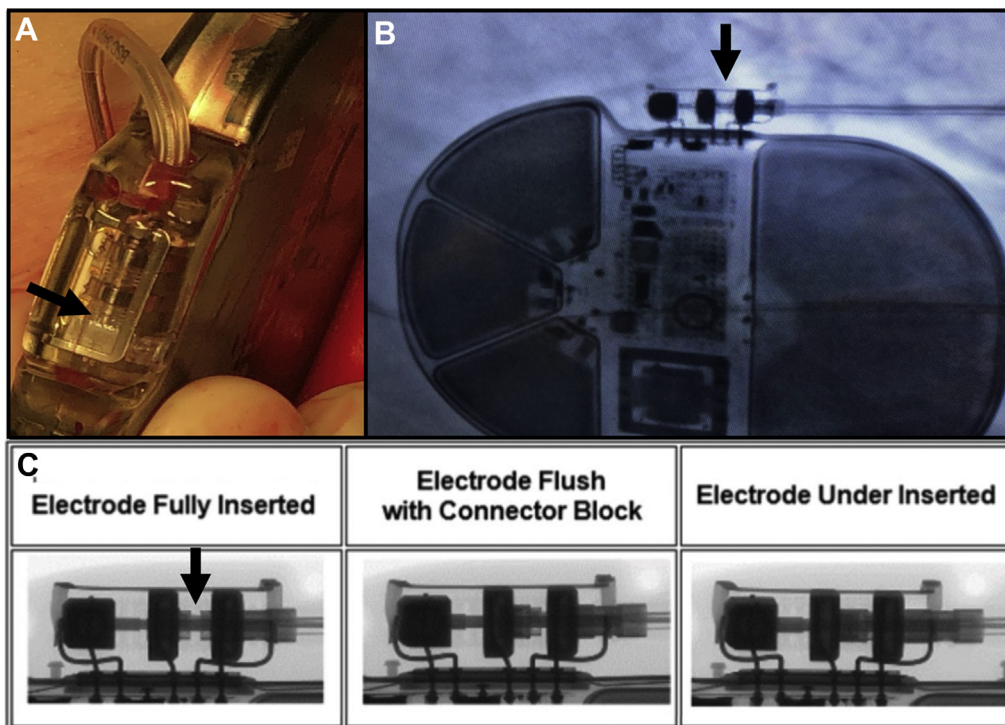
**Figure 2** Inspection of the subcutaneous implantable cardioverter-defibrillator at the time of device revision. **A:** Visual inspection of the device suggested that the lead was fully inserted in the header (arrow showing radiolucent marker). **B:** Cine fluoroscopy of the header suggested the lead was fully inserted in the header (arrow) when compared to panel C. **C:** Images showing the fluoroscopic appearance of fully (arrow showing radiolucent marker) and incompletely inserted leads (Courtesy of Boston Scientific, with permission).

Cine fluoroscopy identified no apparent fracture and the suture sleeve was not overlapping the primary sensing electrode, although both of these explanations remained possible, as the fracture may not have been visible on fluoroscopy and the lead could have been mobile within the suture sleeve. The decision was made to open the pocket and inspect the device visually to determine whether a problem with the lead-header interaction was present and to subsequently extract the device if no reversible etiology could be identified. On visual inspection the lead was fully inserted in the header, and on cine fluoroscopy of the pulse generator the lead appeared to be adequately positioned within the header. A loose set screw was unlikely to be the cause of the noise artifacts because pulling on the lead demonstrated that it was not movable within the header and when the screwdriver was inserted into the header, the set screw was confirmed to be tightly sealed. Given the reproducibility of the noise with manipulation of the lead, a fracture was initially suspected. After the lead was cleaned and reinserted, the electrical noise artifacts disappeared immediately and were not present in any vector. This confirmed that there had been inadequate connection between the lead and the header, despite the contrary visual and fluoroscopic evidence. Additionally, low-amplitude electrograms as seen in [Figure 1](#) were no longer observed after reinsertion of the lead into the header. This suggested that the low-amplitude signals were likely the result of insufficient electrode contact owing to inadequate insertion of the lead into the generator. Electrograms recorded during the second

There is no evidence that this problem could have been detected prior to the inappropriate shocks, as the lead appeared to be well inserted into the header, and there was no problem with sensing or noise at the time of implant and shock impedance at the time of defibrillation threshold testing was excellent. Furthermore, despite careful assessment of the S-ICD system, had the lead not been cleaned and reinserted, a fracture would have been assumed to be present, resulting in an unnecessary device extraction and implantation of a transvenous ICD. It is important that electrophysiologists be aware of this rare cause of inappropriate shocks and that inadequate lead-header interactions be assessed when other causes are not identified.

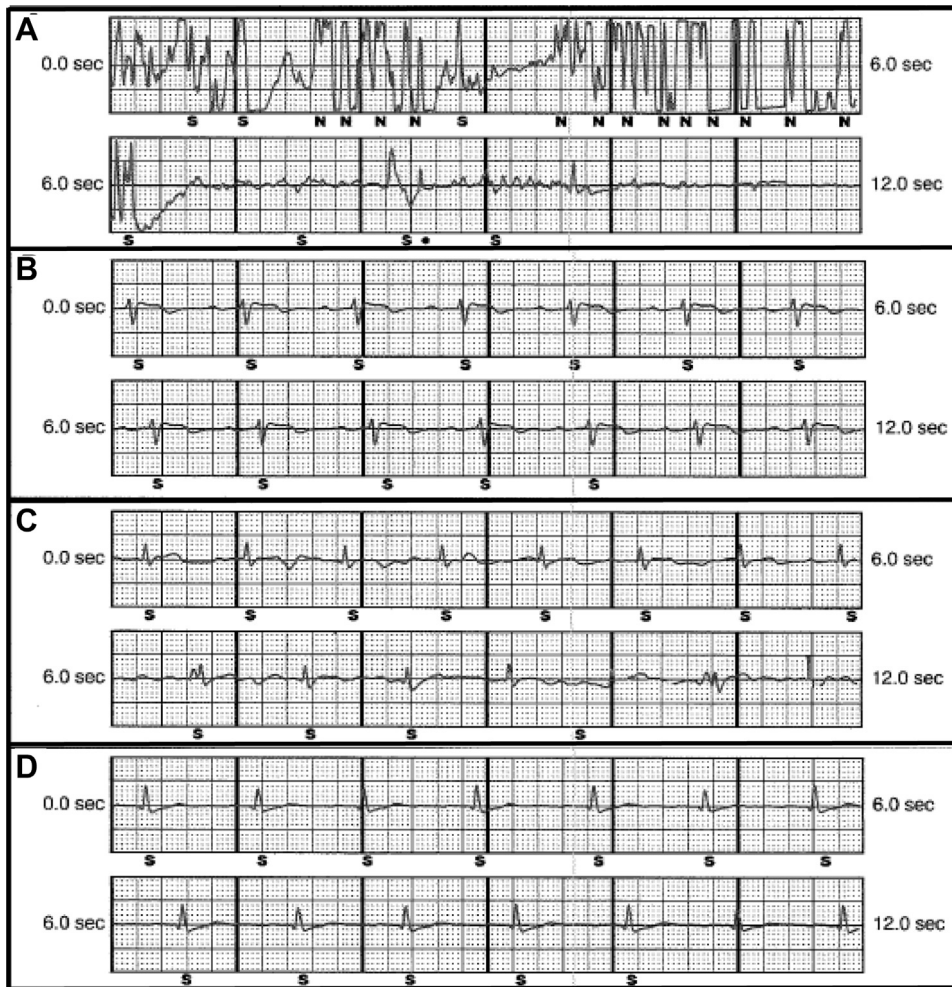
**Figure 3** Electrograms recorded during device revision. **A:** Noise similar to the clinical episodes was easily reproduced with manipulation of the lead within 5 centimeters of the header when sensing in the “Alternate” vector. **B–D:** After removing the lead from the header, cleaning it, and reinserting it fully, device and lead manipulation in the “Alternate” (**B**), “Secondary” (**C**), and “Primary” (**D**) vectors elicited no electrical noise artifact.

The following day, the patient was taken to the electrophysiology laboratory for evaluation of the device and possible extraction. In the preoperative area, manipulation of the lead and pulse generator were performed while sensing in “Primary,” “Secondary,” and “Alternate” vectors. No electrical noise artifacts were detected in standing, sitting, or supine positions. Cine fluoroscopy of the lead and generator revealed no evidence of lead fracture and the suture sleeve for the lead was separated from and not touching the primary, proximal electrode. The pocket was opened, the generator inspected, and the lead appeared to be fully inserted into the header (Figure 2A). Pulling on the lead showed that it was not movable within the header. Cine fluoroscopy of the generator and header showed appropriate placement of the lead within the header (Figure 2B and 2C). Manipulation of the lead within several centimeters of the header elicited reproducible electrical noise artifact similar to that recorded in association with the inappropriate S-ICD shock

(Figure 3A). A screwdriver was inserted into the header and the set screw was confirmed to be securely tightened. The lead was removed from the header and visual inspection revealed no apparent debris. While lead failure was suspected, on the off-chance that the lead was imperfectly seated in the header, the lead was cleaned with saline and gauze and reinserted into the header. Further manipulation resulted in no additional noise in any vector (Figure 3B–3D). The device was repositioned in the pocket and there was no additional noise noted. During 4 months of follow-up, there were no inappropriate therapies and there was no noise detected on the device.
